**FRIENDS OF THE HEADWATERS**  
**RESPONSE TO THE MINNESOTA DEPARTMENT OF COMMERCE**  
**LINE 3 DRAFT EIS - Dockets CN-14-916, PPL-15-137**  
**JULY 10, 2017**

**C-1 Montana IPTF**

CONSTRUCTION OF THE NORTHERN BORDER PIPELINE IN MONTANA

January 1982

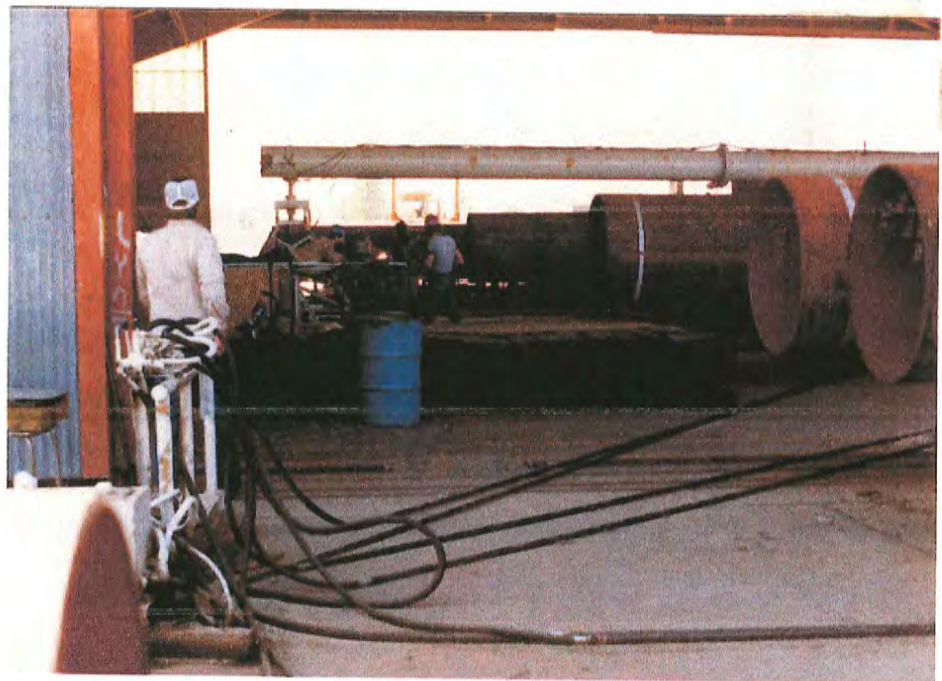
- #2 Two forty-foot sections were machine welded together at Valley Industrial Park ("double-jointing").

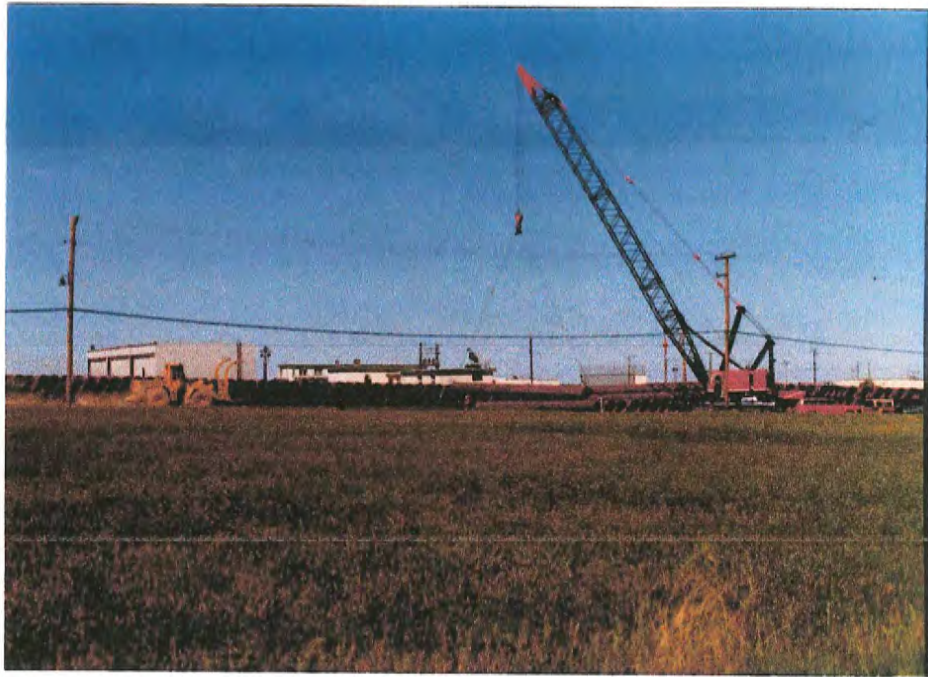
#3 Storage of 80-foot sections ("joints) at VIP.

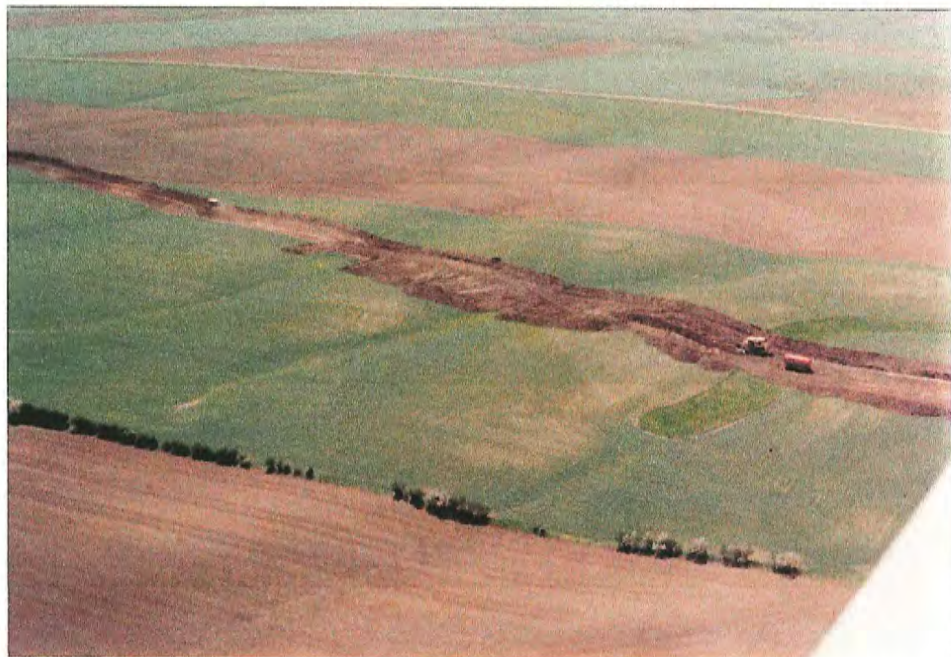
#4 Right-of-way clearing June 26. Soil and spoil is usually moved perpendicular to the centerline to simplify recontouring. All clearing was completed in Montana by July 15.

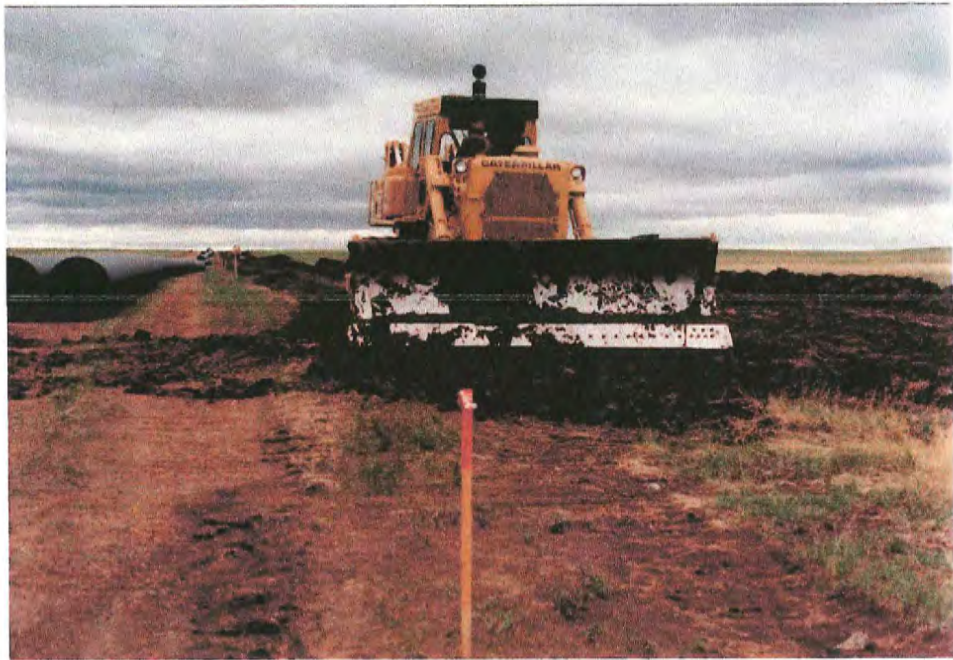
#5 Dozer blading 3-4 inches of topsoil from over trench area prior to ditching. This operation was combined with r-o-w clearing when the terrain was not as flat as shown in the photo, taken on July 16 on state land parcel VA057 west of the West Fork Procupine Creek.

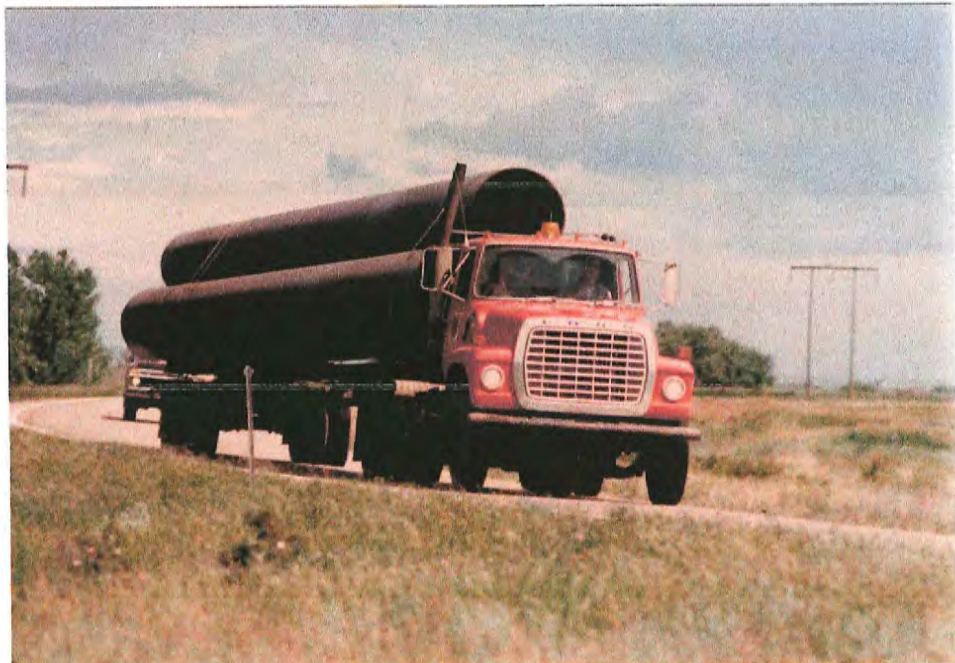
#6 Pipe truck hauling three 80-foot joints on U.S. Highway 2. Load is approximately 63,000 pounds.

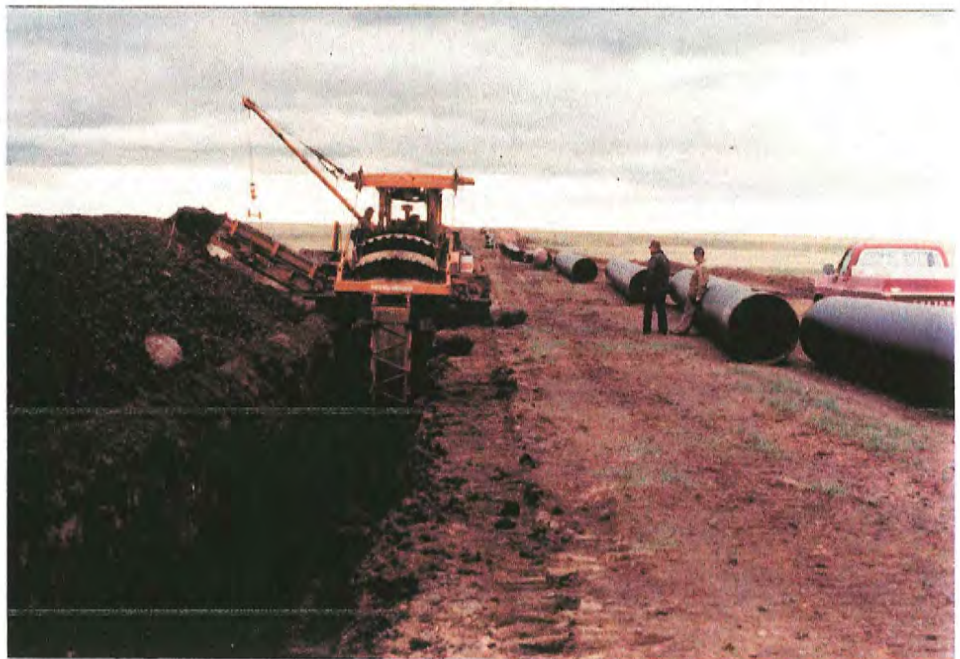
#8 Trenching on state parcel VA052 on July 16. Note the grass remaining on the work area. Terrain was flat and little side-hill cutting was required.

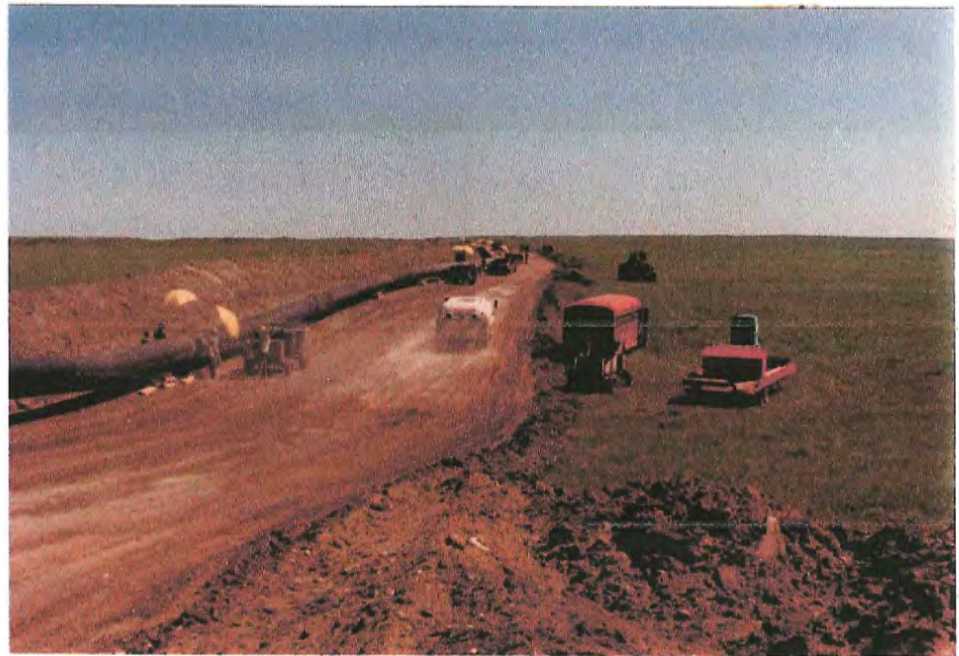
#11 Welding spread in Phillips County on state land parcel PH018 near Turkey Track Road. Photo taken June 25. Note the welding trailers at each weld. The farm tractor on the right side of the r-o-w was used to pull the trailer. The bus was used to bring pipeliners to work. It was about a 1.5 hour one-way trip to this work site from Glasgow.

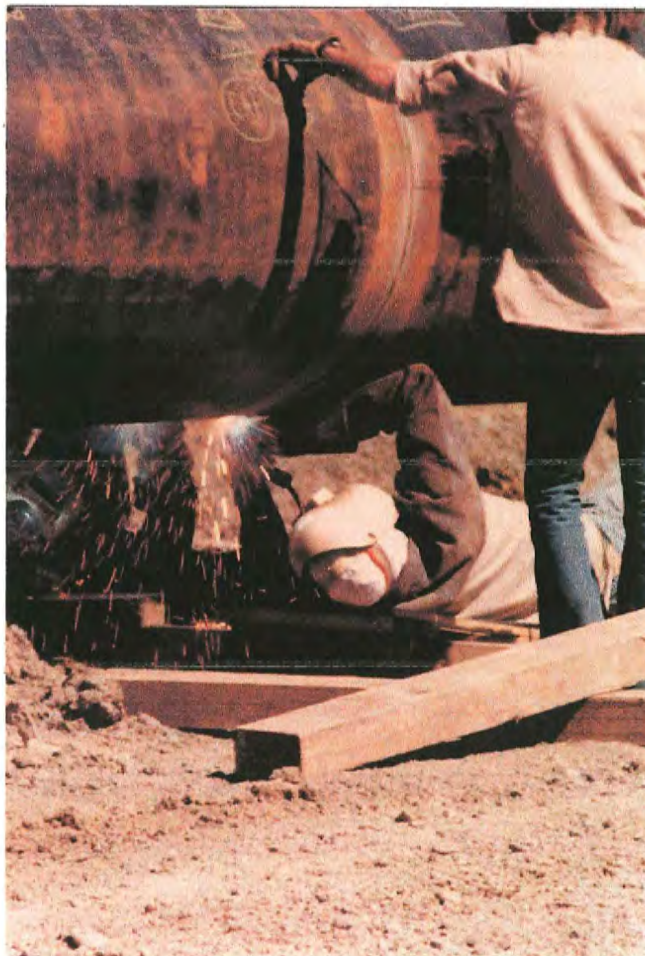
#12 Two welders joining 80-foot joints. Eleven welding passes were needed to join the .598 inch thickness pipe. Each weld was x-rayed for damage or faulty welds.

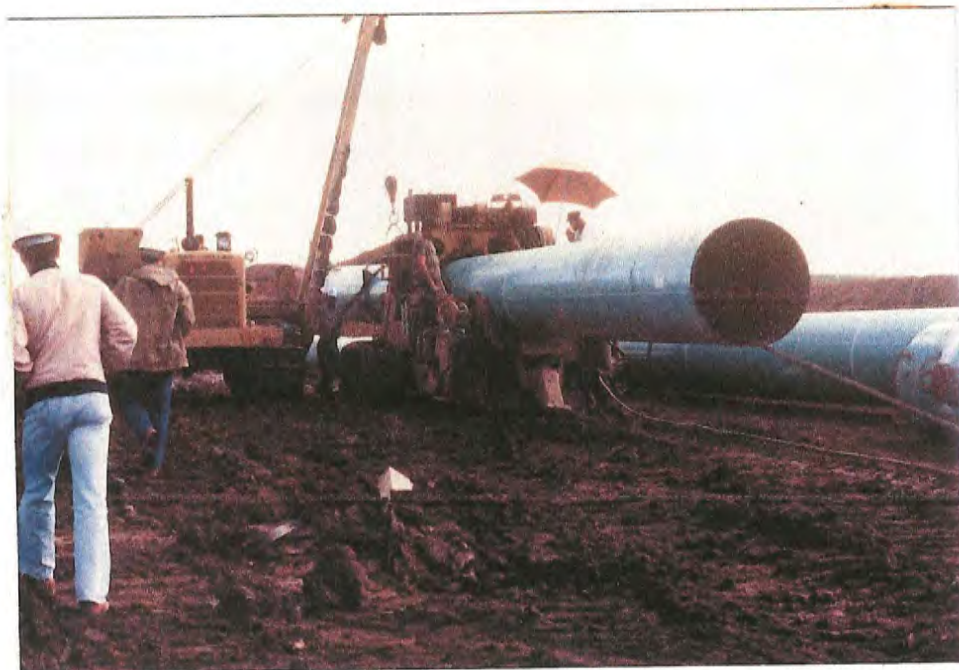
- #9 Pipe joint in bending machine in Idaho on the Western Leg of the ANGTS. Similar machines were used in Montana. Pipe was coated with teflon, rather than tape, on the Western Leg. Pipe is bent to closely conform to terrain after it is strung out on the r-o-w.

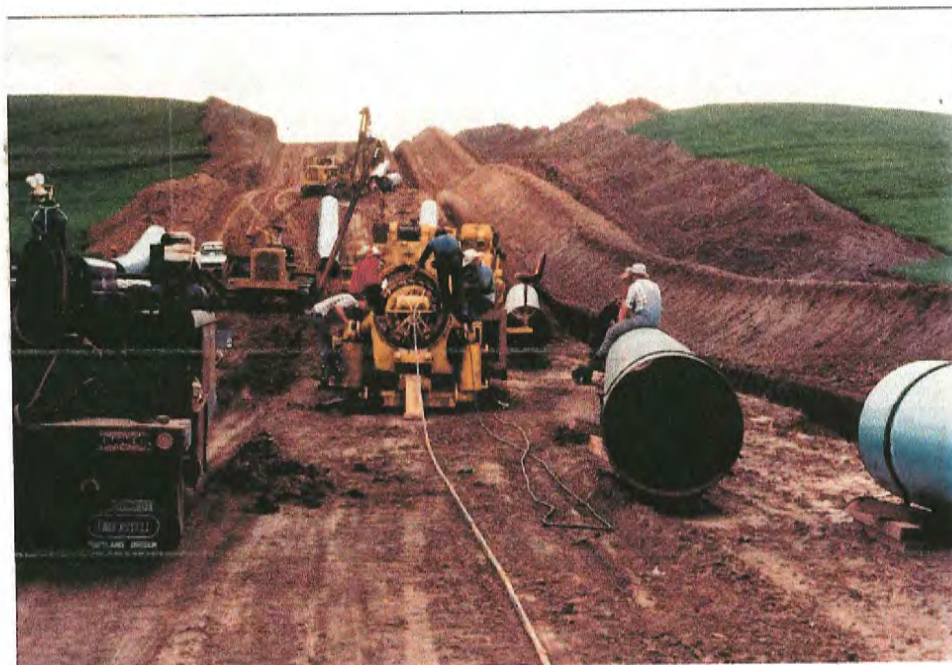
- #10 Bending machine again in Idaho. Note the "pig" which is run into the pipe joint to prevent kinking during bending by applying hydraulic pressure against the inside of the pipe. Photo taken June 24, 1981.

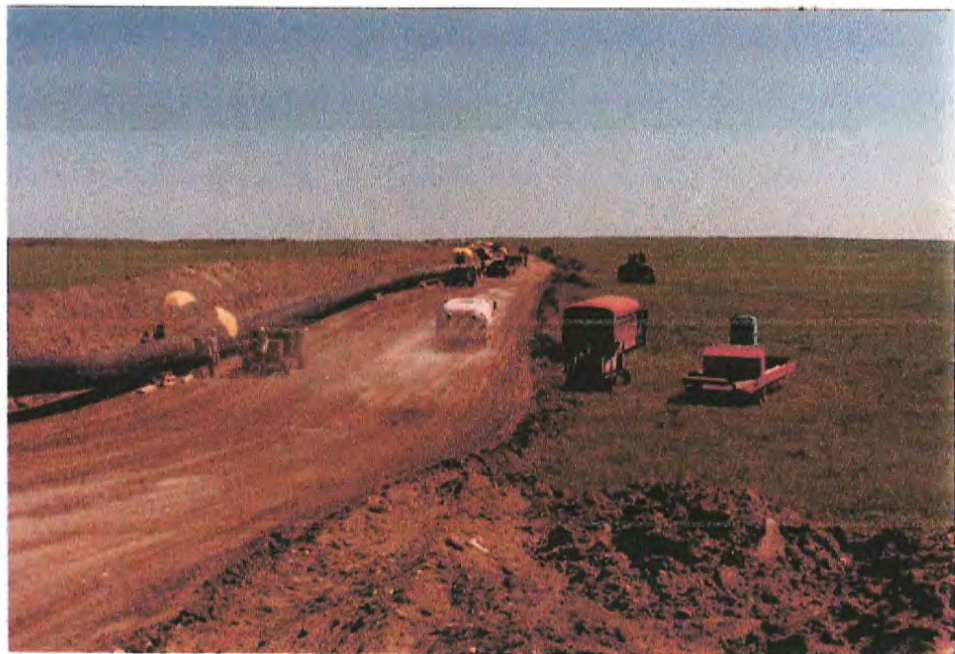
#11 Welding spread in Phillips County on state land parcel PH018 near Turkey Track Road. Photo taken June 25. Note the welding trailers at each weld. The farm tractor on the right side of the r-o-w was used to pull the trailer. The bus was used to bring pipeliners to work. It was about a 1.5 hour one-way trip to this work site from Glasgow.

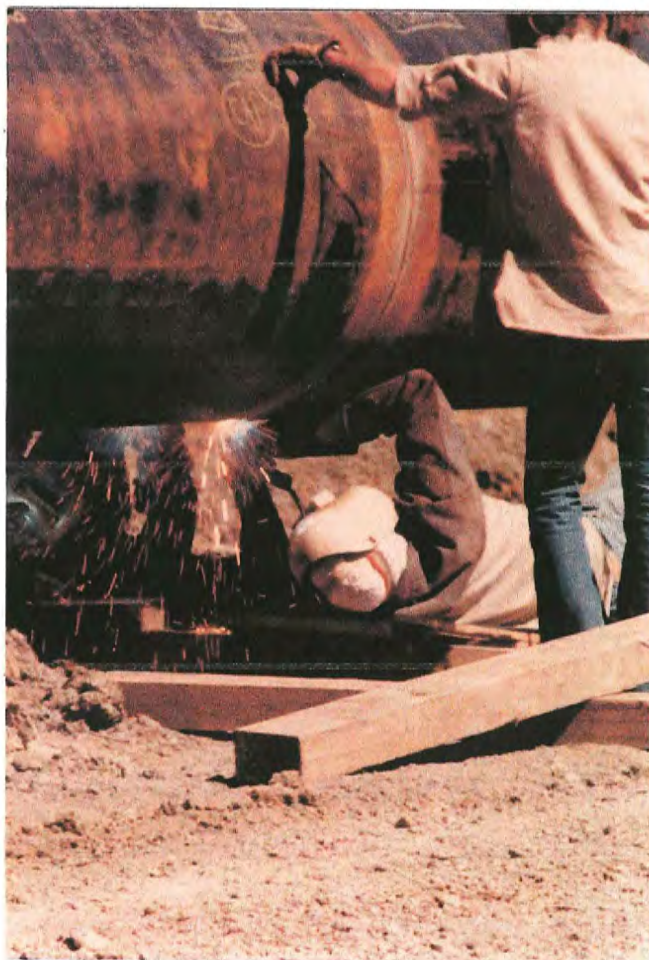
#12 Two welders joining 80-foot joints. Eleven welding passes were needed to join the .598 inch thickness pipe. Each weld was x-rayed for damage or faulty welds.

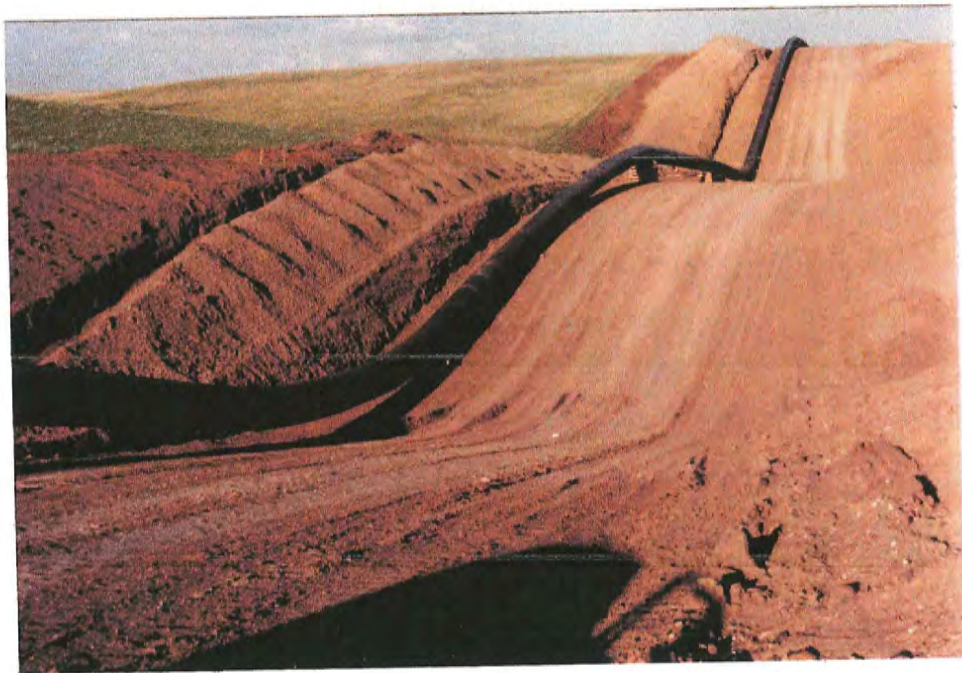
#13 Welding completed, and pipe ready for wrapping and lowering-in in Phillips County.

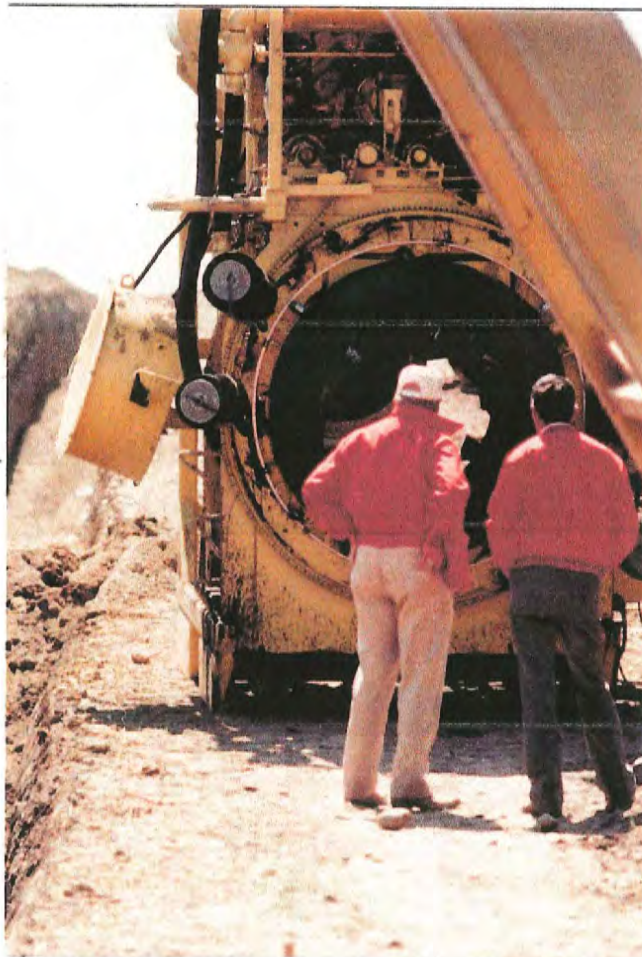
#14 Taping machine. In operation, it is suspended by a side-boom tractor. Pipe was coated with Teflon on the Western Leg of ANGTS rather than being wrapped with tape (see photo #9).

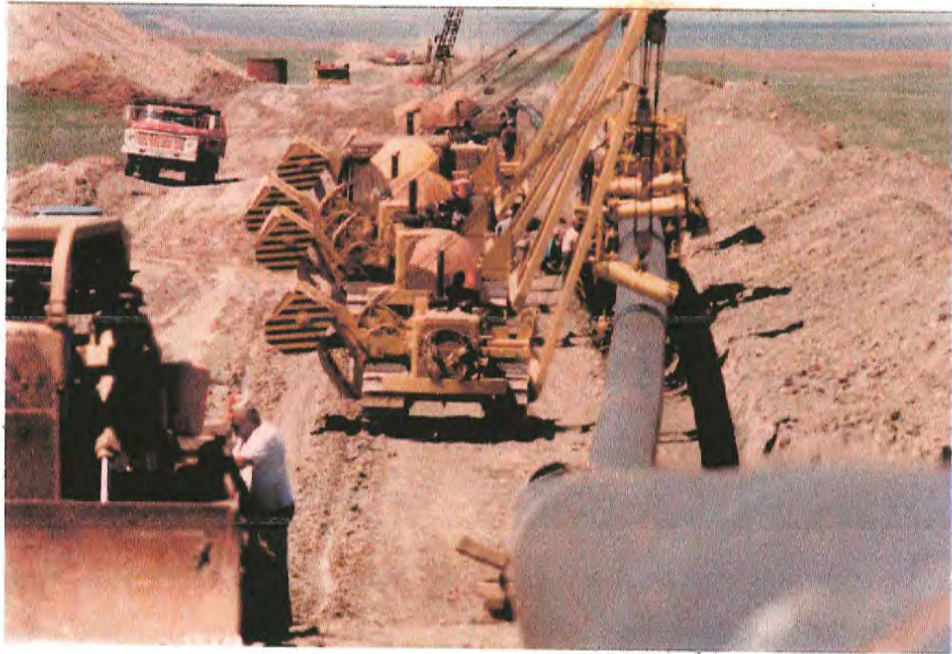
#15 Side-boom tractors lifting pipe and feeding it into the tape machine behind them. The tractors move slowly forward and the pipe is suspended on rollers. After wrapping, the pipe is lowered into the trench. The tractor in the foreground pulls a cart which carries hardwood blocks that prop up the welded pipe. This is state parcel PH012 on June 26.

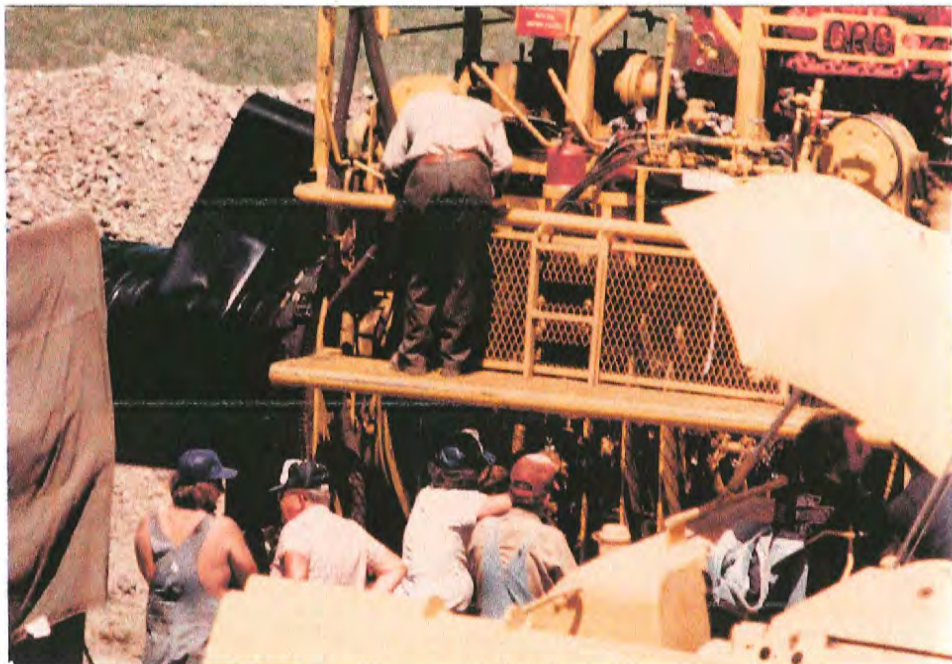
#16 Taping machine wrapping pipe with plastic tape to prevent corrosion. It was stalled at the time of the photograph.

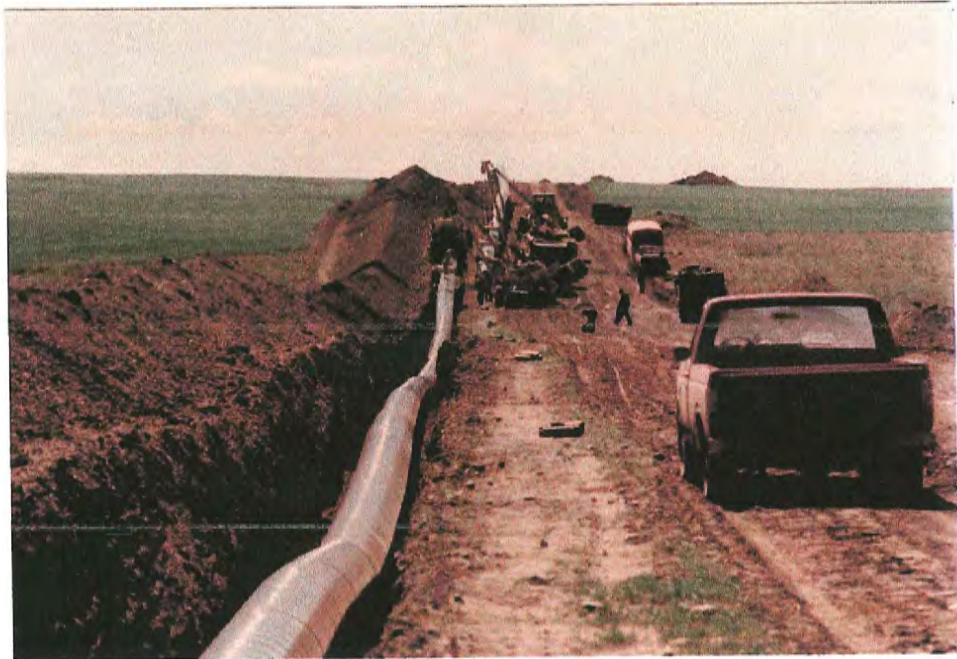
#17 Taped pipe after lowering-in, ready to be covered.  
Photo taken June 26 on state parcel PH012.

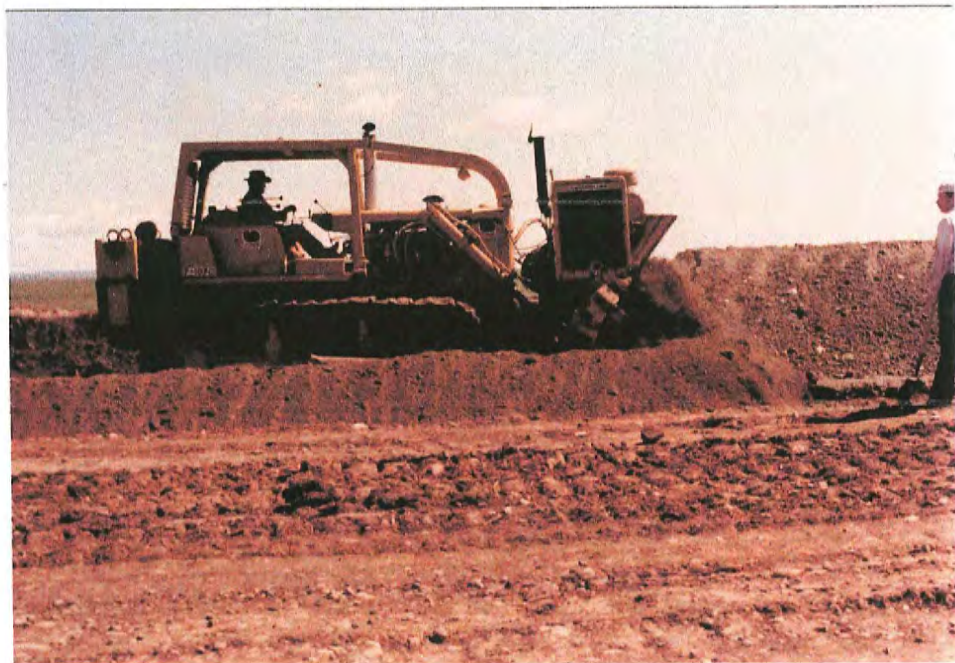
#18 Ditch spoil being replaced by auger mounted on front of tractor.

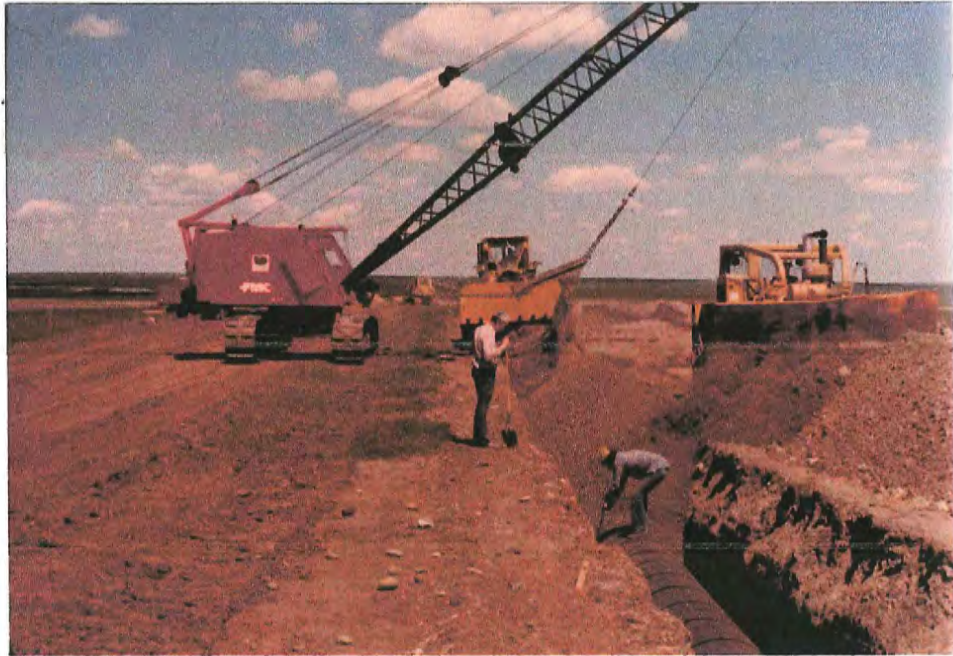
#19 Backfill operation consists of: augering, a dragline pulling in the rest of the ditch spoil, and a front-loader bringing up the rear acting as a packer. The man on the pipe in front of the auger is responsible for flipping rocks off the pipe to prevent damage to the wrap. Photo taken June 26 on state parcel PH012.

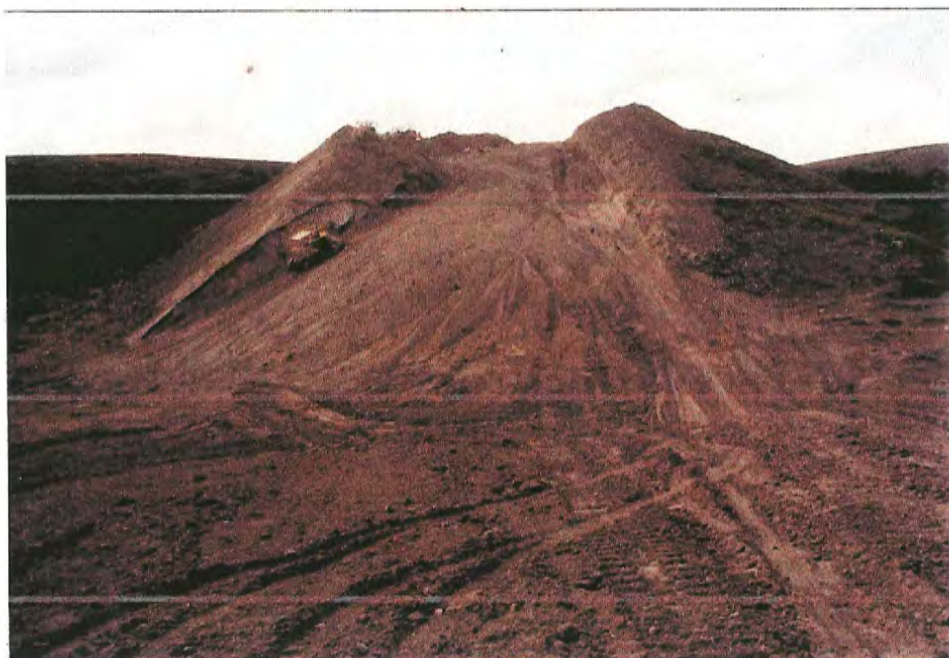
#22 West bluff of Frenchman Creek Valley being re-contoured on July 22. See photos #40 to #43 for a more detailed description of restoration on rough terrain.

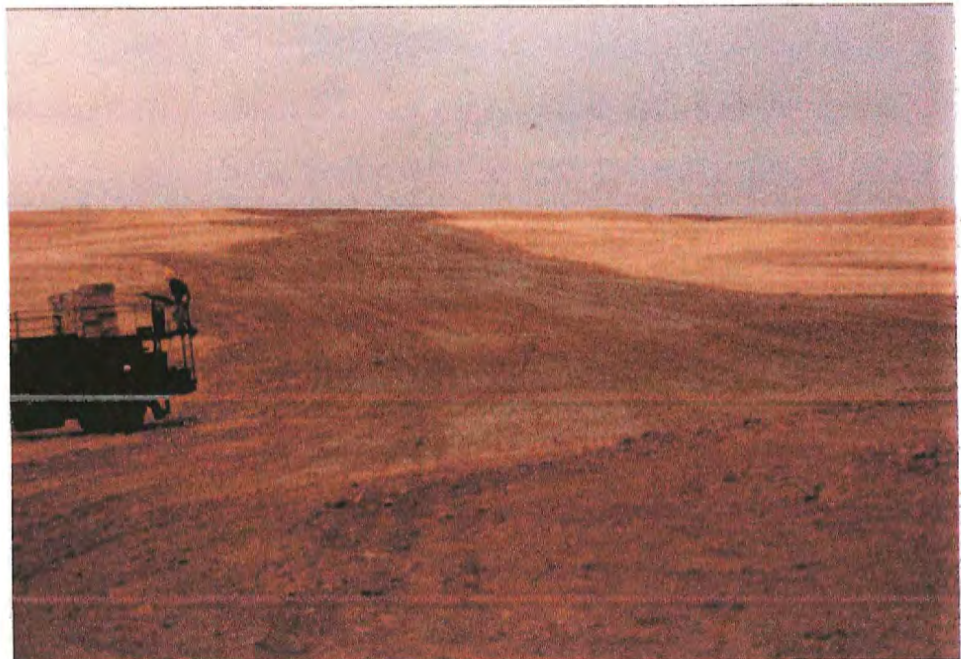
#24 Reclamation, November, 1981, in Phillips County. Mulch has been applied (photos#24 through #27 courtesy of Office of the Federal Inspector.)

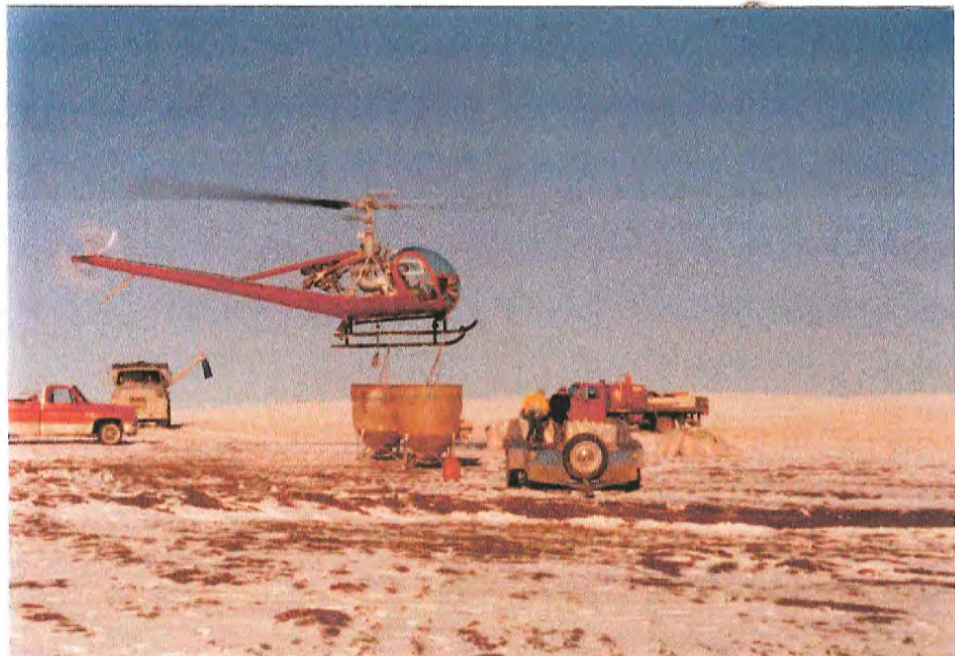
#26 Helicopter seeding crew. The helicopter carries a bucket that spreads native grass seeds on the r-o-w.

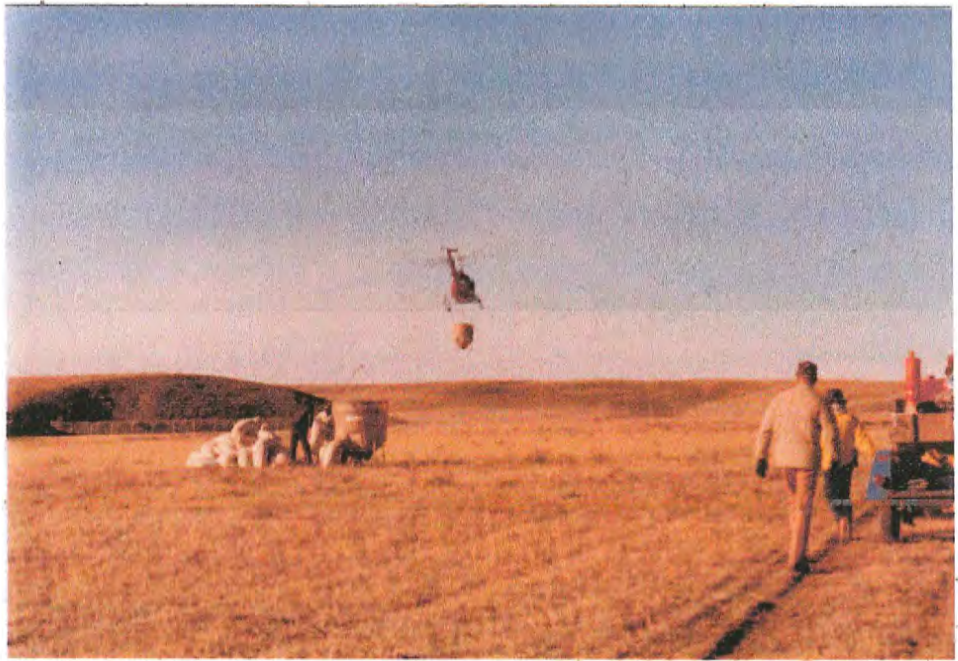
#27 Helicopter seeding crew.

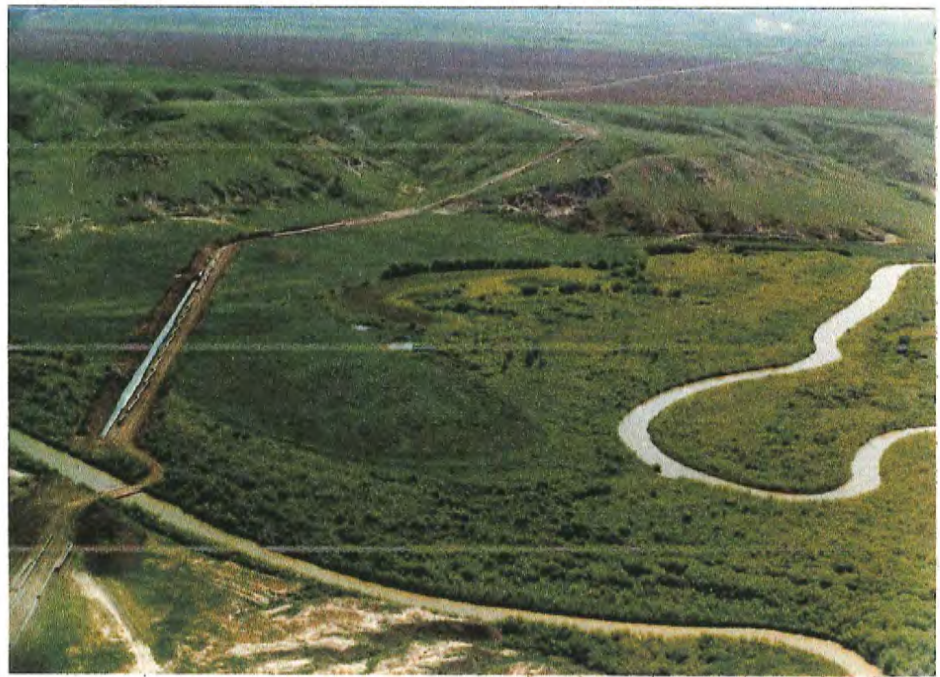
#28 Crossing of Frenchman Creek Valley looking east on June 26. The Frenchman Reservoir is just downstream, and a proposal to raise the reservoir level would result in this area being flooded. Note: 1) the east bluff had not been cleared at the time of the photo because no final agreement had been reached with the landowner, even though construction began nearly 7 weeks before, 2) the DNRC owns 40 acres of flood-plain just west of the base of the bluff which is crossed by the pipeline (VA001), 3) a floating bridge which remained until completion of construction.

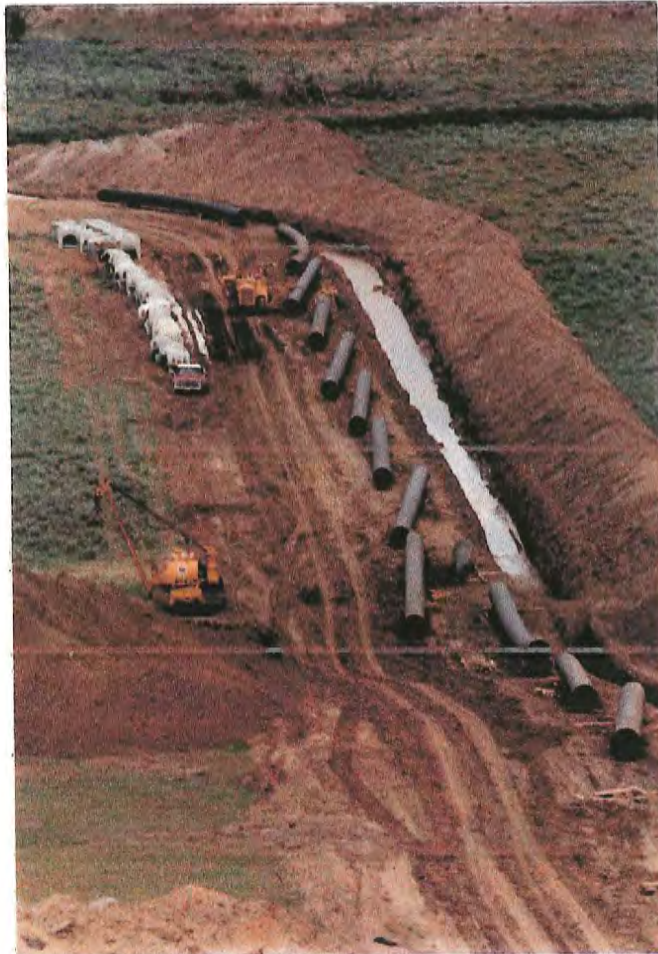
- #29 East side of Frenchman Creek floodplain on July 14, pipe ready for welding. The eastern side of state parcel VA001 is just beyond the pipe bend. Note: 1) Trench filled with water across most of floodplain seen in #28, 2) Concrete weights to prevent pipe rising out of saturated floodplain, ready to be placed on pipe. Two kinds can be seen; rectangular "set-ons", and rounded "bolt-ons" are placed both above and below the pipe, 3) Trench side-wall slump, requiring additional backhoe excavation.

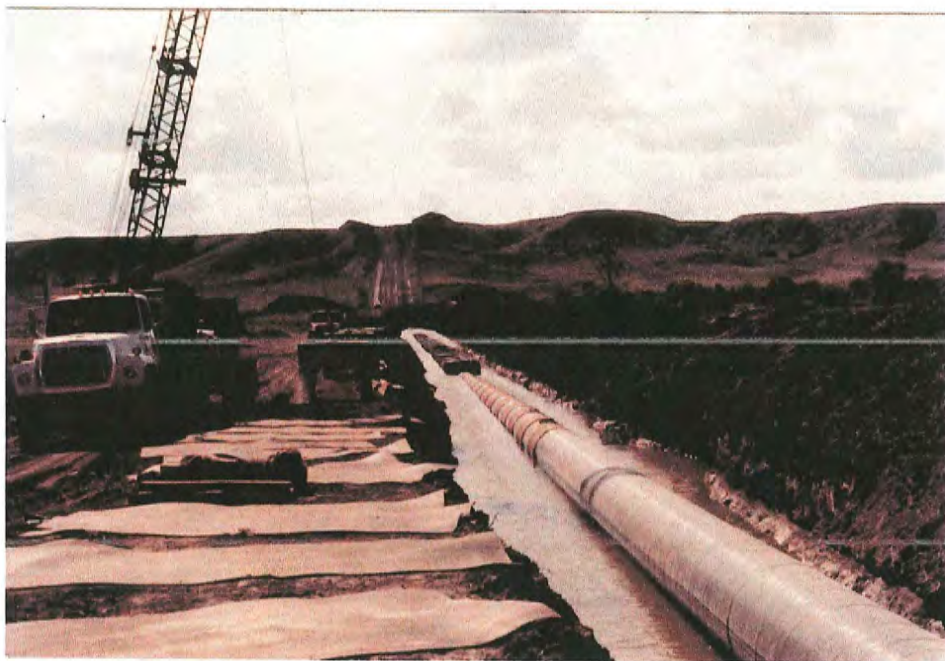
#30 Set-on weights being placed on pipe after it is in trench. Note the thick felt pads placed around the pipe to protect it. Photo taken July 14 on state parcel VA001.

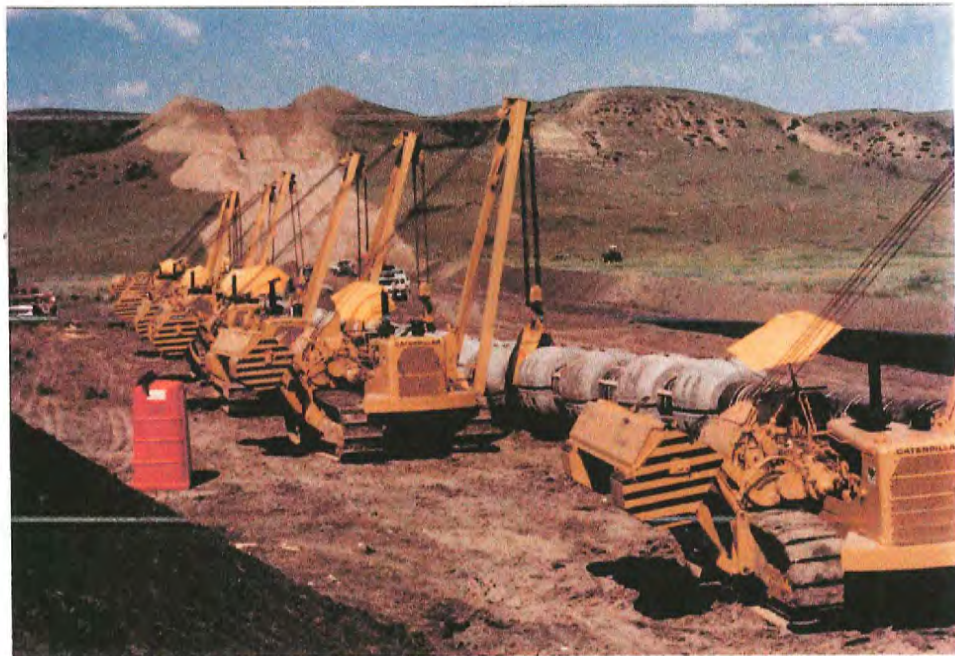
#32 Side-boom tractors lifting the creek section to pull it across. Concrete weights in place. The lead tractor, which winches the section across the creek with a cable, is in the foreground.

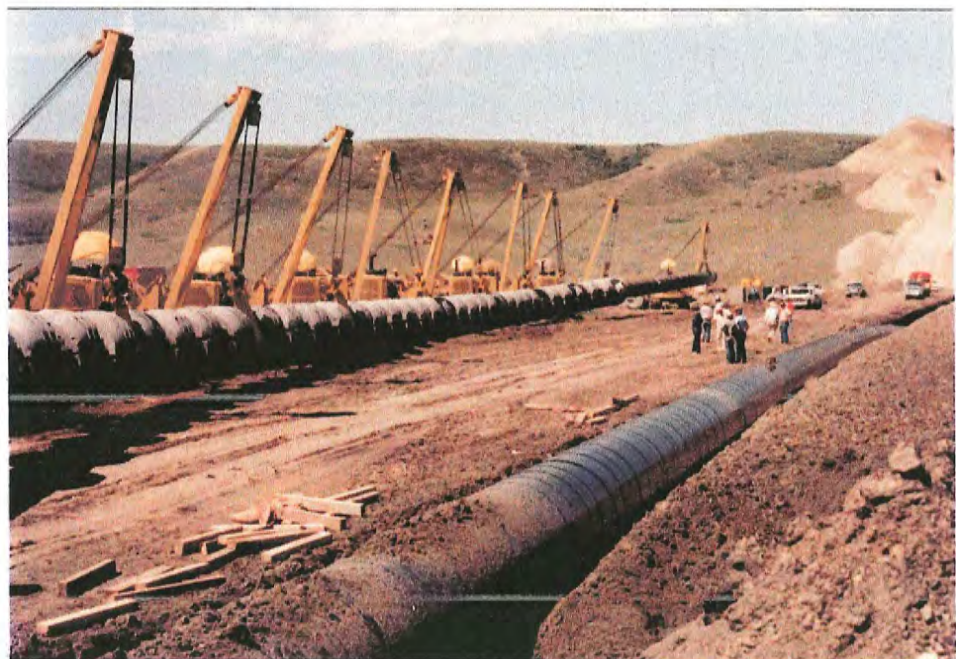
#33 Another view of the river section ready for pulling. View is looking west on July 14.

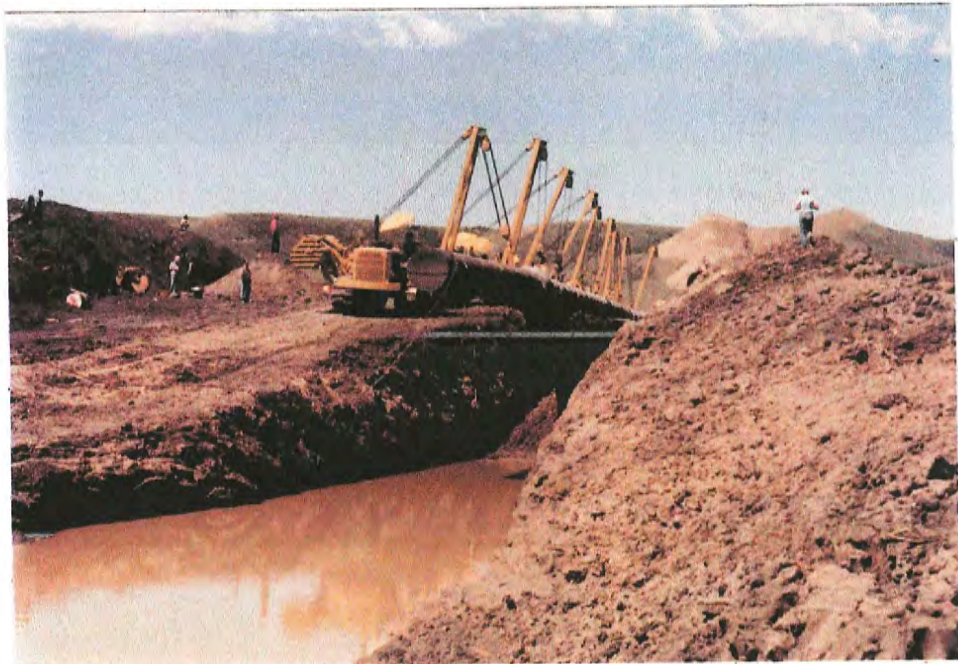
#34 Approaching the creek from the west. The lead tractor, not in the photo, has started to run out cable for pulling pipe. The foreman across the stream stands on the spoil bank to the right and orchestrates the movement of the tractors.

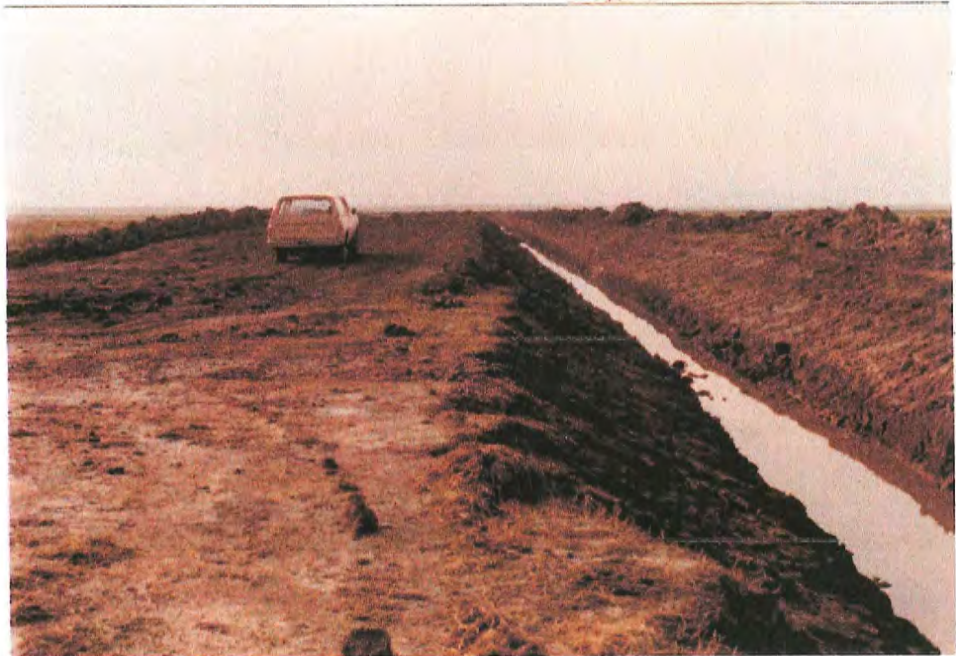
#36 Ditched floodplain of Big Muddy Creek, Roosevelt County, looking west from creek edge on July 24.

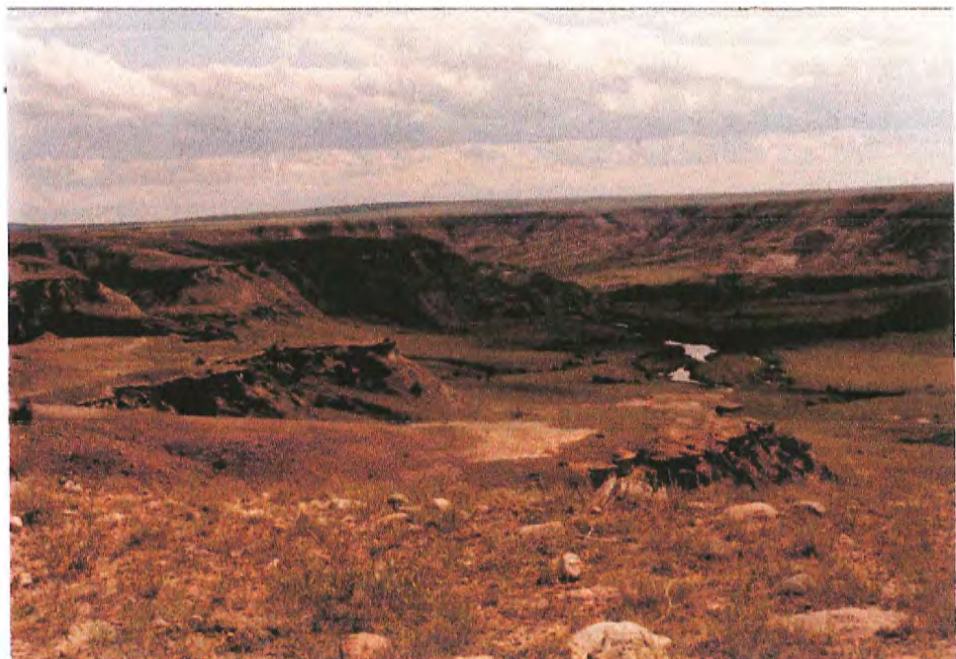
#37 Rock Creek Canyon, Valley County, looking south from the pipeline right-of-way on the east bluff on July 14.

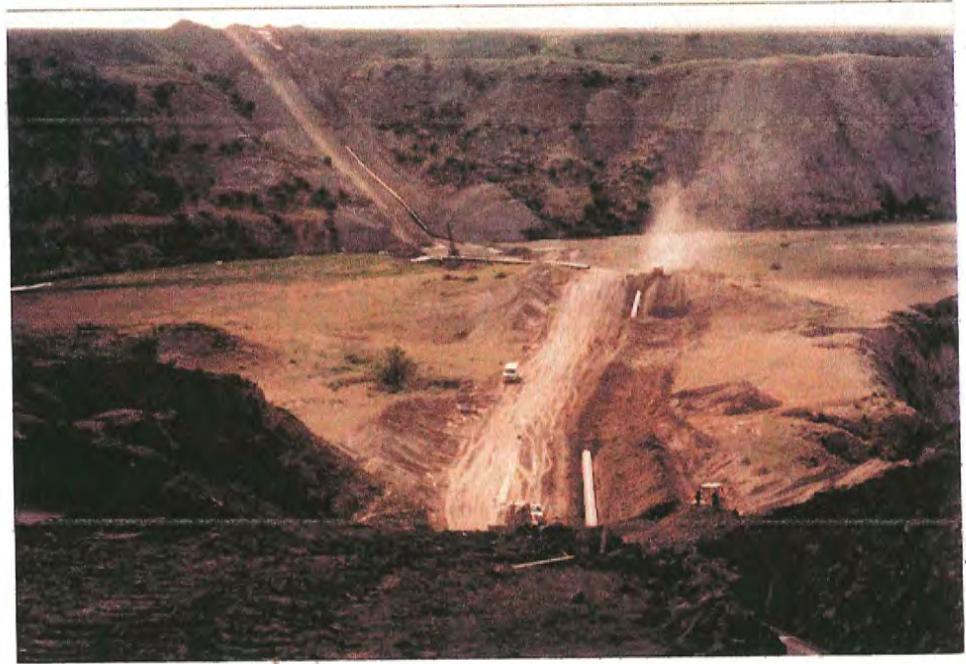
#38 Rock Creek Canyon, looking west on July 22, construction in progress. Note: 1) Dozer covering pipeline, 2) River section lying next to creek on the base of the west bluff. This was the roughest terrain encountered in Montana.

On steeply rolling terrain, or on bluffs above river valleys, pipe bends do not exactly follow the terrain. For example, on the Rock Creek bluffs seen in #38, the drop-off bend into the valley began before it reached the extreme edge of the bluff. This is done to avoid sharp bends as much as possible, and to reduce the overall amount of bending. This can be seen also in the terrain shown in #13. This requirement causes substantial increases in the right-of-way width at the bluff edge, primarily for soil/spoil storage. Photographs #69 through #73 depict some areas where this occurred.

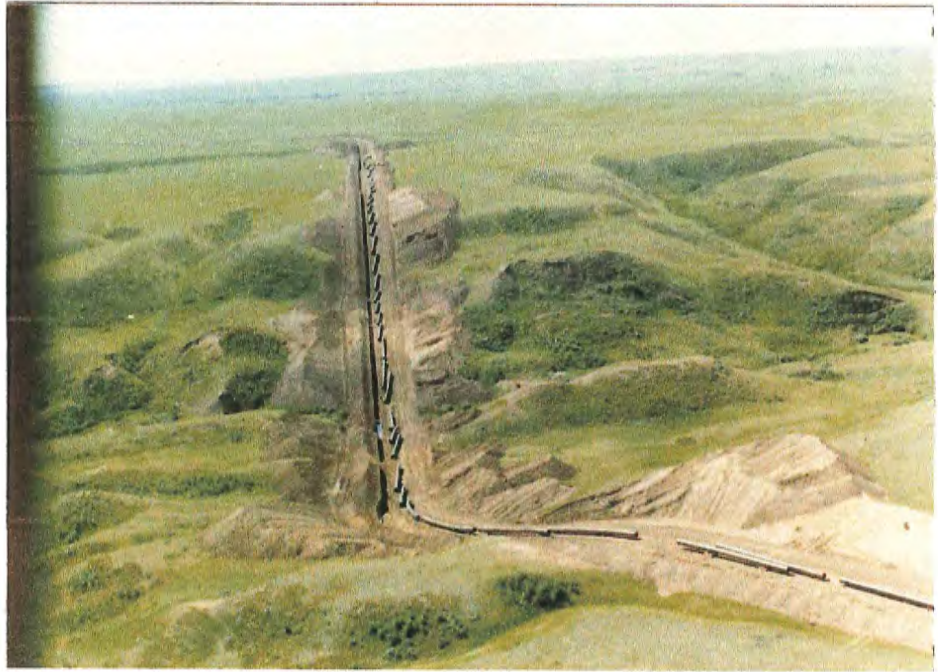
#40 Aerial view of Coyote Coulee area, Phillips County, looking east on June 26 toward Frenchman Creek on the horizon. (This is partially BLM land, parcels PH028 and PH029.) Compare this with next three photos and see "Right-of-way requirements" section.
