**FRIENDS OF THE HEADWATERS**  
**RESPONSE TO THE MINNESOTA DEPARTMENT OF COMMERCE**  
**LINE 3 DRAFT EIS - Dockets CN-14-916, PPL-15-137**  
**JULY 10, 2017**

**C-1 Montana IPTF**

CONSTRUCTION OF THE NORTHERN BORDER PIPELINE IN MONTANA

January 1982

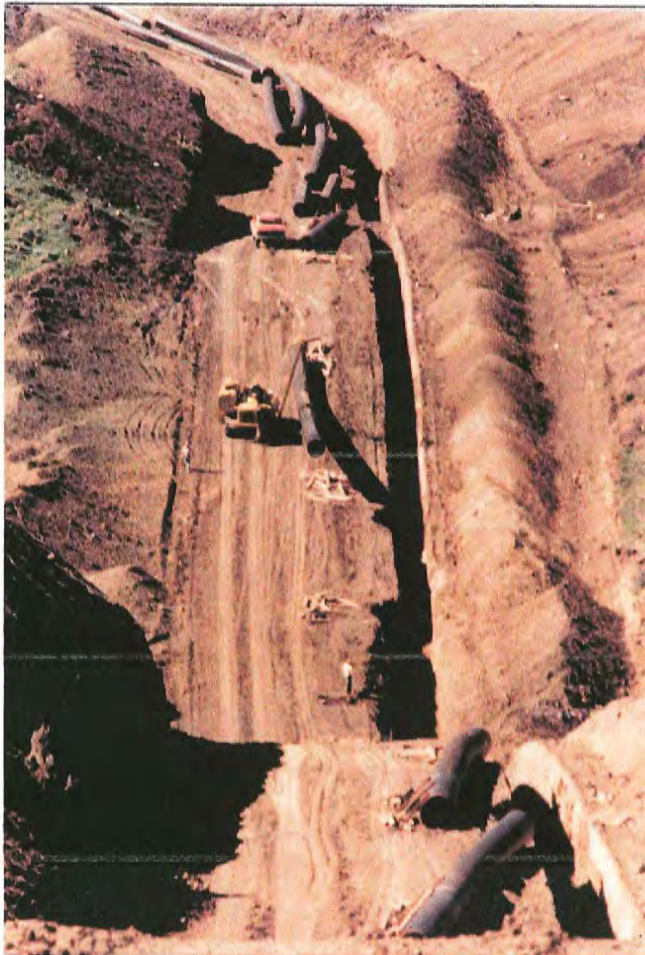
#41 Same coulee as above, looking west on June 25. Note: 1) the side-boom tractor negotiating the 80-foot pipe section, 2) depth of burial of the pipe in some cuts (see photos #69-#73 below).

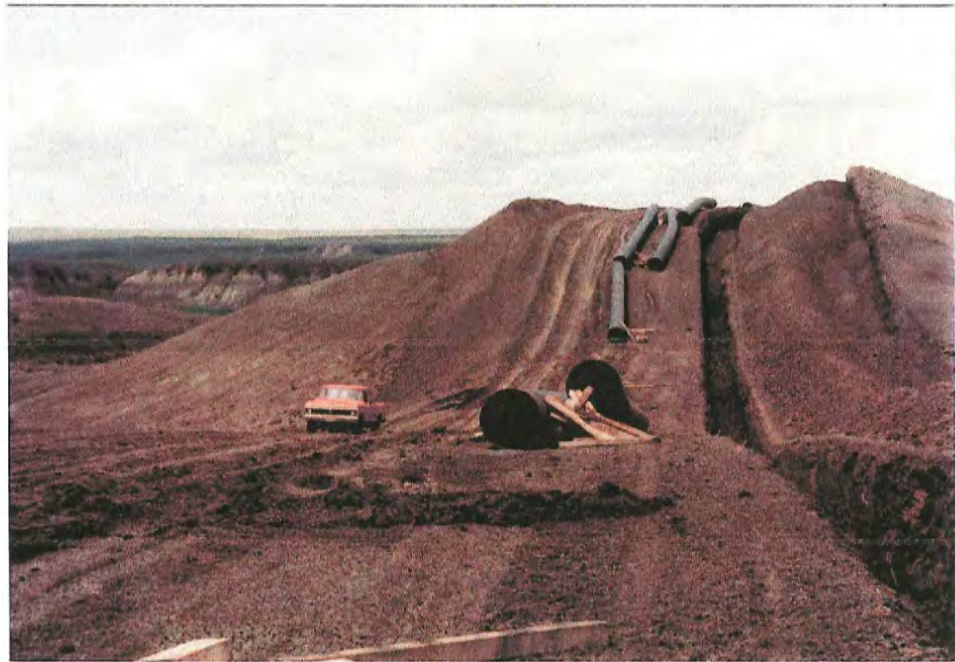
#44 Construction across badlands. The r-o-w crosses an unvegetated shale knob on the east side of the Bitter Creek Valley. The top of the knob was crossed rather than a drainageway because less erosion would occur on top. Note the depth of cut into the knob on the right side of the picture. Photo taken looking west on July 22.

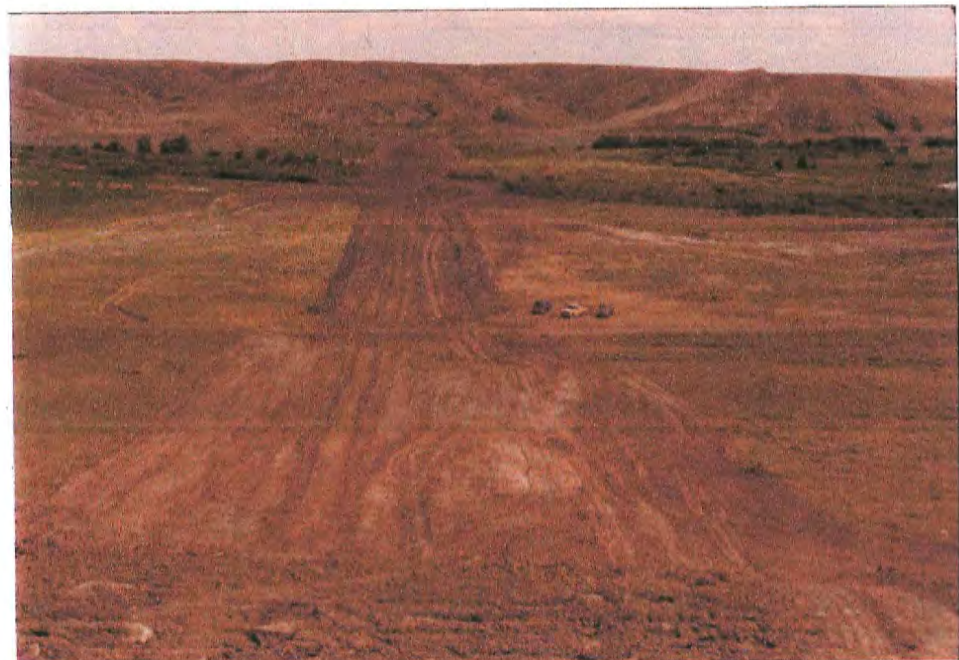
#45 Frenchman Creek crossing after re-contouring, looking east from the base of the west bluff on July 22.

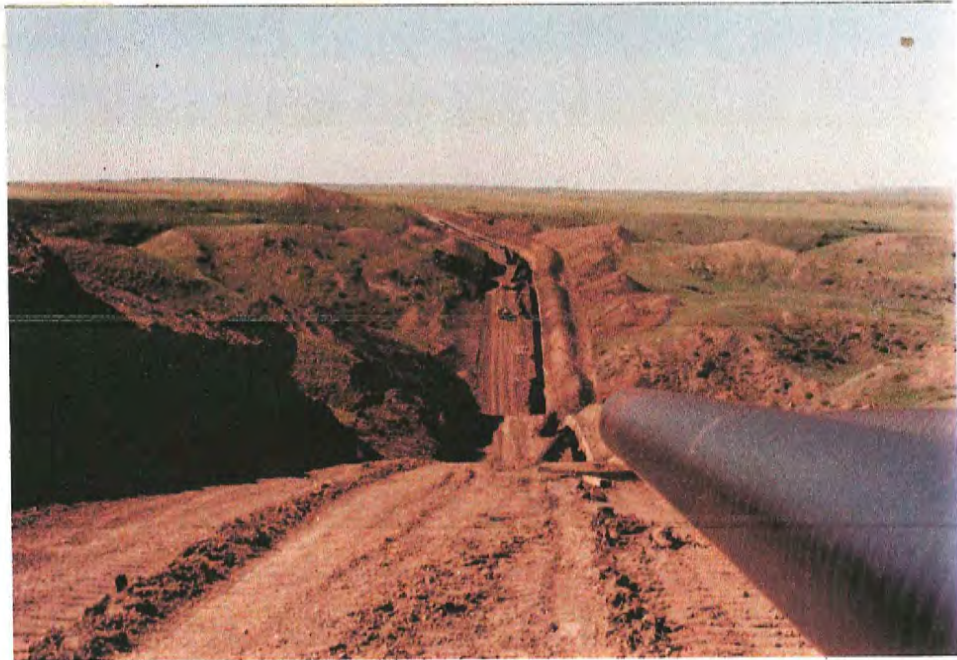
#42 Same coulee looking west from east side on June 25.

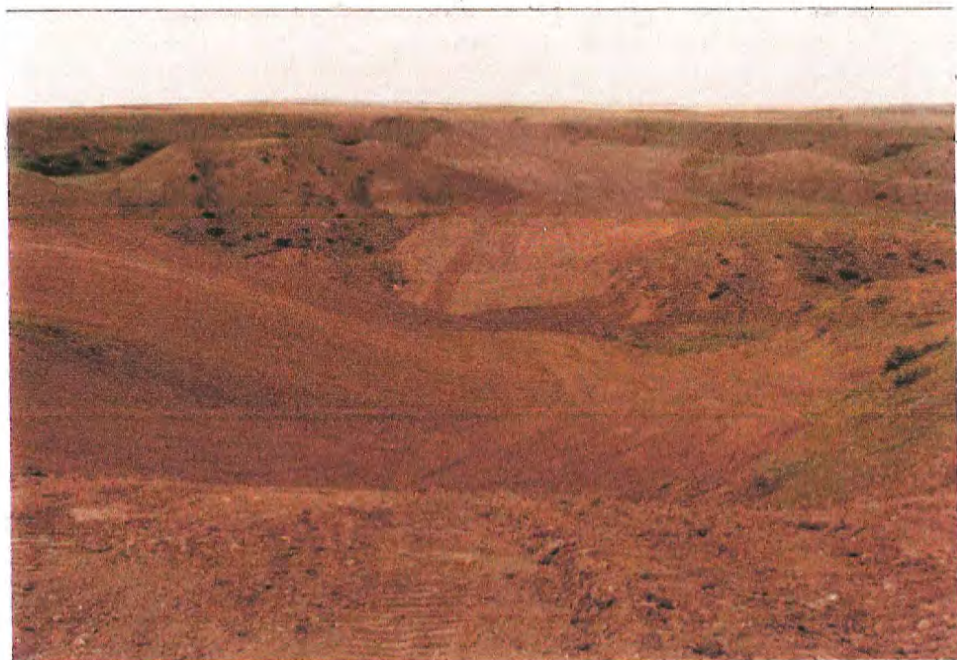
#43 Same coulee on July 22, from approximately the same spot as #42, after re-contouring. Waterbars, small dikes built across slopes to slow water erosion, are present but not visible.

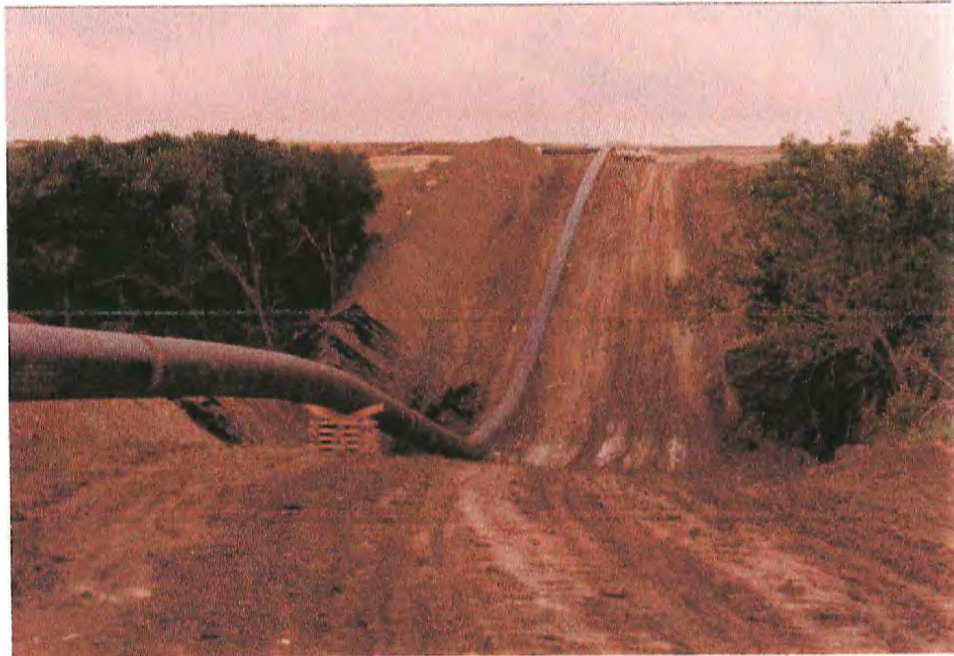
#46 Deciduous shrub/tree coulee about six miles east of Big Muddy Creek, Roosevelt County. American elm and green ash are the main tree species. The black material on the spoil bank is lignite. Photo taken July 24.

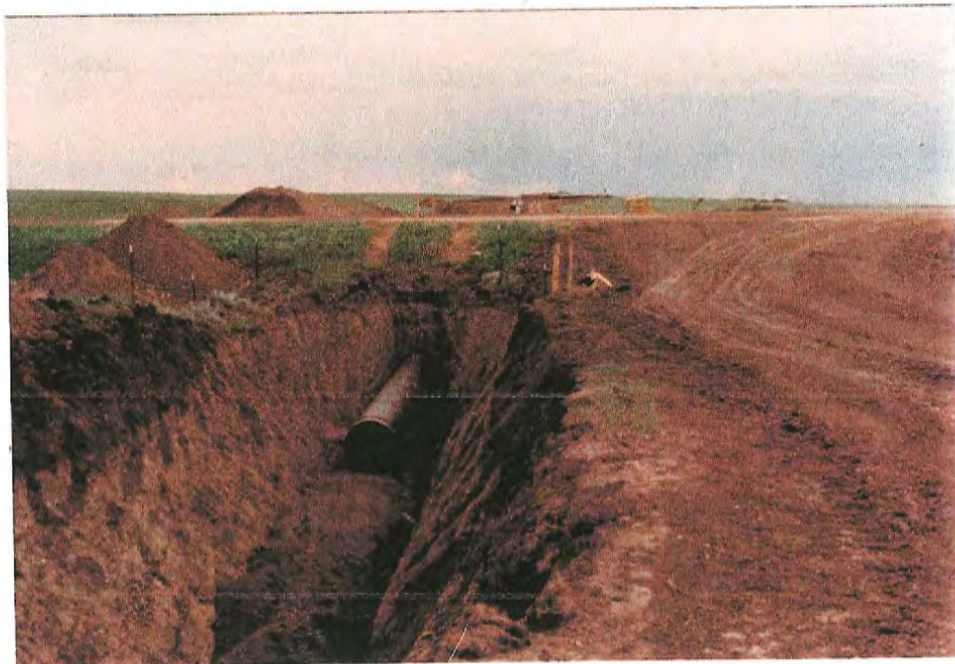
#47 Bored road crossing, Valley County. Boring was done, even on small roads, to prevent road maintenance problems. Photo taken June 23.

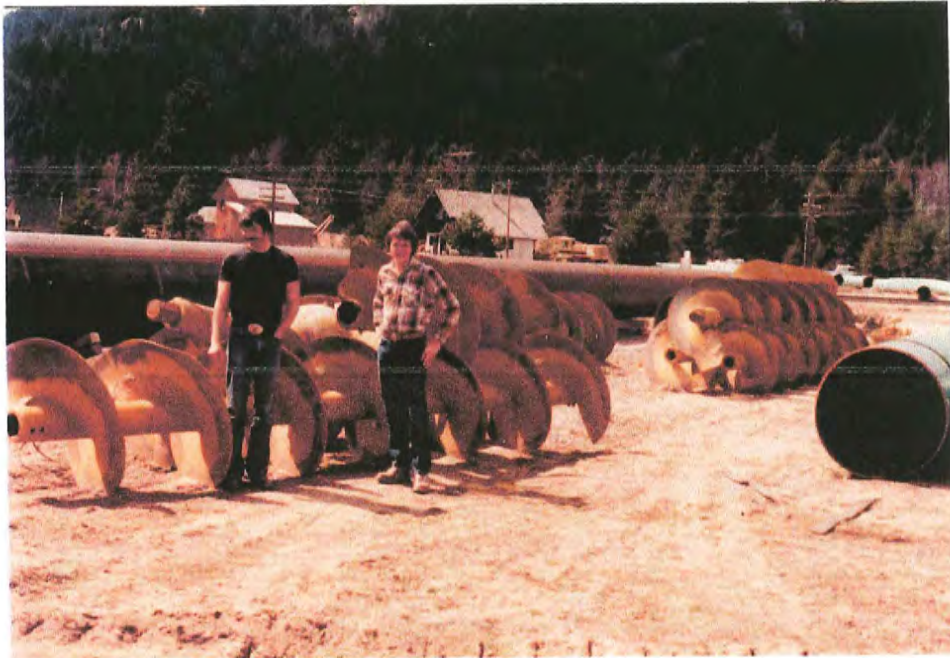
#48 Boring equipment (Idaho).

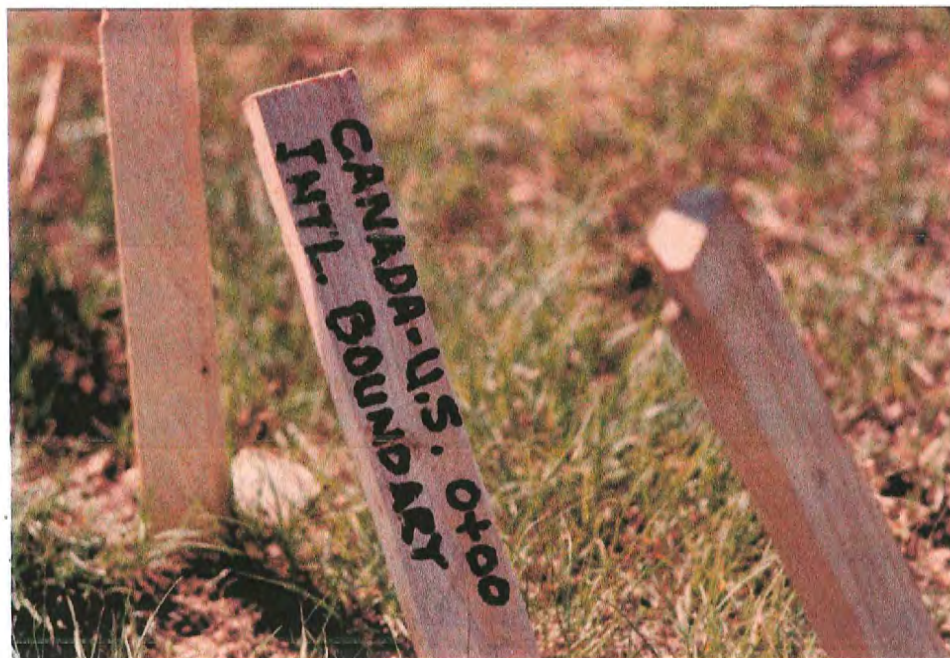
#49 Survey stakes along the r-o-w. Locations are given in the format "0+00". Table 1 gives survey stations for points where the pipeline enters and leaves state lands.

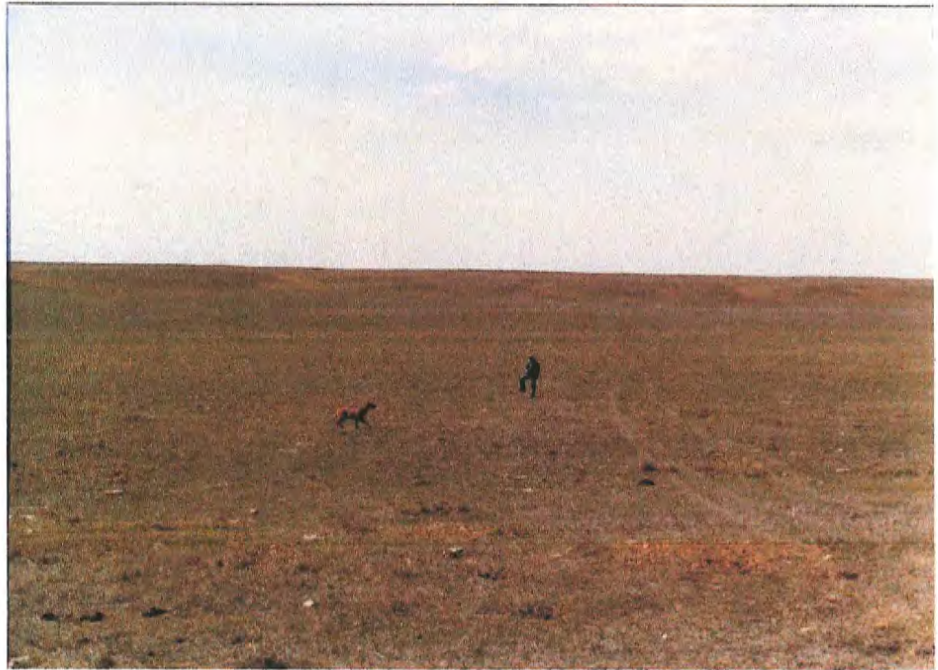
#50 State land parcel. VA057 near the west boundary of the Fort Peck Reservation looking west on April 21 shortly before construction began. (see next photo).

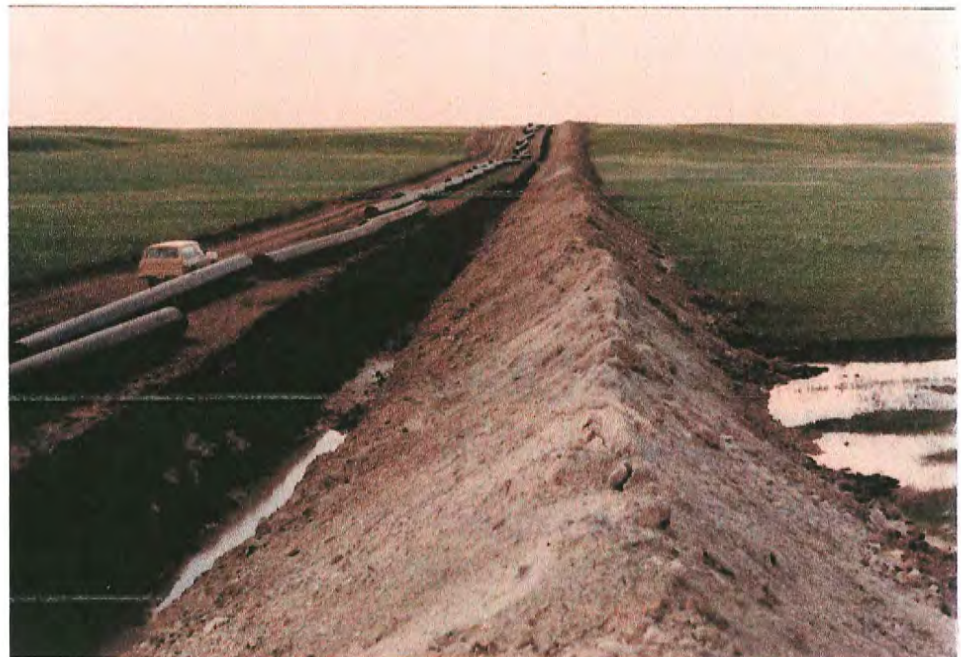
#51 Same view as #50, about 300 yards farther west and from atop the trench spoil bank on July 23. Note that in the distance a trencher was used and in the foreground a backhoe was used. An 85-foot right-of-way was cleared in this area, and it became slightly wider after ditching, especially where the backhoe was used.

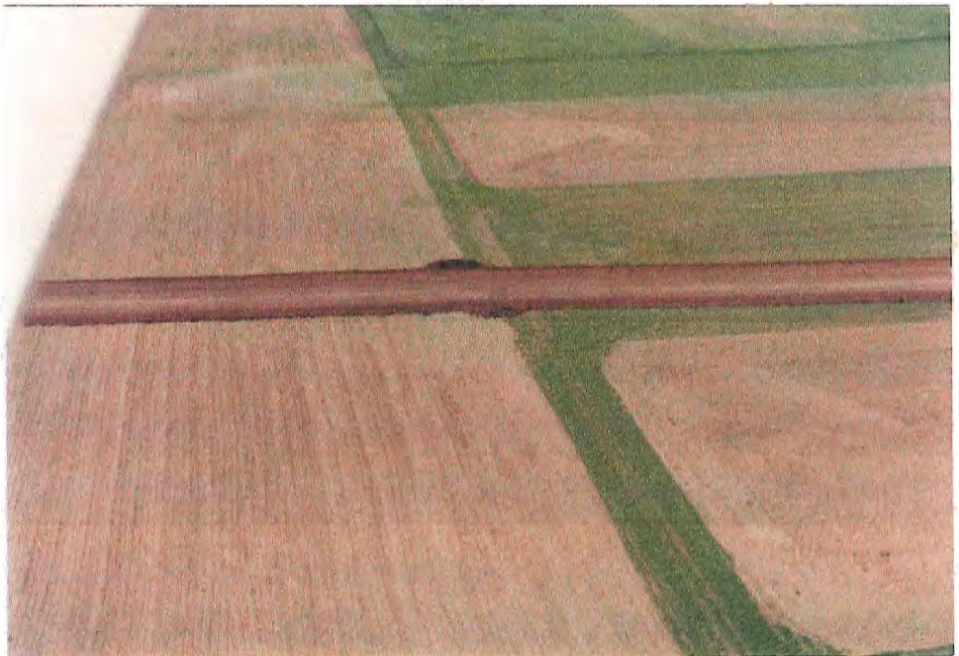
#52 An 85-foot cleared right-of-way on cropland in Roosevelt County on June 26. The r-o-w width increased slightly as the pipeline was constructed, but the width was well within 100 feet in most cases on this flat terrain.

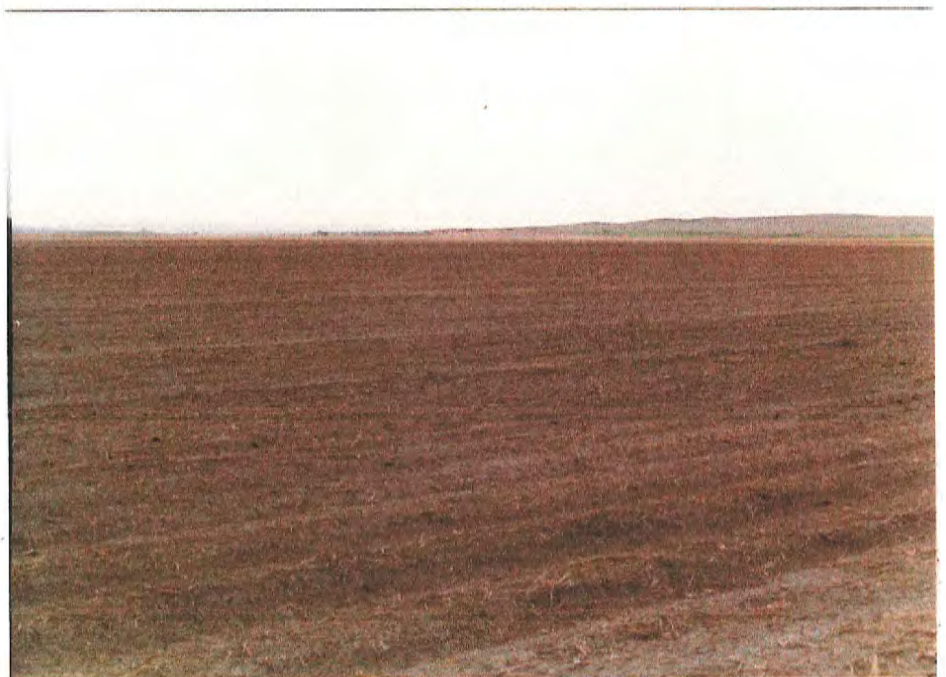
#53 State parcel R0195 southeast of Bainville, looking west on April 21 at an approaching dust storm two weeks before construction began. See next photo.

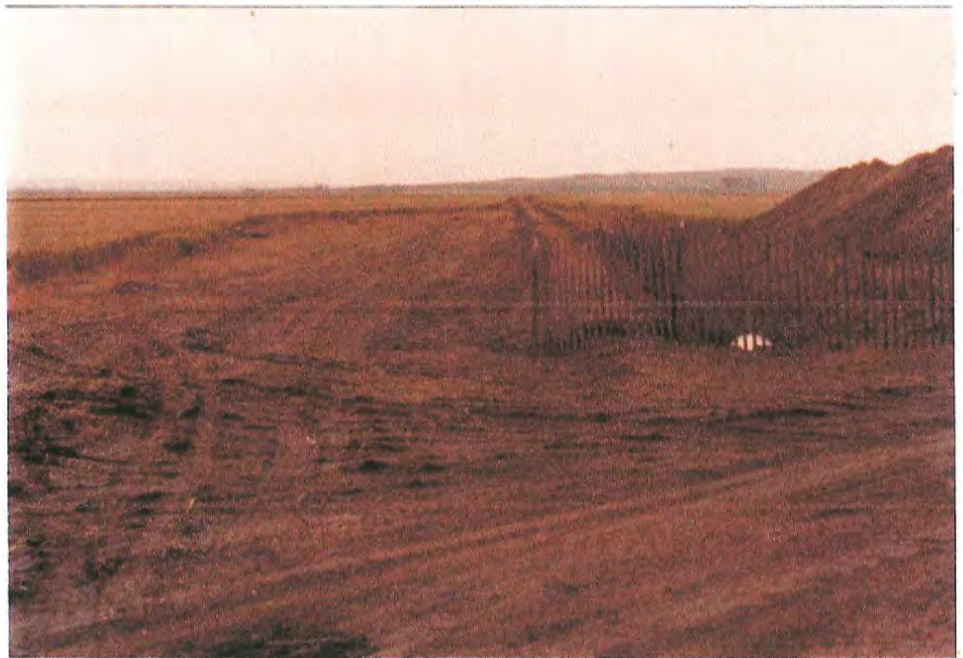
#54 Same view as #53 on July 24. This was the only state parcel that was cropped. The r-o-w was generally about 85 feet wide on this parcel although it was wider in the foreground because the field road was bored under rather than ditched through.

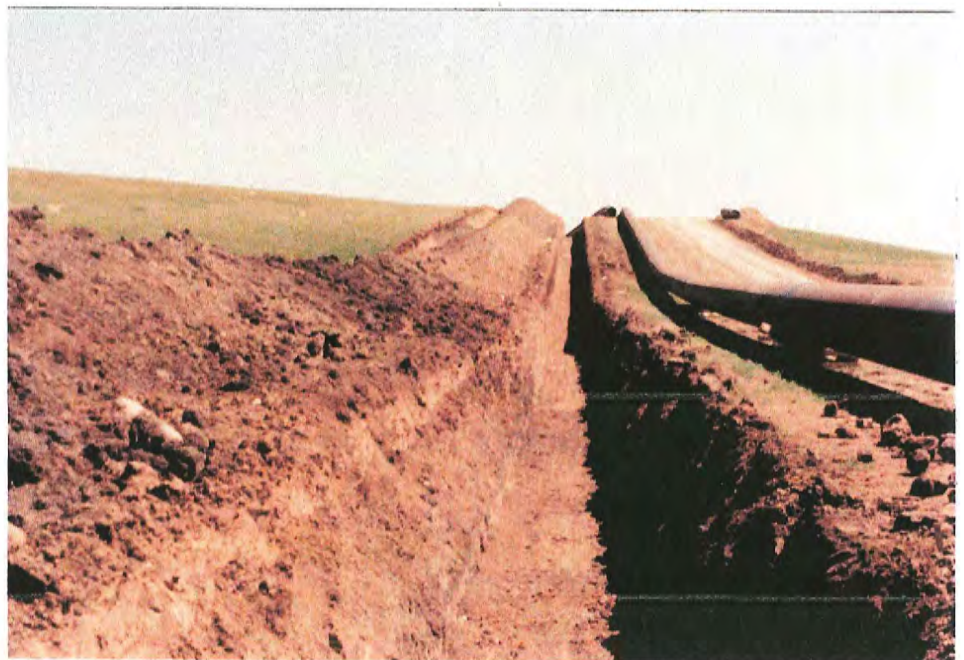
#55 Compare this view with that at cross-section "B" in Figures 1-3 (this view is to the east, however). Note the cut on the left providing fill for the work space on the right. This is taken about 1.5 miles west of state parcel PH018 near Turkey Track Road. Photo taken June 25.

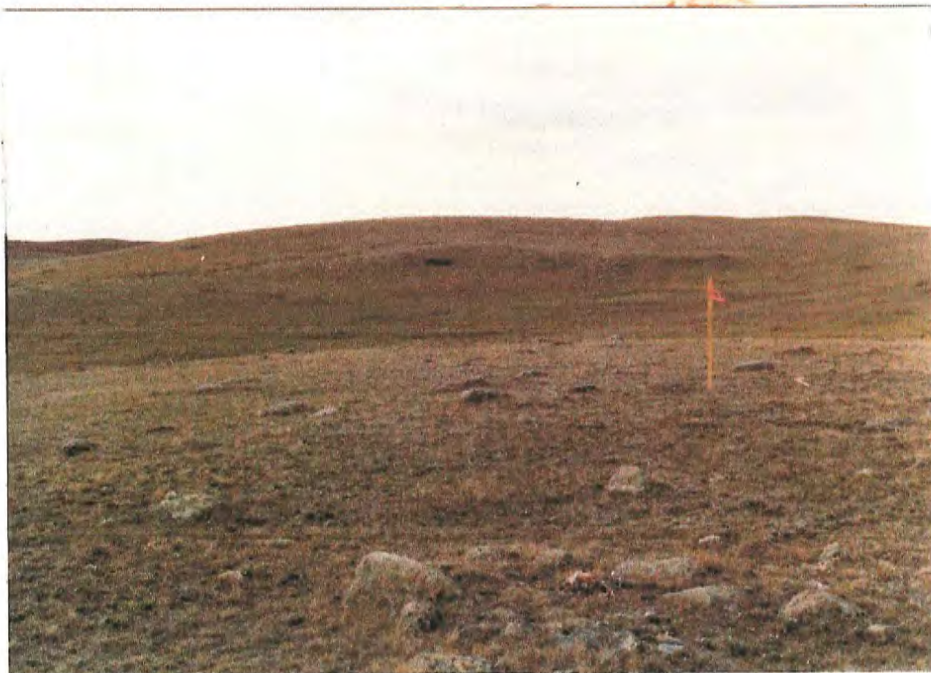
#56 Looking northwest on state parcel PH021 on April 21 before construction began. See next photo.

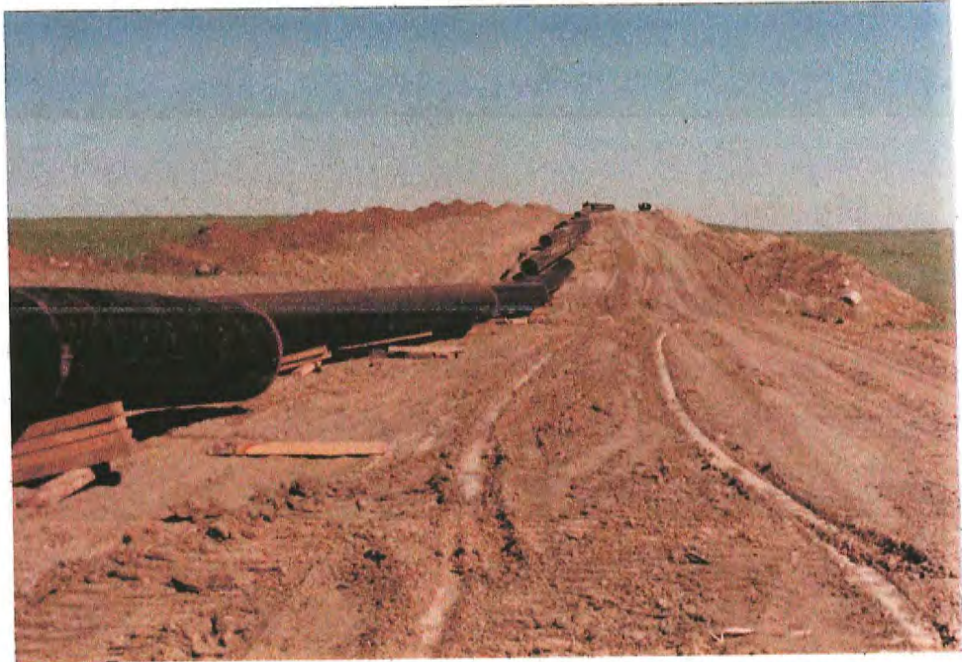
#58 Looking east on June 25 at a long stretch of south-facing slope on state parcel PH026. Note that on this parcel topsoil has been stored uphill to the left.

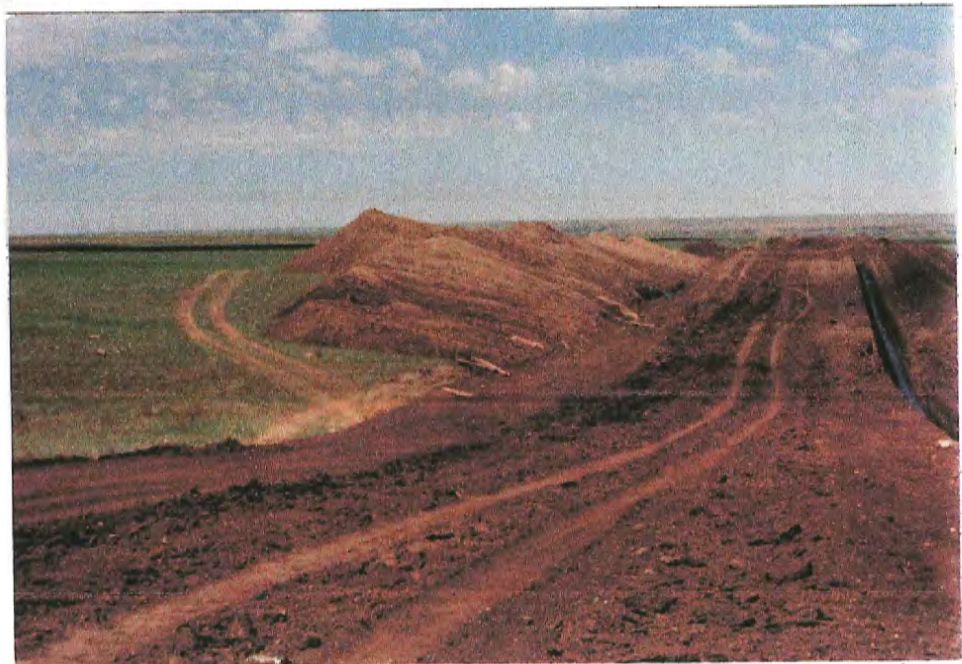
#59 Compare this view to views of cross section "A" on Figures 1-3. This photo, taken July 15, looks west on state parcel VA006. Note that there is poor topsoil separation in this area, although a small pile can be seen behind the large pile of subsoil.

The problem of inadequate topsoil handling is more serious, since it would result in some productivity loss. The problem is, of course, confined to those areas where side-hill cutting occurred, and over the trench. Problems on state parcels, however, could indicate problems on the whole route because there was no apparent difference between

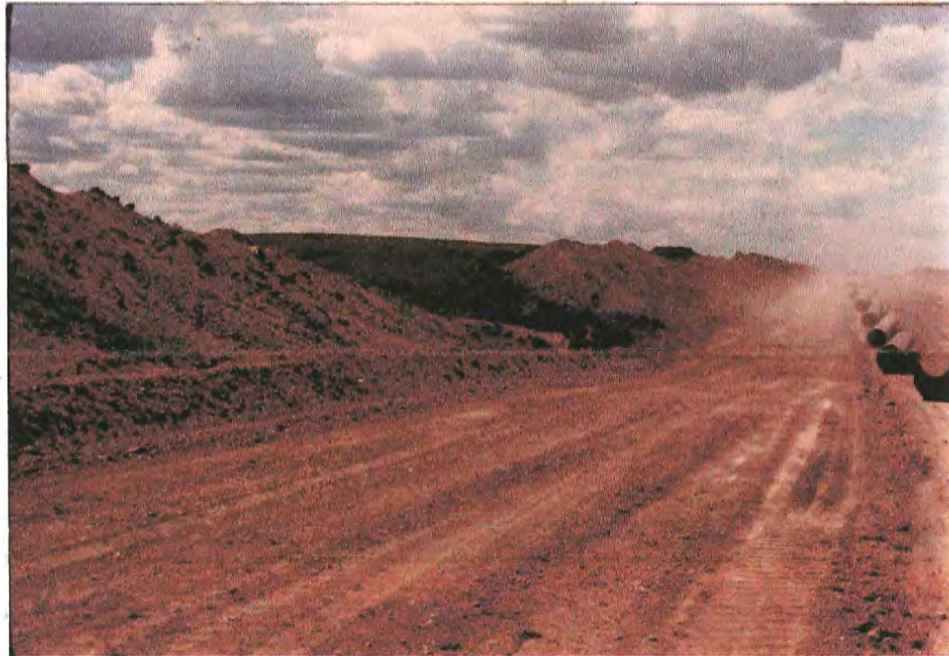
- #60 Compare this view to cross section "A" (on Figures 1-3) and to #59. This view looks west on private land several miles west of the parcel shown in #59. Note the pile of topsoil on the outside of the pile of material from the cut.

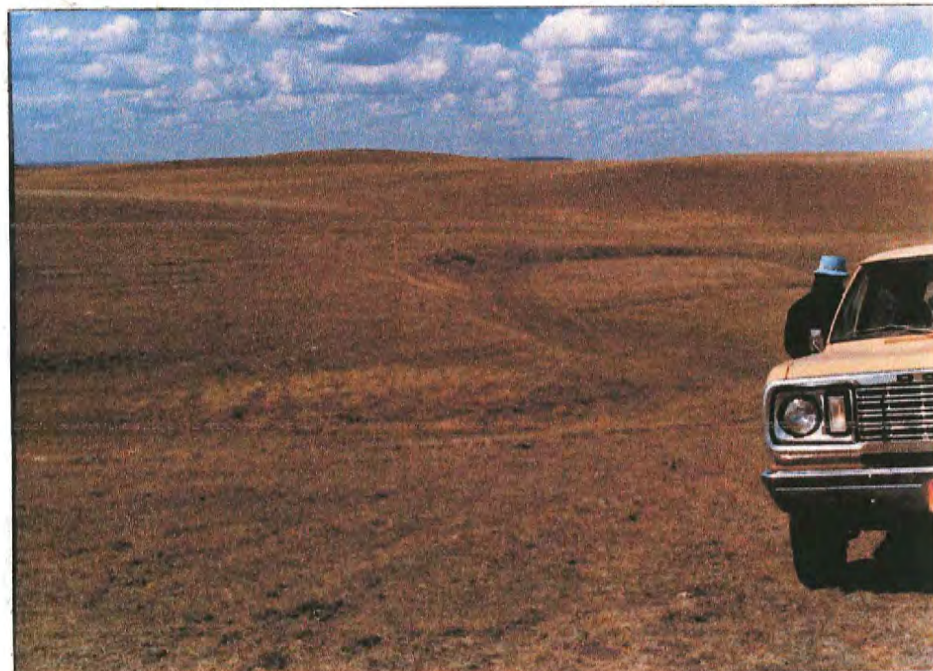
- #61 Compare this view with that of #62. Both look west on state parcel PH012 from about the same spot. This photo was taken a few feet downhill from #62 on April 21, shortly before construction began.

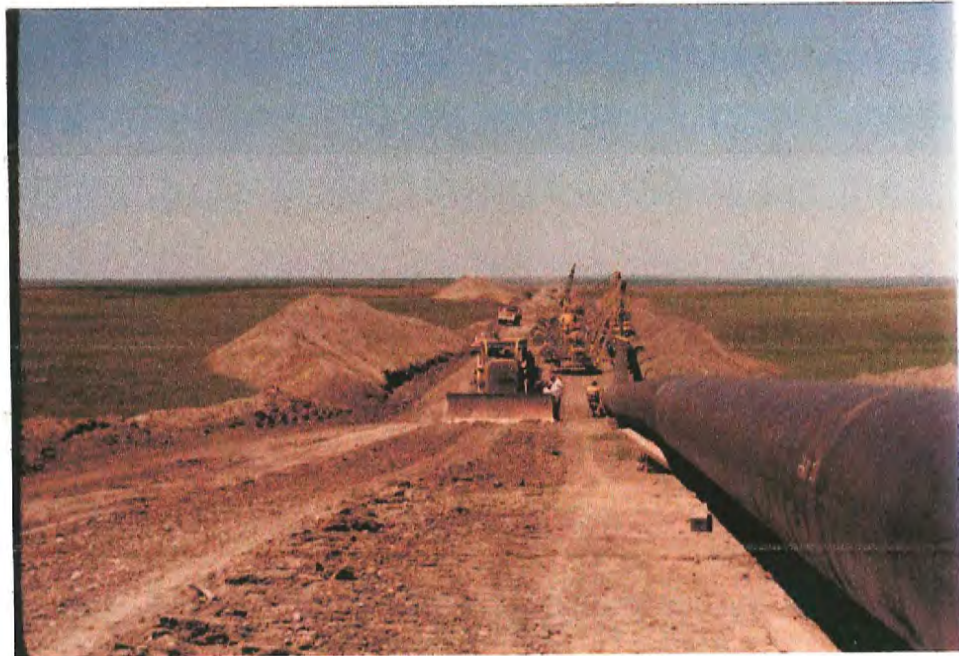
#62 Same view as #61 on June 26, and see view "A" on Figures 1-3. Note the lack of topsoil storage piles. This section was cleared in the first few days after construction began, and little topsoil was saved even though saving 12 inches of "topsoil" was stipulated on the Department of Lands lease. (See conclusions section.)

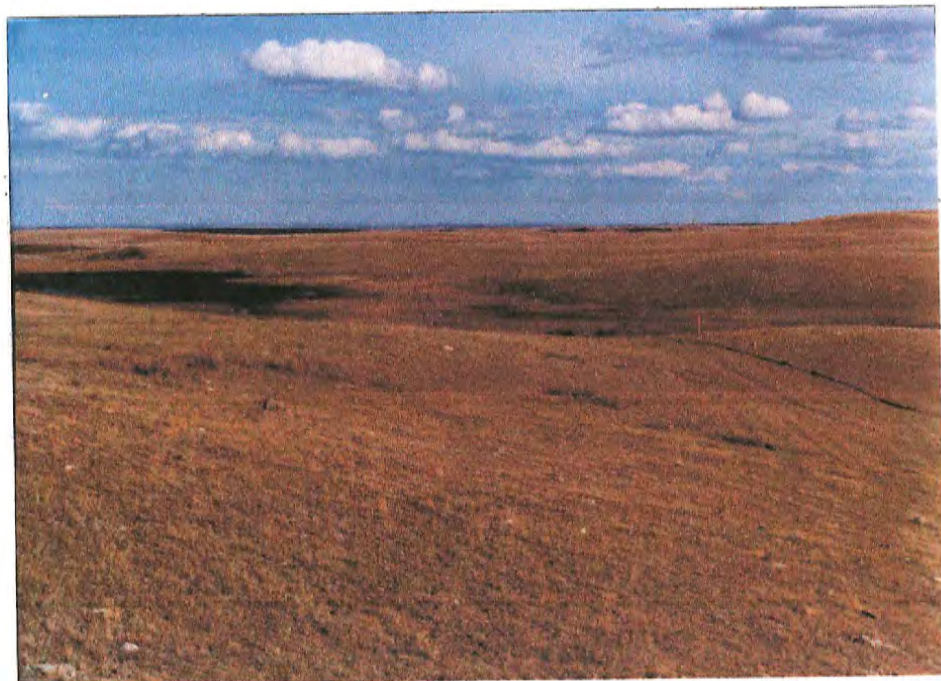
#63 State parcel PH026 on April 21, looking southeast past the reservoir in the middle of the section. See #64, #65, and #66.

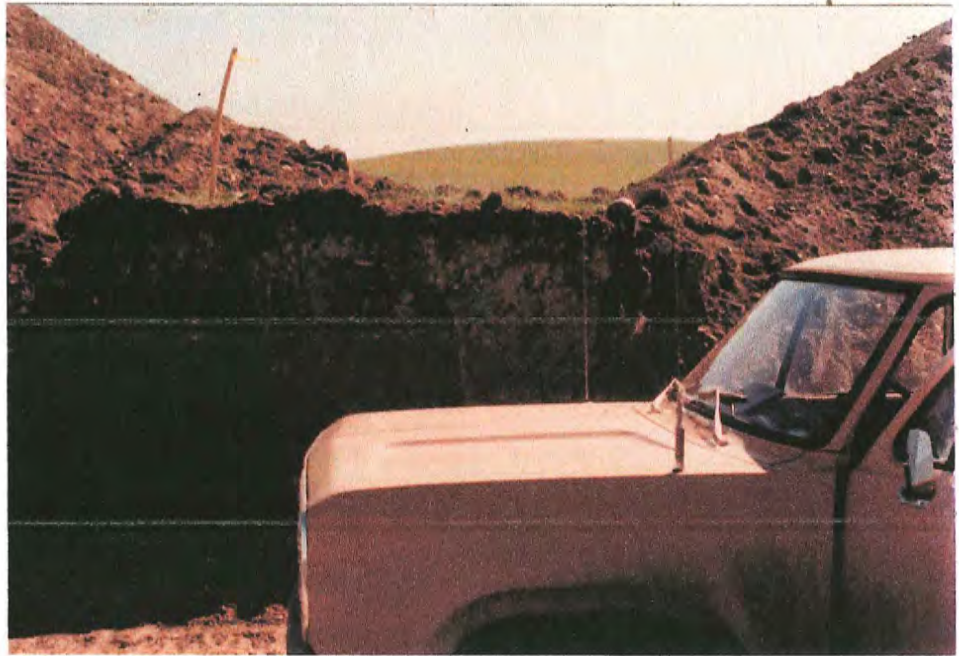
#64 Side-hill cut on work pad (as in cross section "A" on Figure 2) on state parcel PH026. This was the cut made in the hill on the other side of the drainage way shown in #63. Note the shallow depth of the A horizon (compare to #74 below.) Slope is about 7 degrees on this hill. Photo taken June 25.

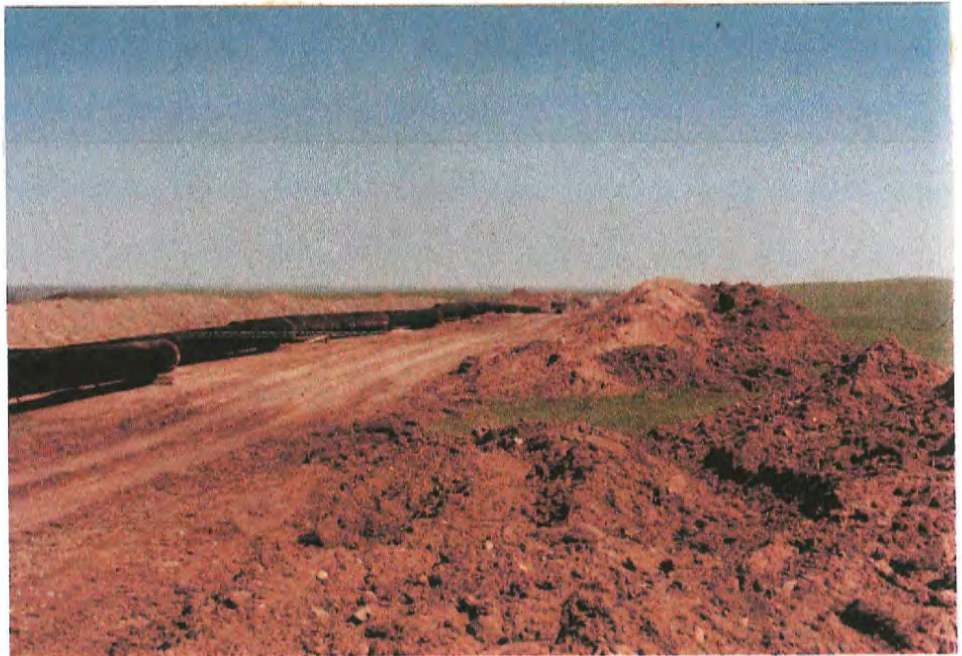
#66 Topsoil storage on PH026. View is to the southeast on June 25.

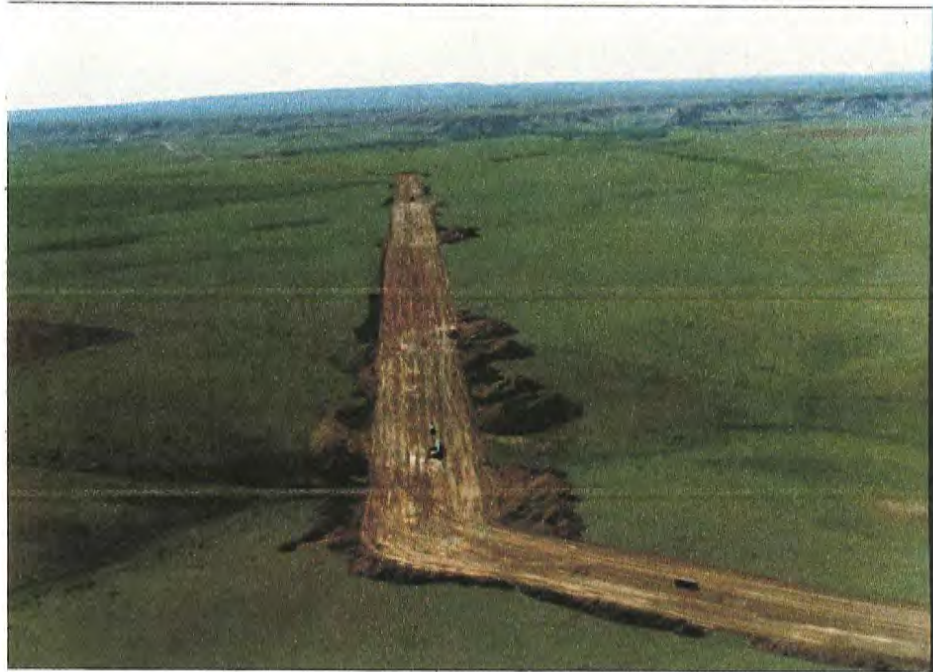
- #68 View of state parcel VA27.5 looking southeast toward the Willow Creek valley before pipe-stringing began. Note: 1) soil/spoil storage is on alternate sides of the r-o-w, depending on the direction of slope, 2) the cleared r-o-w is about 85 feet wide on the flat areas shown in the photo, and 3) r-o-w requirements rapidly expand when soil/spoil storage areas are needed. VA27.5 begins on the other side of the fence beyond the sharp bend. This bend is the beginning of the "Bitter Creek Re-route" which follows an old road through the Bitter Wilderness Study area. Photo taken on June 26.

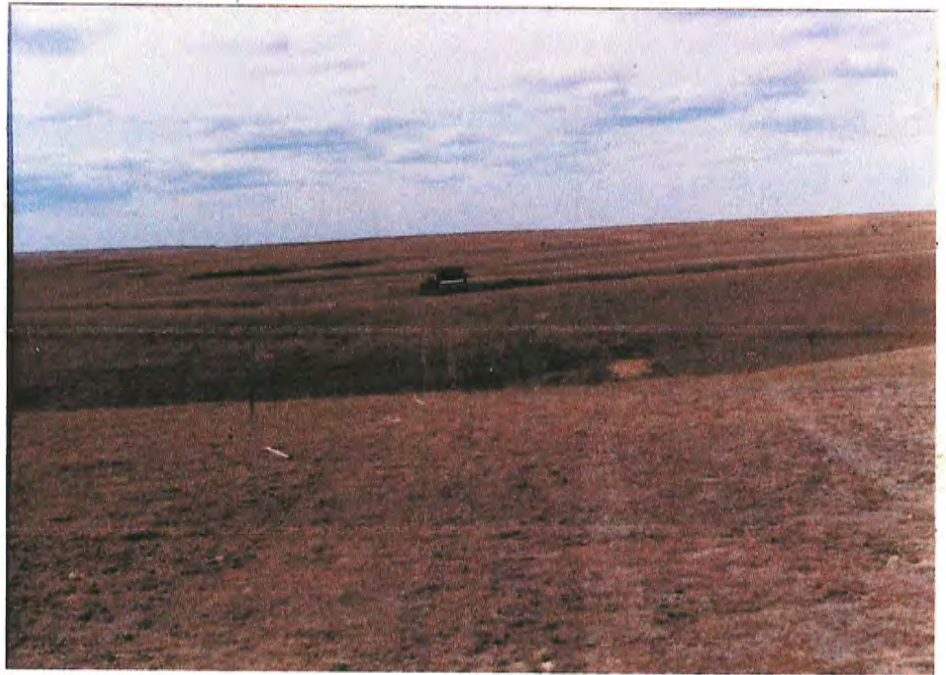
#69 State section VA051 looking west down staked centerline on April 21, 2 weeks before construction began. Compare with #70 and #71. This area is about four miles west of the west boundary of the Fort Peck Reservation.

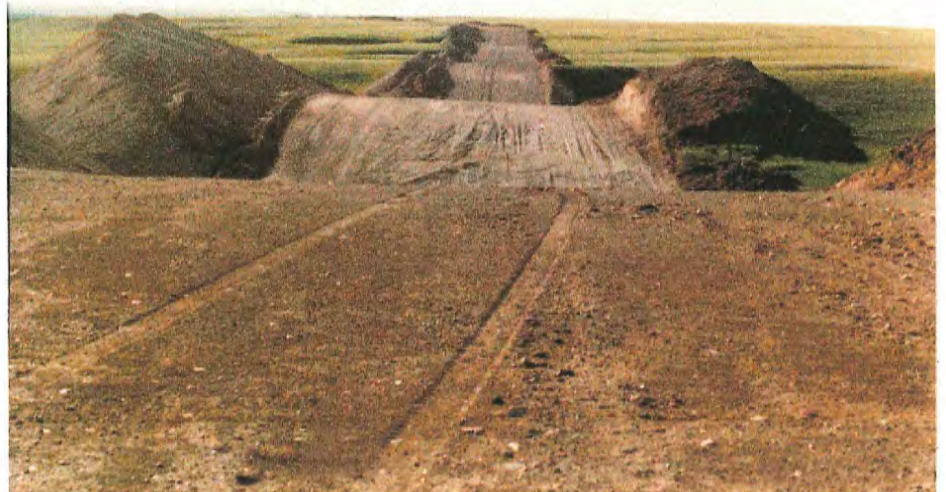
#70 Same view as #69, same spot, taken June 26, before ditching and pipe stringing began. Note that each ridge is cut extensively, resulting in more gradual bends on top of the hills. This result cannot be obtained at the bottom of drainageways, however, because the pipe cannot be placed in unconsolidated fill.

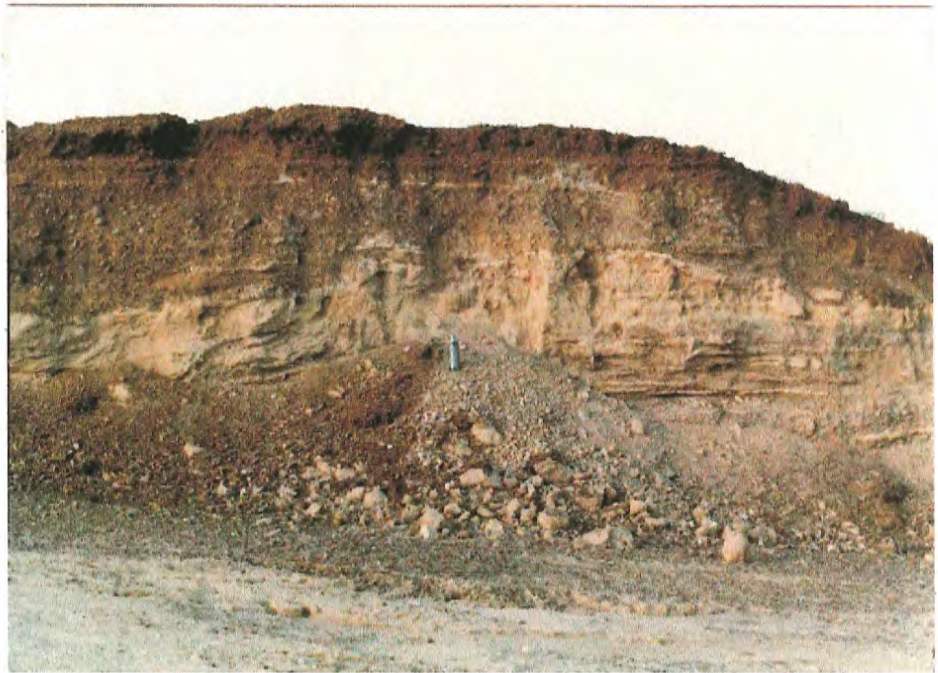
- #71 Close-up view of the first cut on the right side of #70. Note the 1 quart thermos for scale. This area was very gravelly and sandy. The bottom of the pipe will be 7 feet below the level surface at the bottom of the photo. This means pipe burial of about 13 feet deep from the top of this ridge. The cut shown is about 10 feet deep.

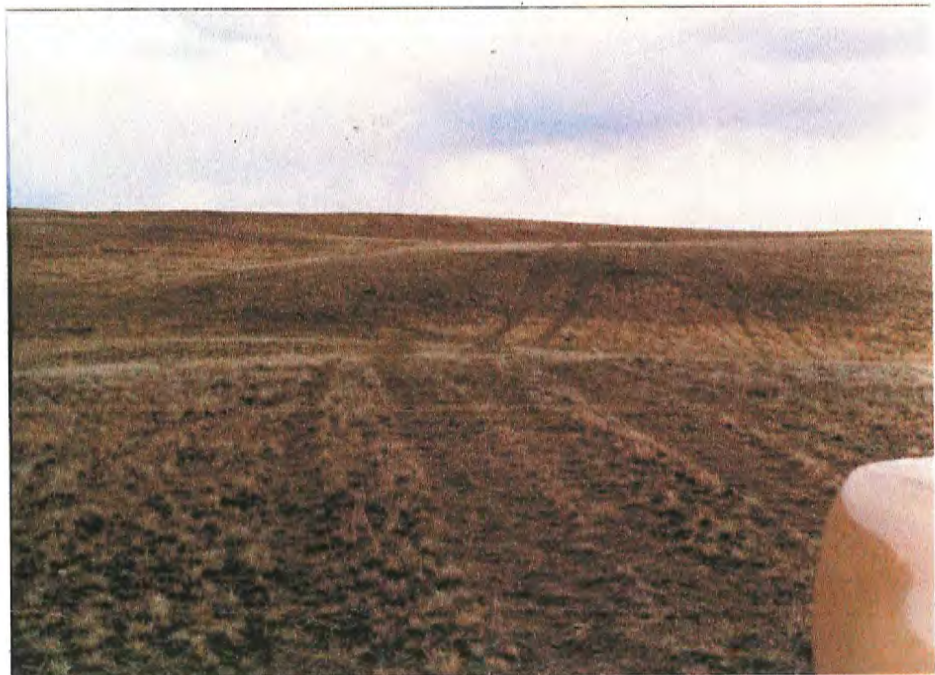
- #72 State parcel PH012 looking southeast on April 21 down the staked centerline before construction began. NBPC personnel estimated a r-o-w width of 100 feet here on this date. Compare with #73.

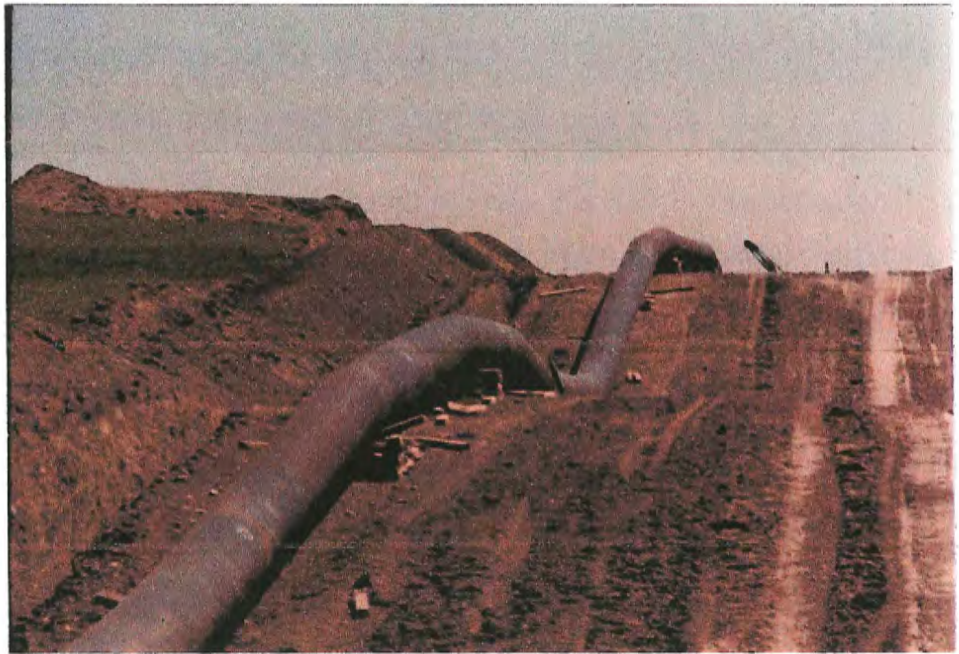
- #73 Looking southeast at approximately the same spot as #72 on June 25. The r-o-w was about 230 feet wide here as a result of this side-hill cutting, which occurred within a few days of construction start-up (May 4).

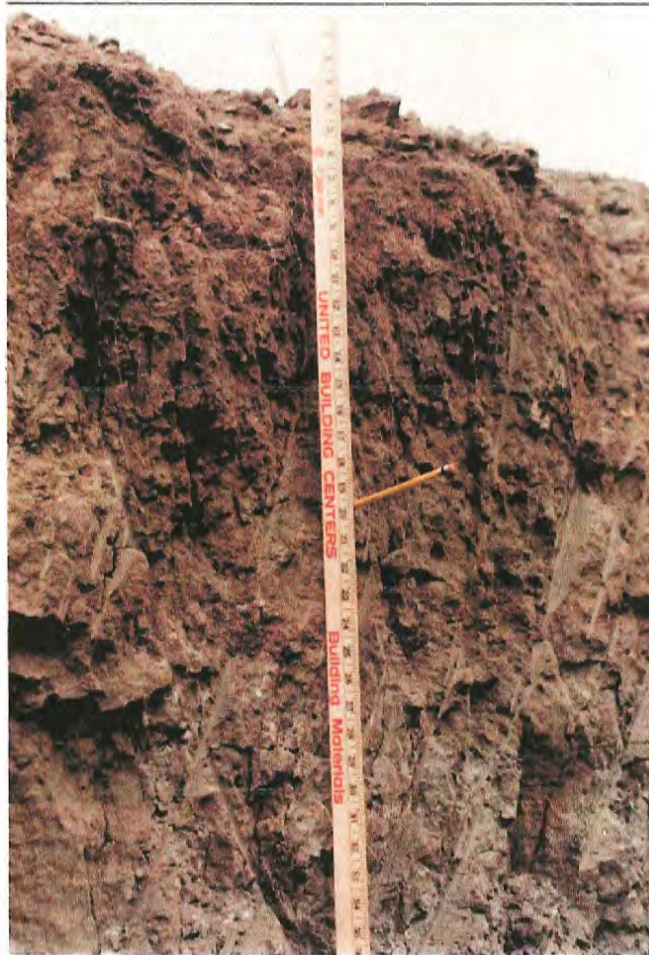
- #74 Lack of sufficient topsoil removal as indicated on trench side wall on state parcel VA052. The top of the yard stick is at the surface after removal of 3-4 inches of topsoil. The pencil is at the level where an acid reaction began (see text). Note the dark and deep A & B horizon.

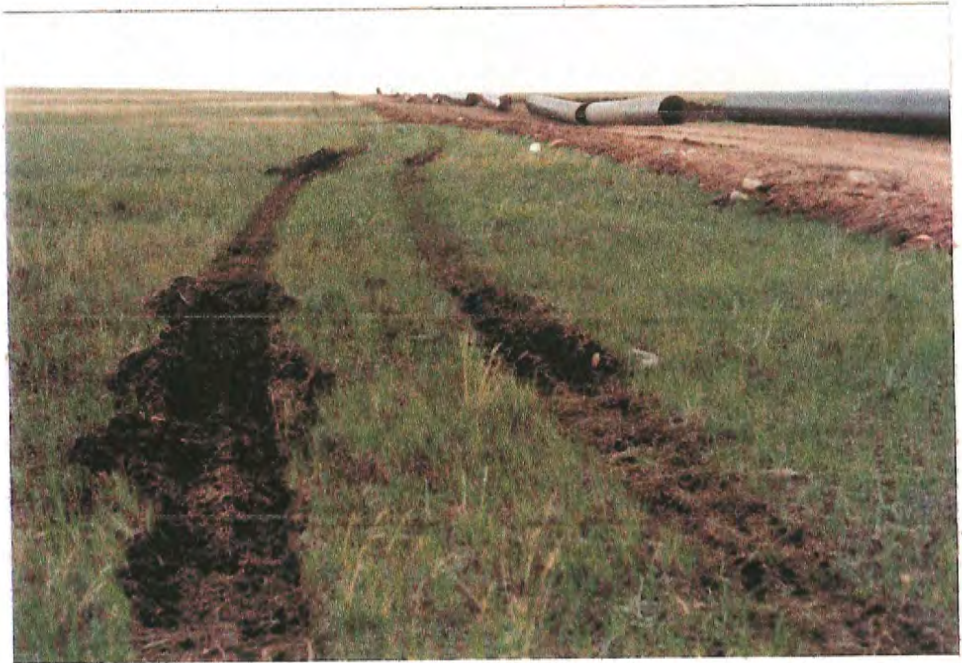
#75 Traffic off the r-o-w under muddy conditions on state parcel VA57. Photo taken July 15.

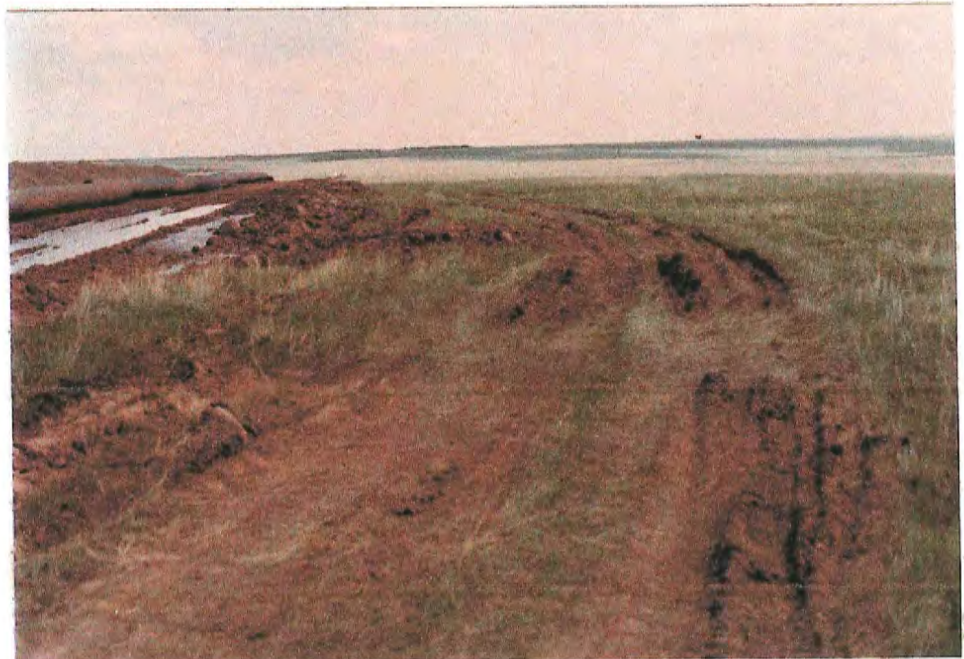
#76 Traffic off the r-o-w to avoid a mudhole on state parcel VA56. The prairie in this area was poorly drained. Photo taken July 23.
