**FRIENDS OF THE HEADWATERS**  
**RESPONSE TO THE MINNESOTA DEPARTMENT OF COMMERCE**  
**LINE 3 DRAFT EIS - Dockets CN-14-916, PPL-15-137**  
**JULY 10, 2017**

**C-1 Montana IPTF**

CONSTRUCTION OF THE NORTHERN BORDER PIPELINE IN MONTANA

January 1982

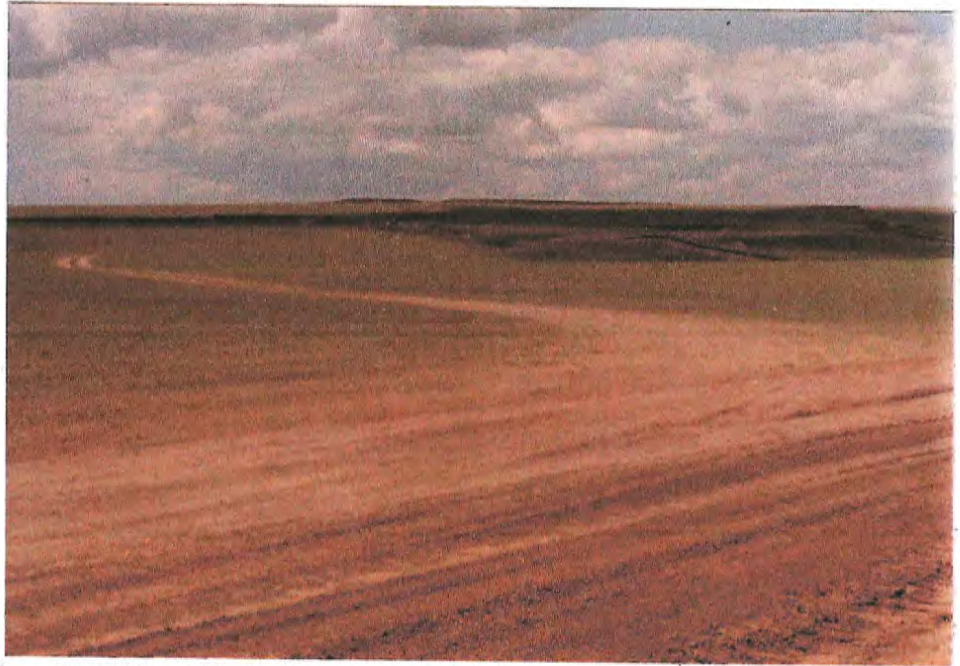
#77 Traffic off the r-o-w on state parcel VA027.5 to avoid two gates near the northern part of parcel. Photo taken July 15.

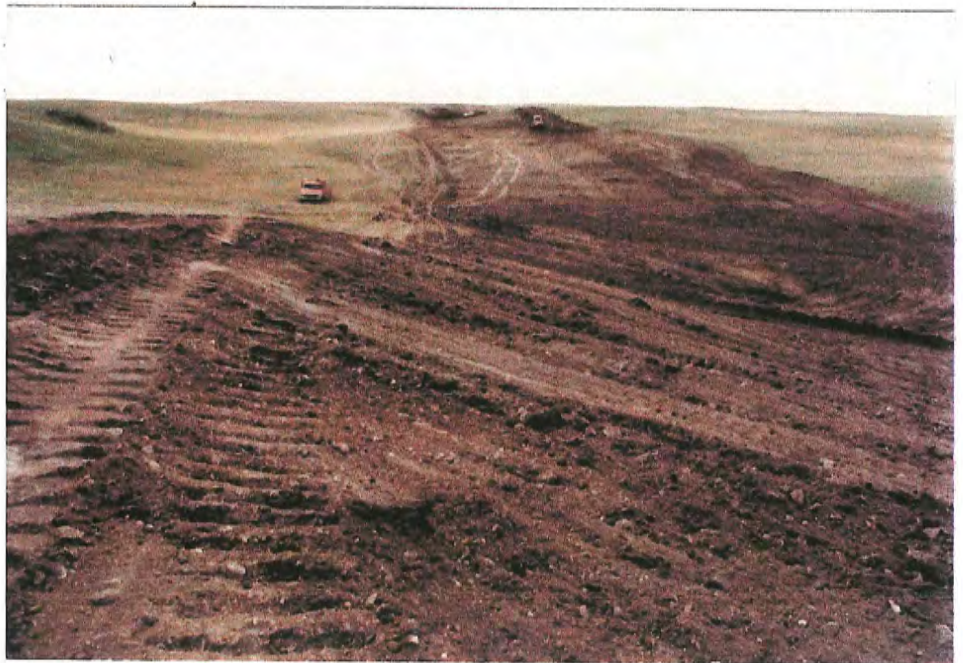
#78 Typical clean-up in progress in wide r-o-w area in Phillips County. Dozers first push the soil back roughly to the original contour, then a road grader with chisels reduces soil compaction and finishes contouring. Note that there has been extensive traffic outside soil/spoil storage areas. This adds to r-o-w width requirements as noted earlier. Photo taken July 22.

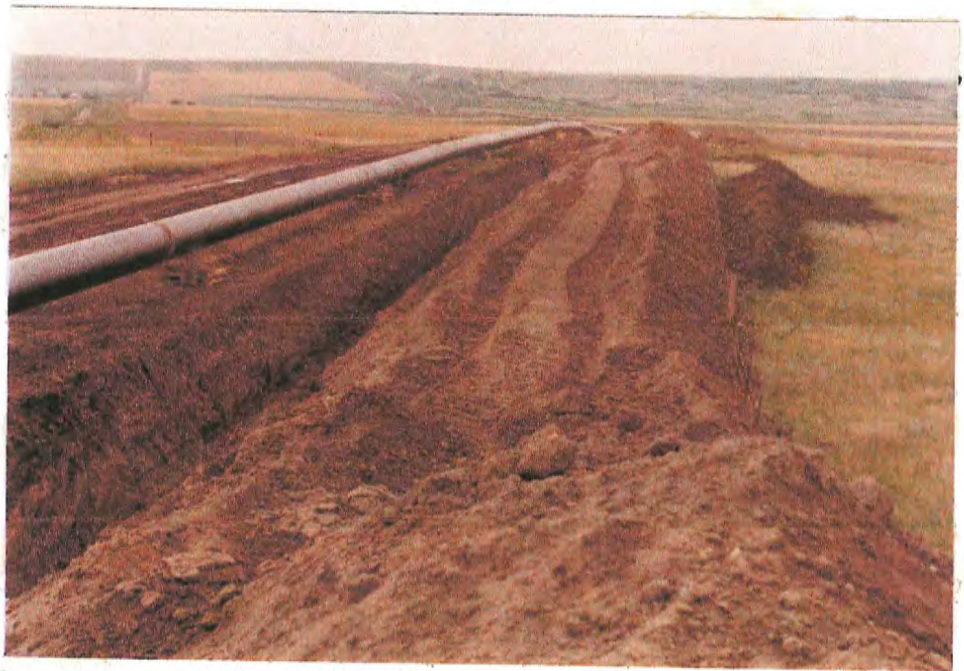
#79 State parcel R0142. Only the area shown in the photo is crossed by the pipeline. Note that the r-o-w was fenced but backhoe widening of the trench added material to the spoil pile, covering the fence and topsoil. The view looks northwest on July 24 from the southern edge of the parcel.

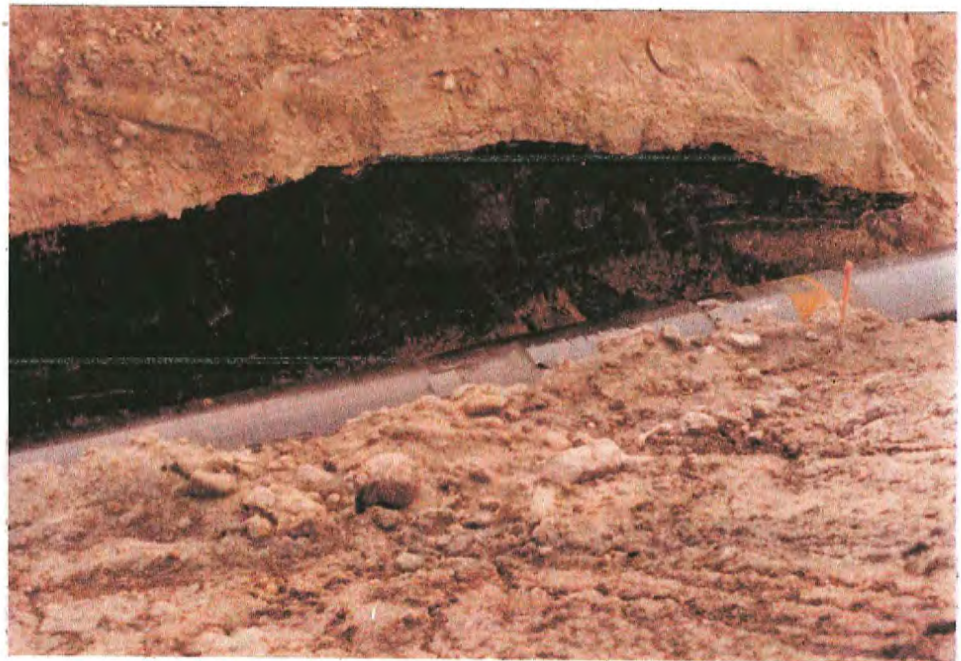
#80 Lignite seam cut by trench on R0142. The seam is directly below the vantage point in #79.
