Overview of wetland WB084.

**Wetland Delineation**  
**Lake Charlotte Solar**  
**Martin County, Minnesota**

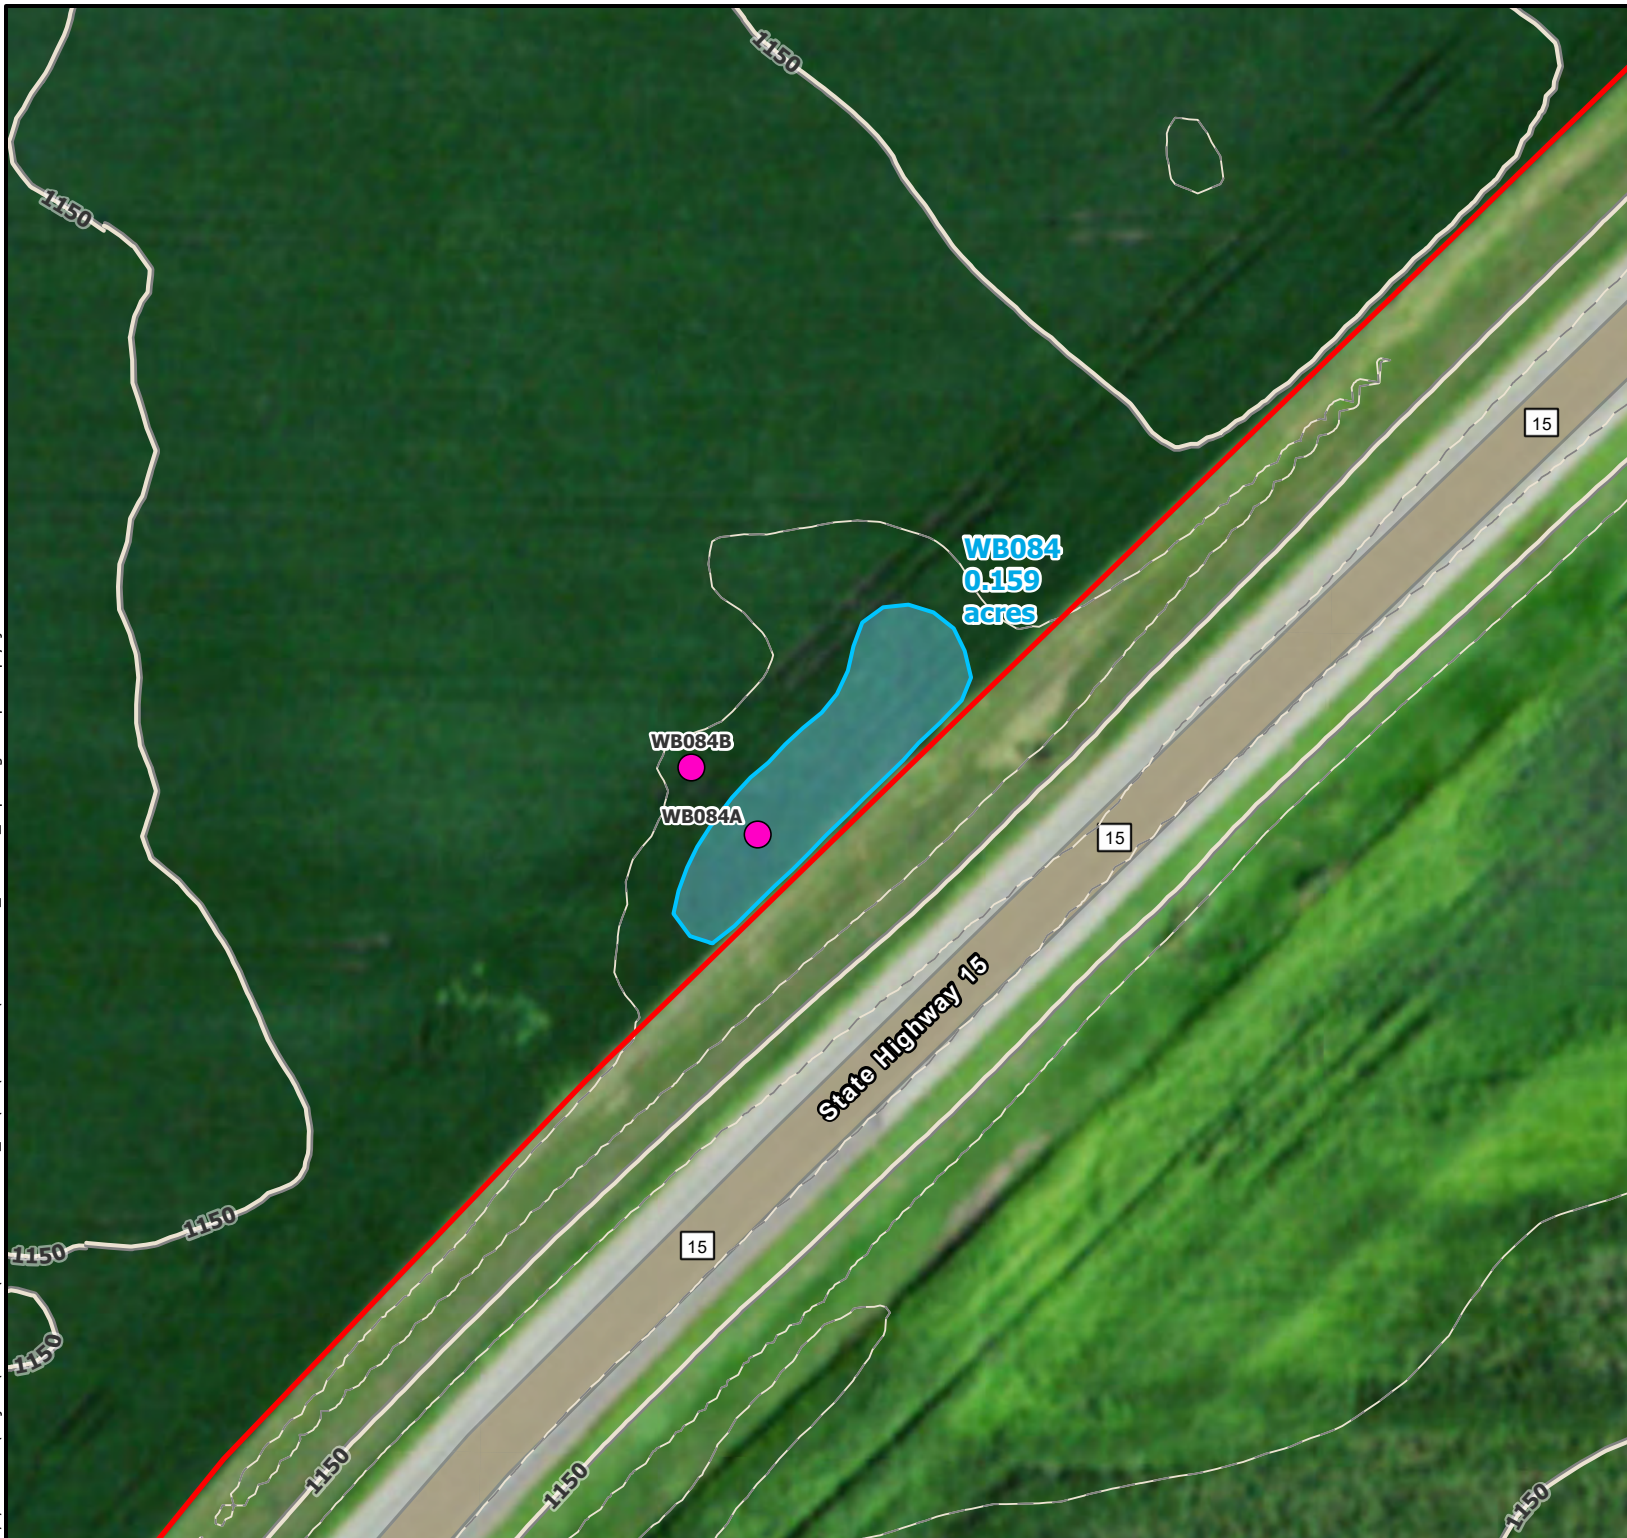
**Wetland ID**  
**WB084**

Direction: Northeast	Photo ID: f_photo-20221025-134848.jpg	Date: 10/25/2022
Project Name: Lake Charlotte		Feature ID: WB084

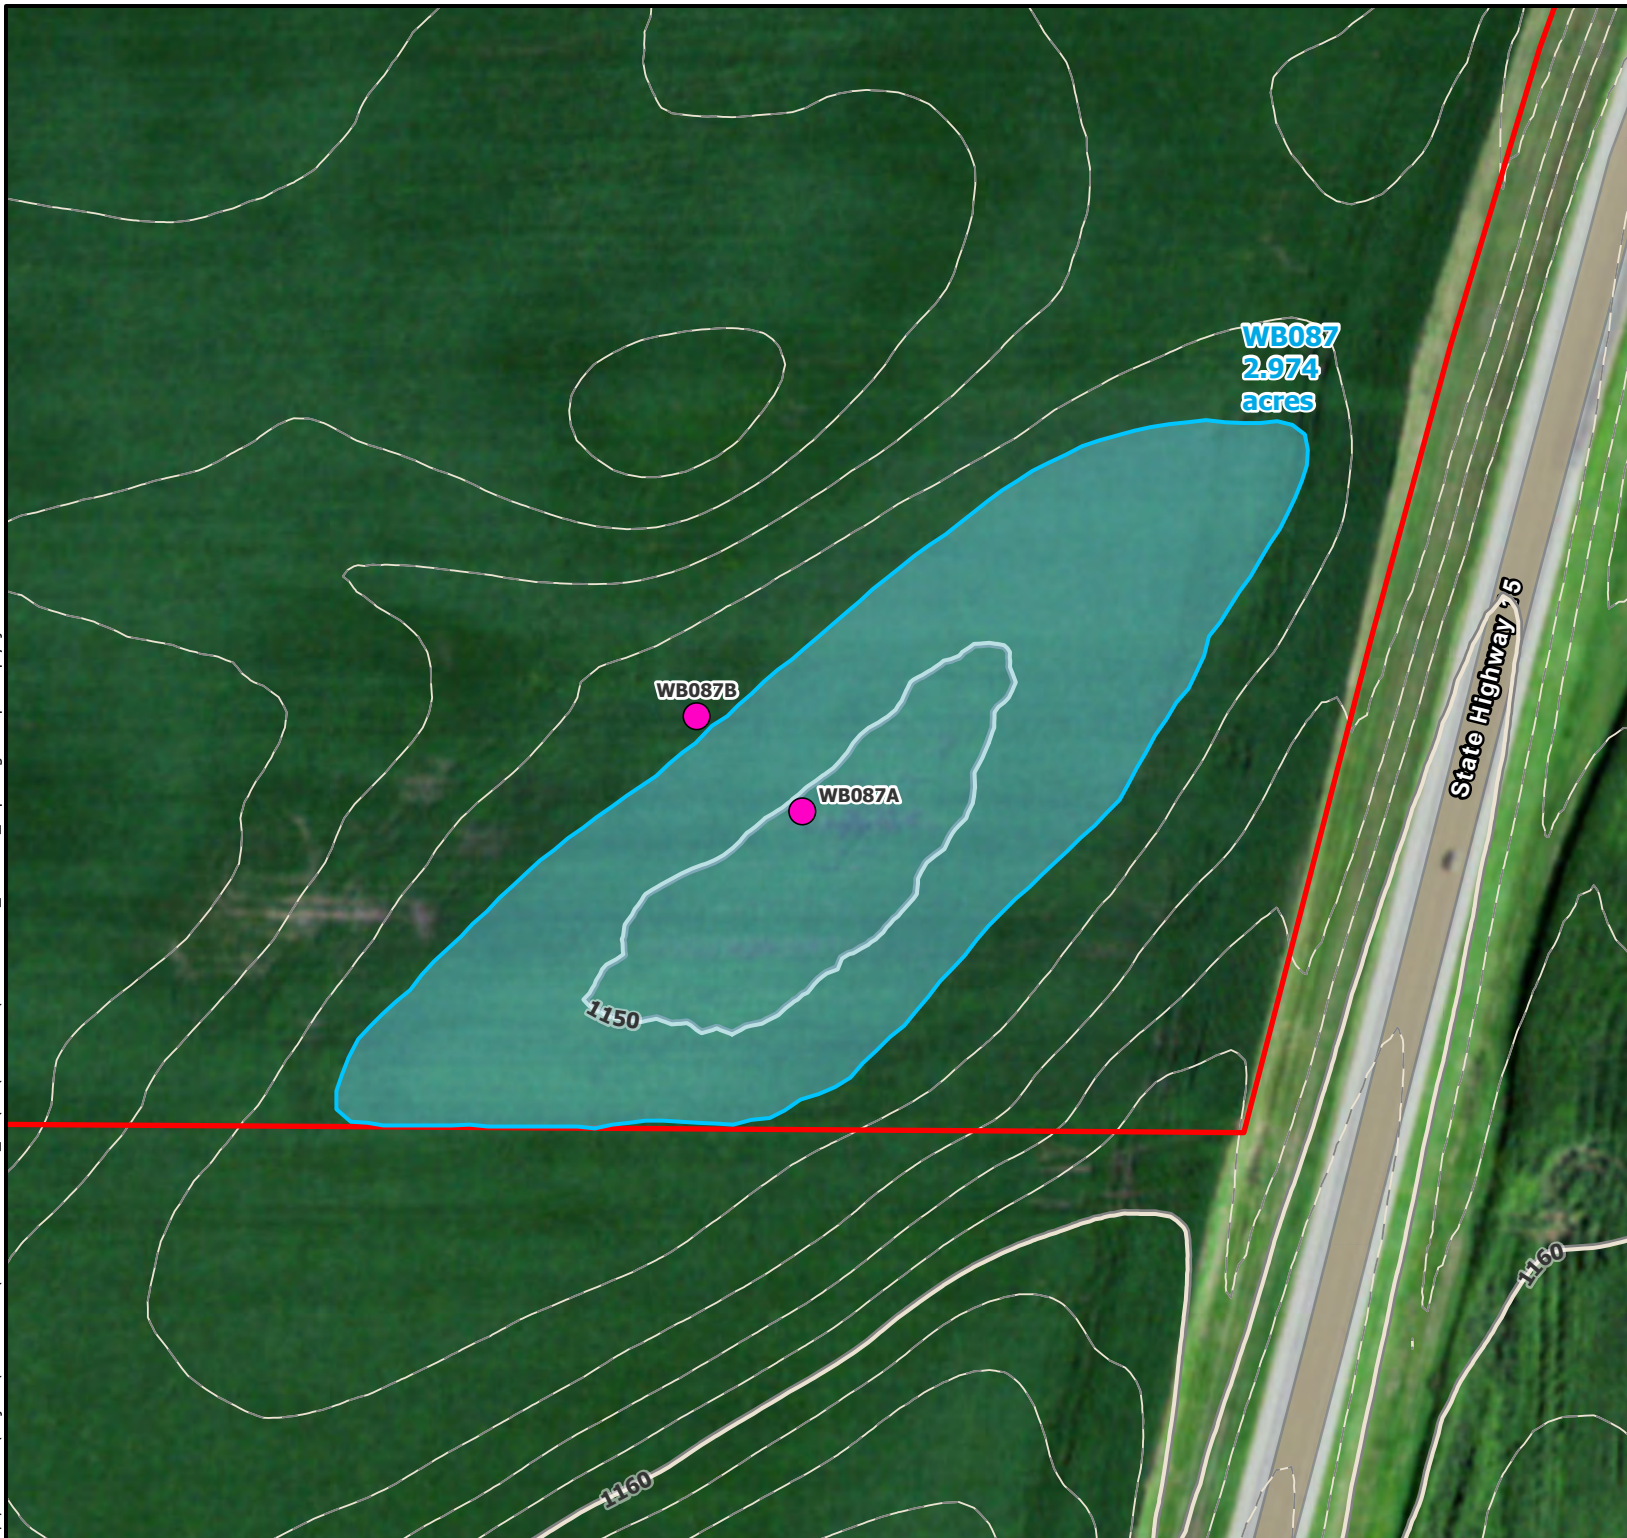
Direction: East	Photo ID: f_photo-20221025-154648.jpg	Date: 10/25/2022
Project Name: Lake Charlotte	Feature ID: WB087

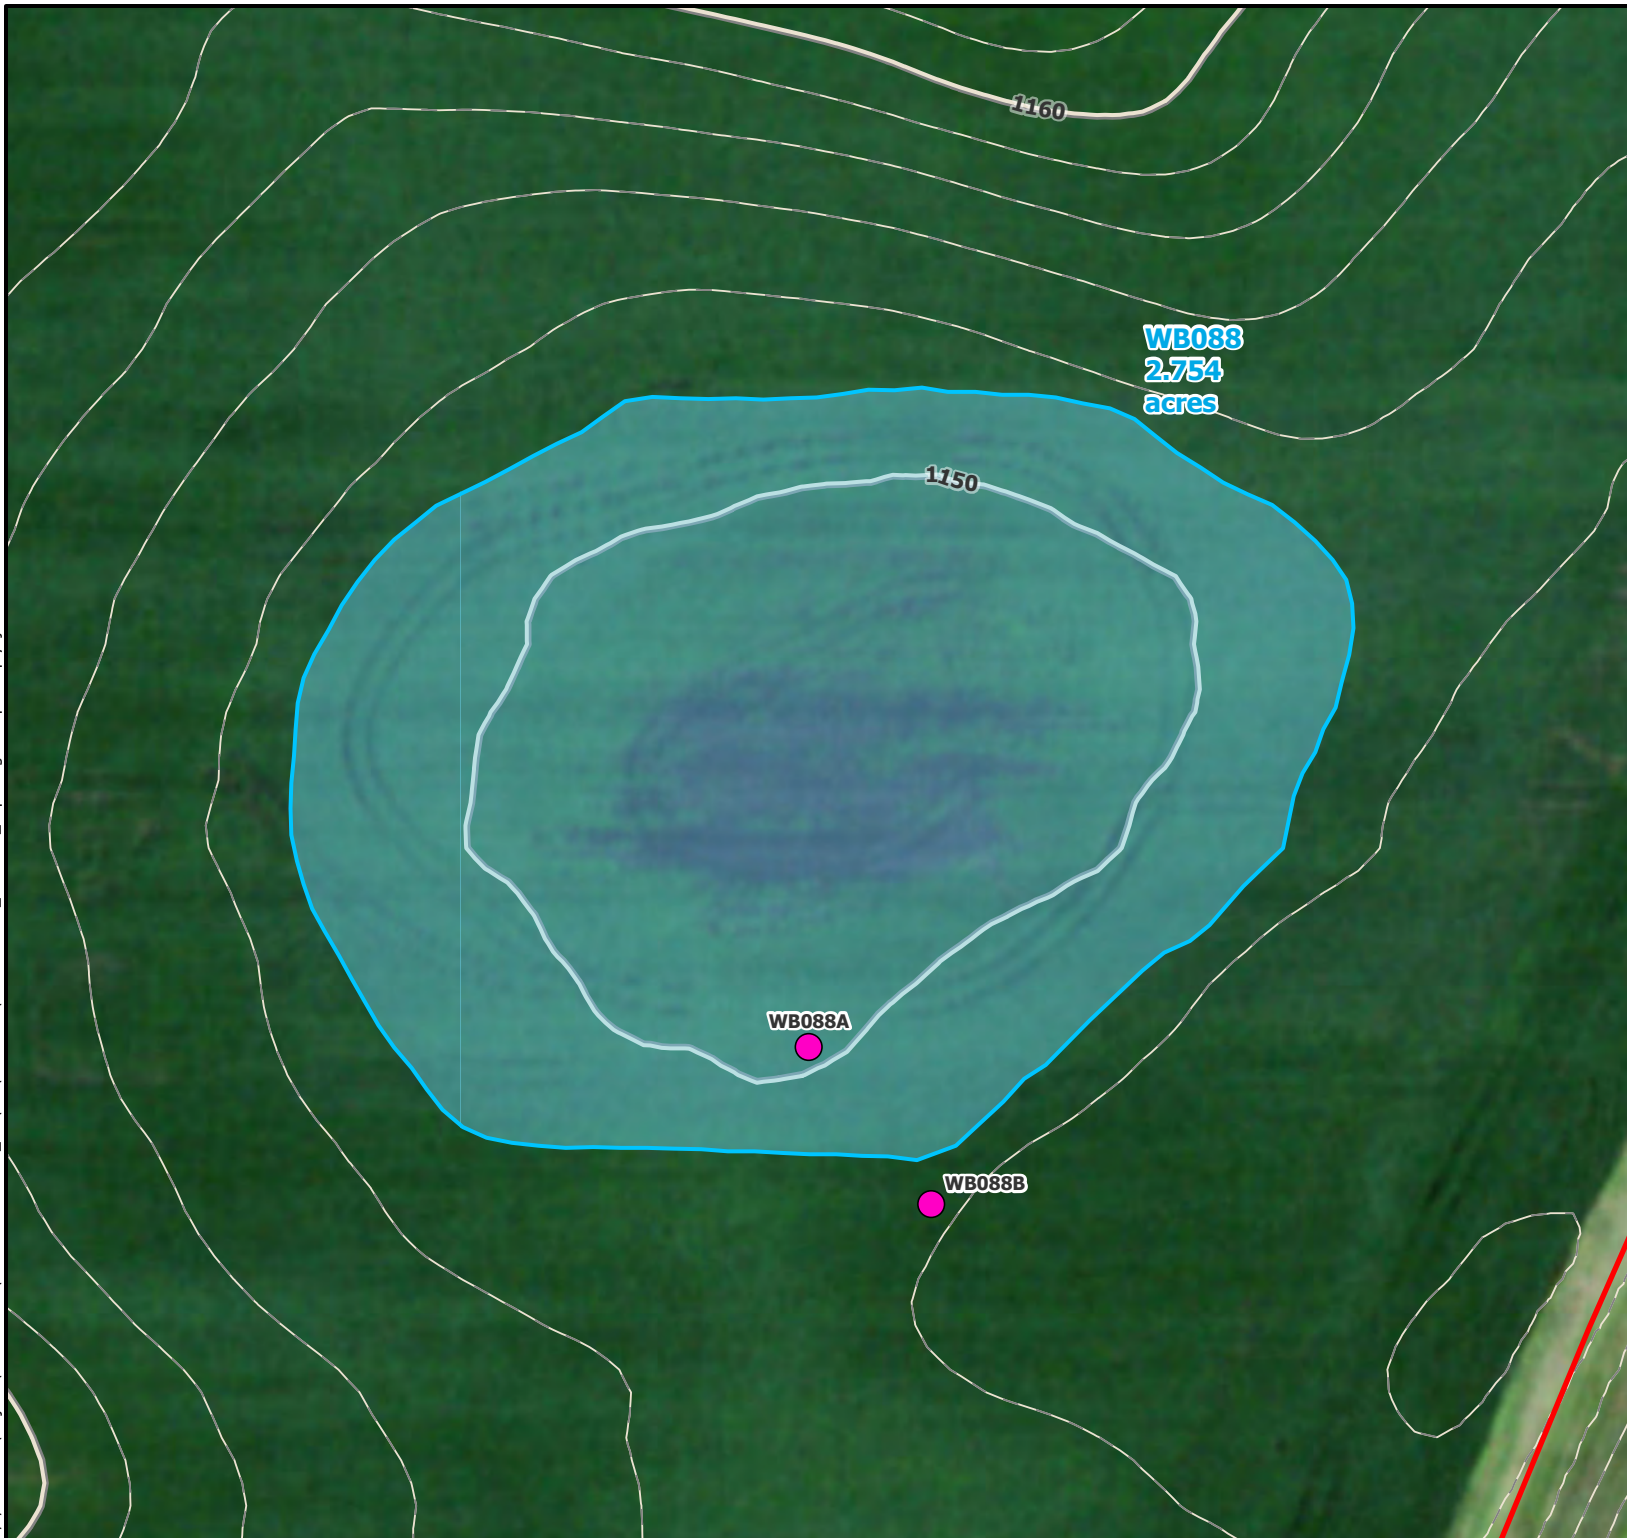
Direction: Northwest	Photo ID: f_photo-20221025-161642.jpg	Date: 10/25/2022
Project Name: Lake Charlotte		Feature ID: WB088

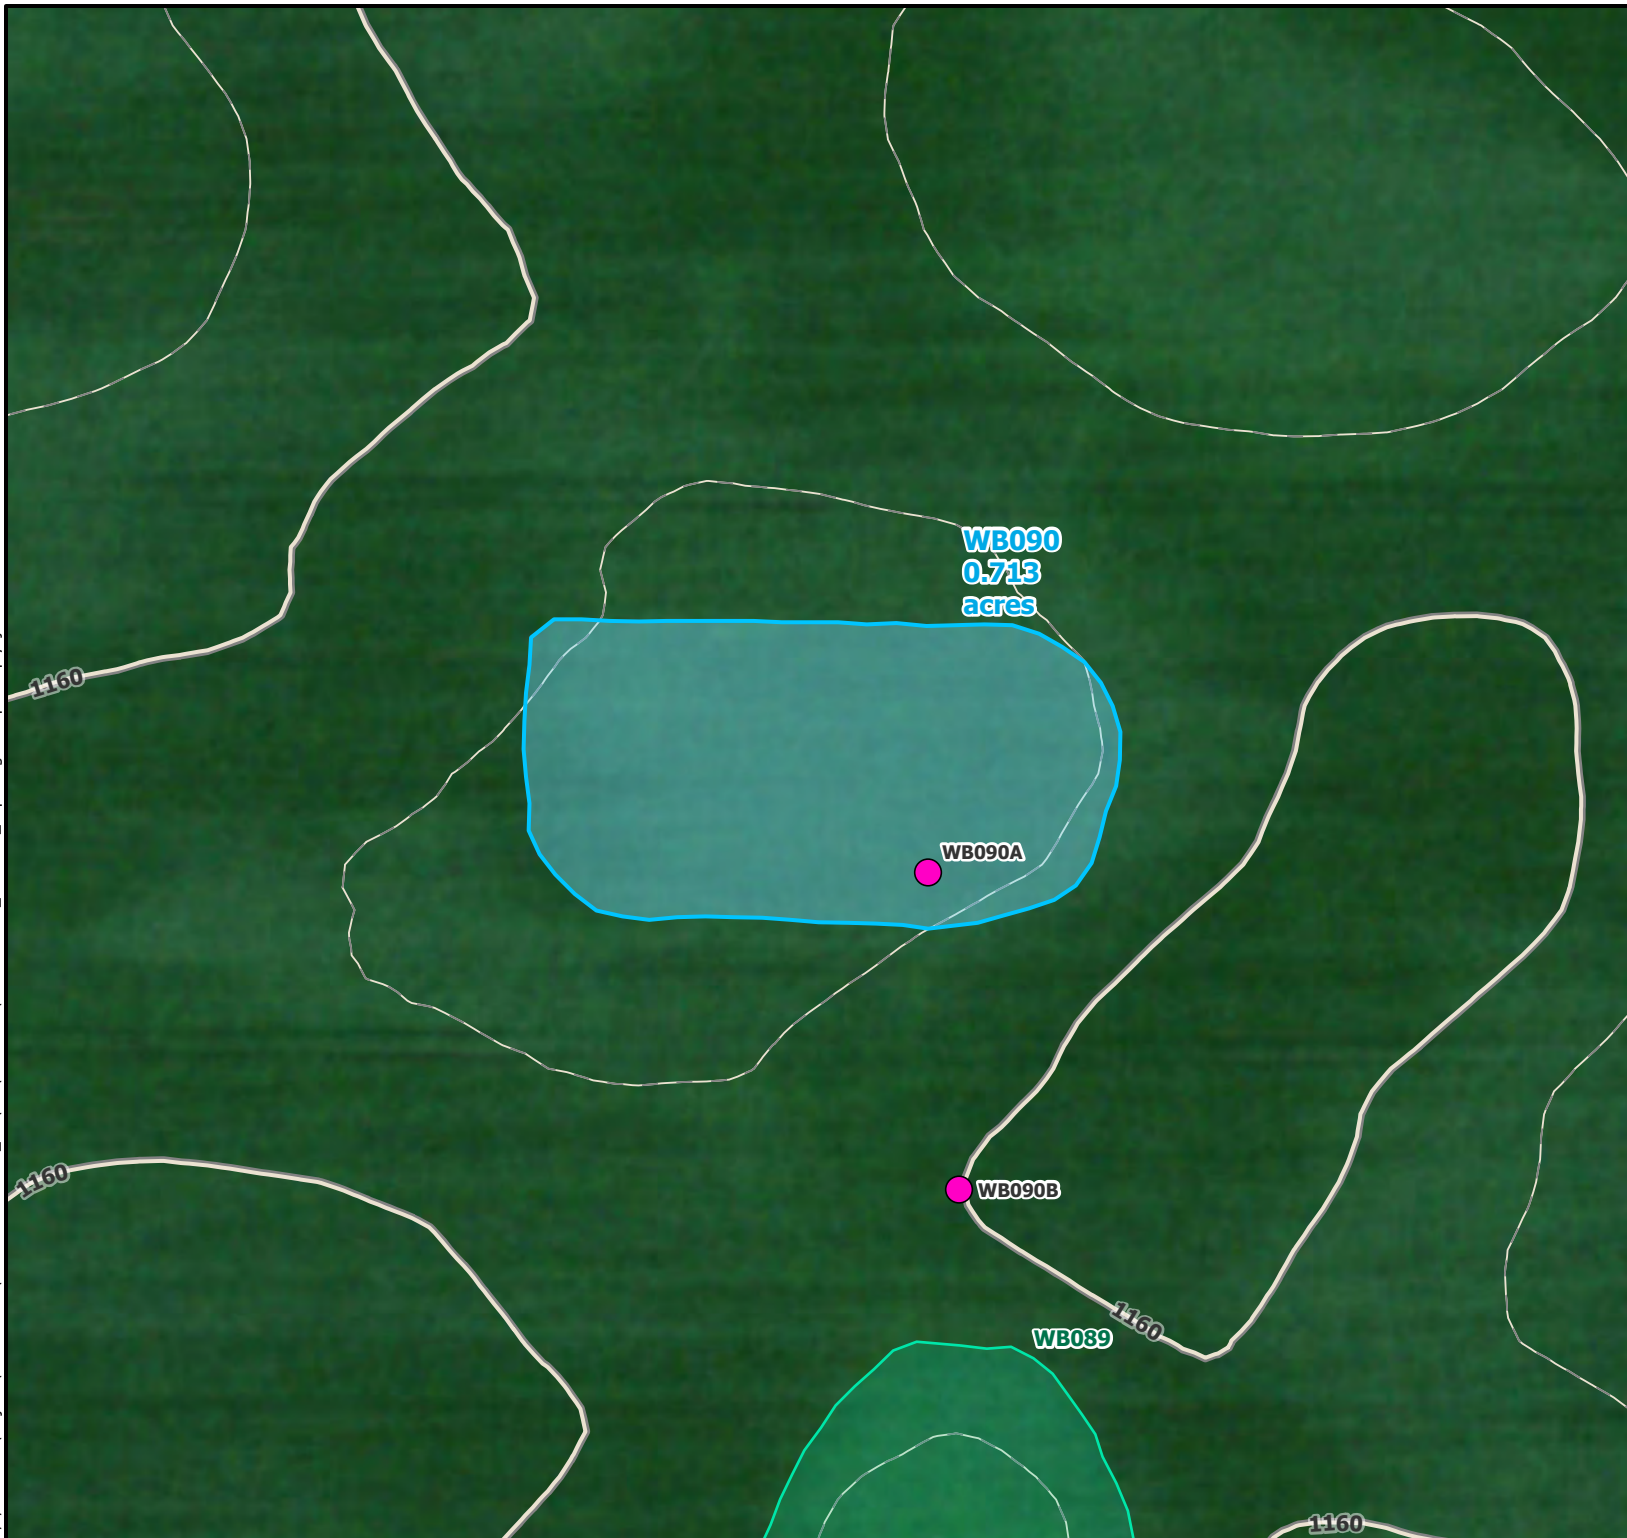
Direction: Northwest	Photo ID: f_photo-20221025-165936.jpg	Date: 10/25/2022
Project Name: Lake Charlotte		Feature ID: WB090

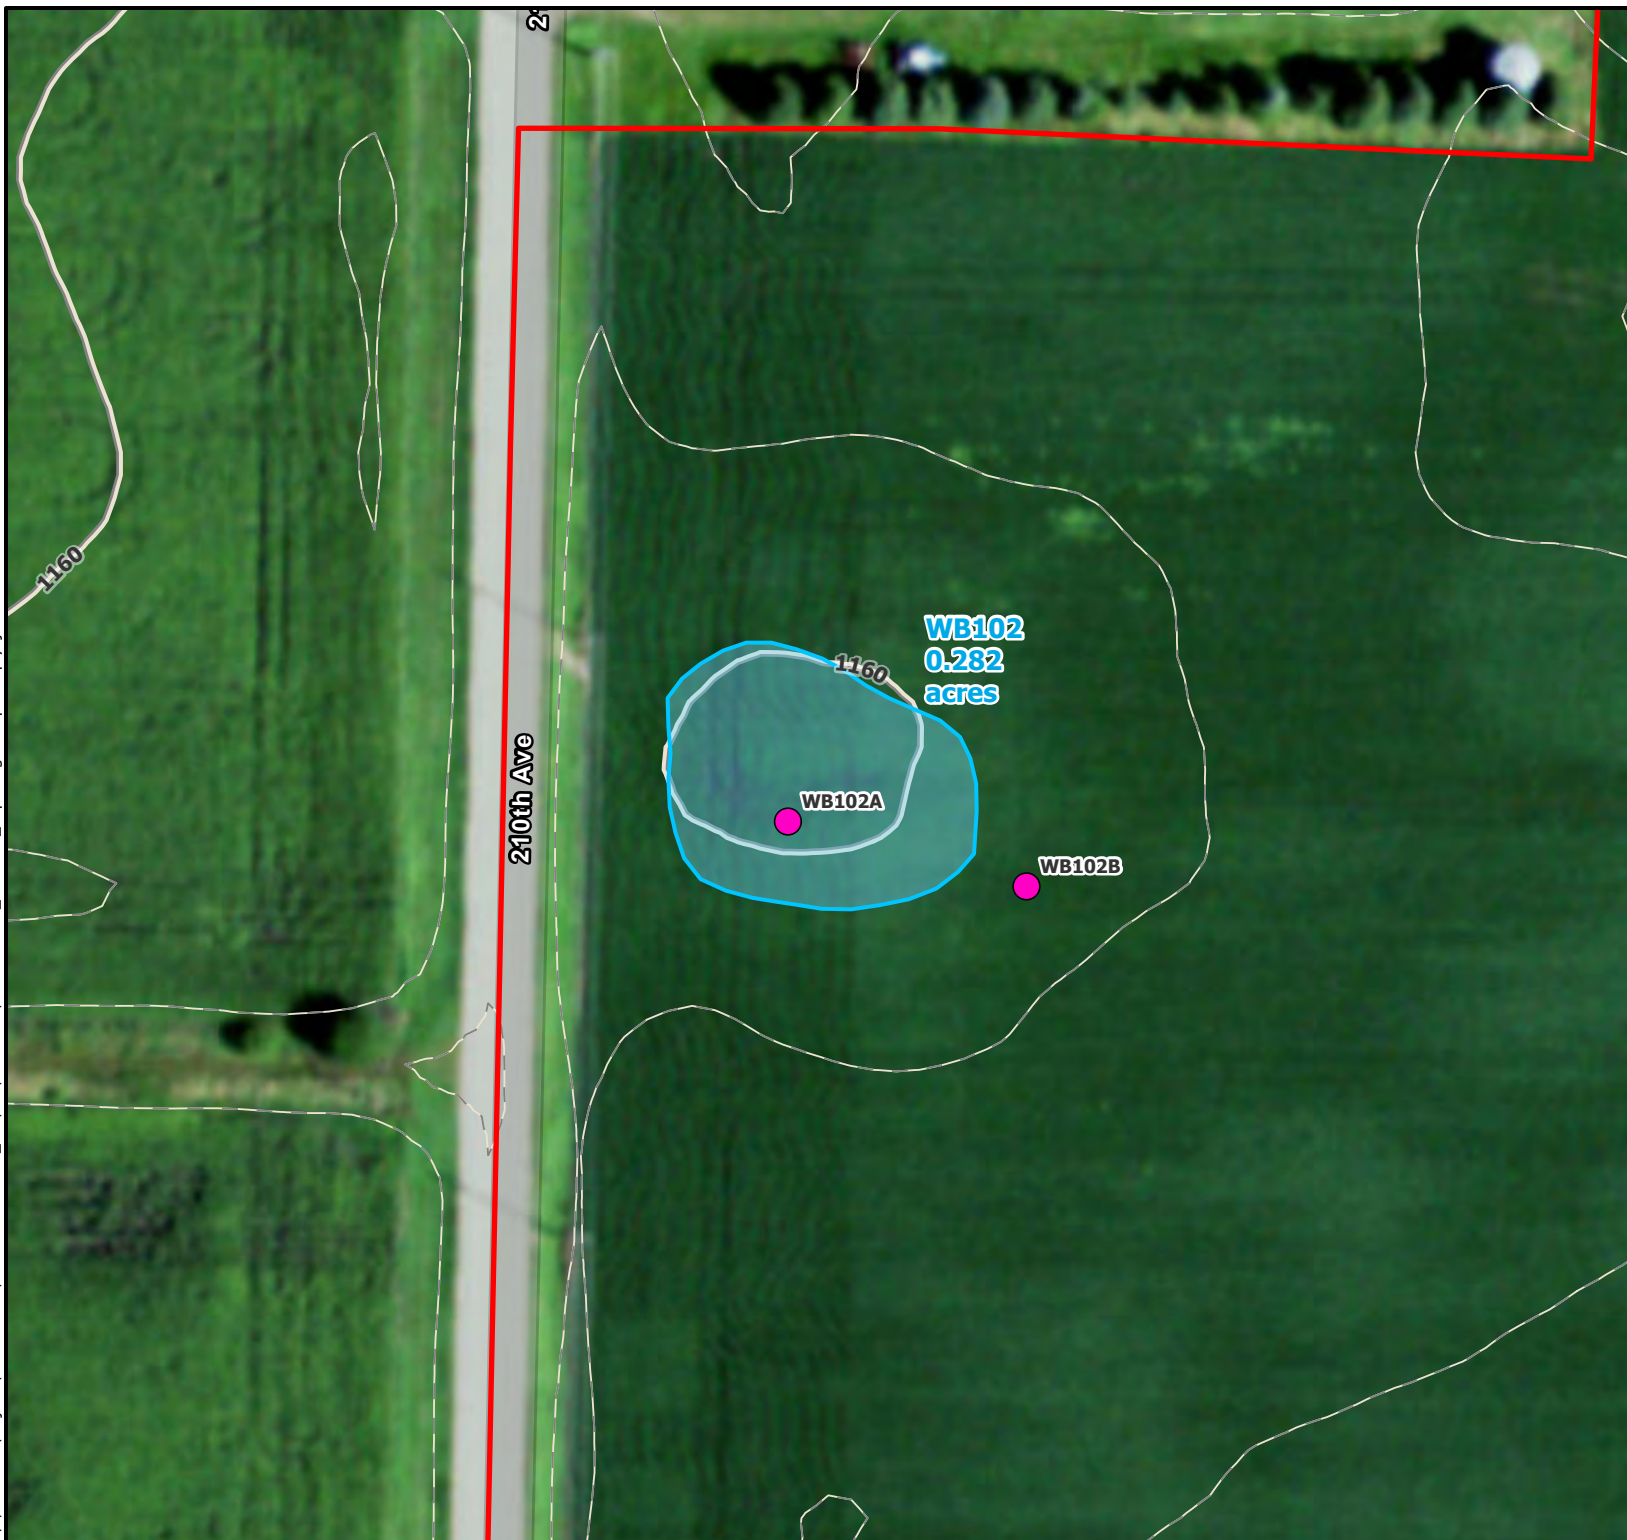
Direction: Northwest	Photo ID: f_photo-20221026-140908.jpg	Date: 10/26/2022
Project Name: Lake Charlotte		Feature ID: WB102

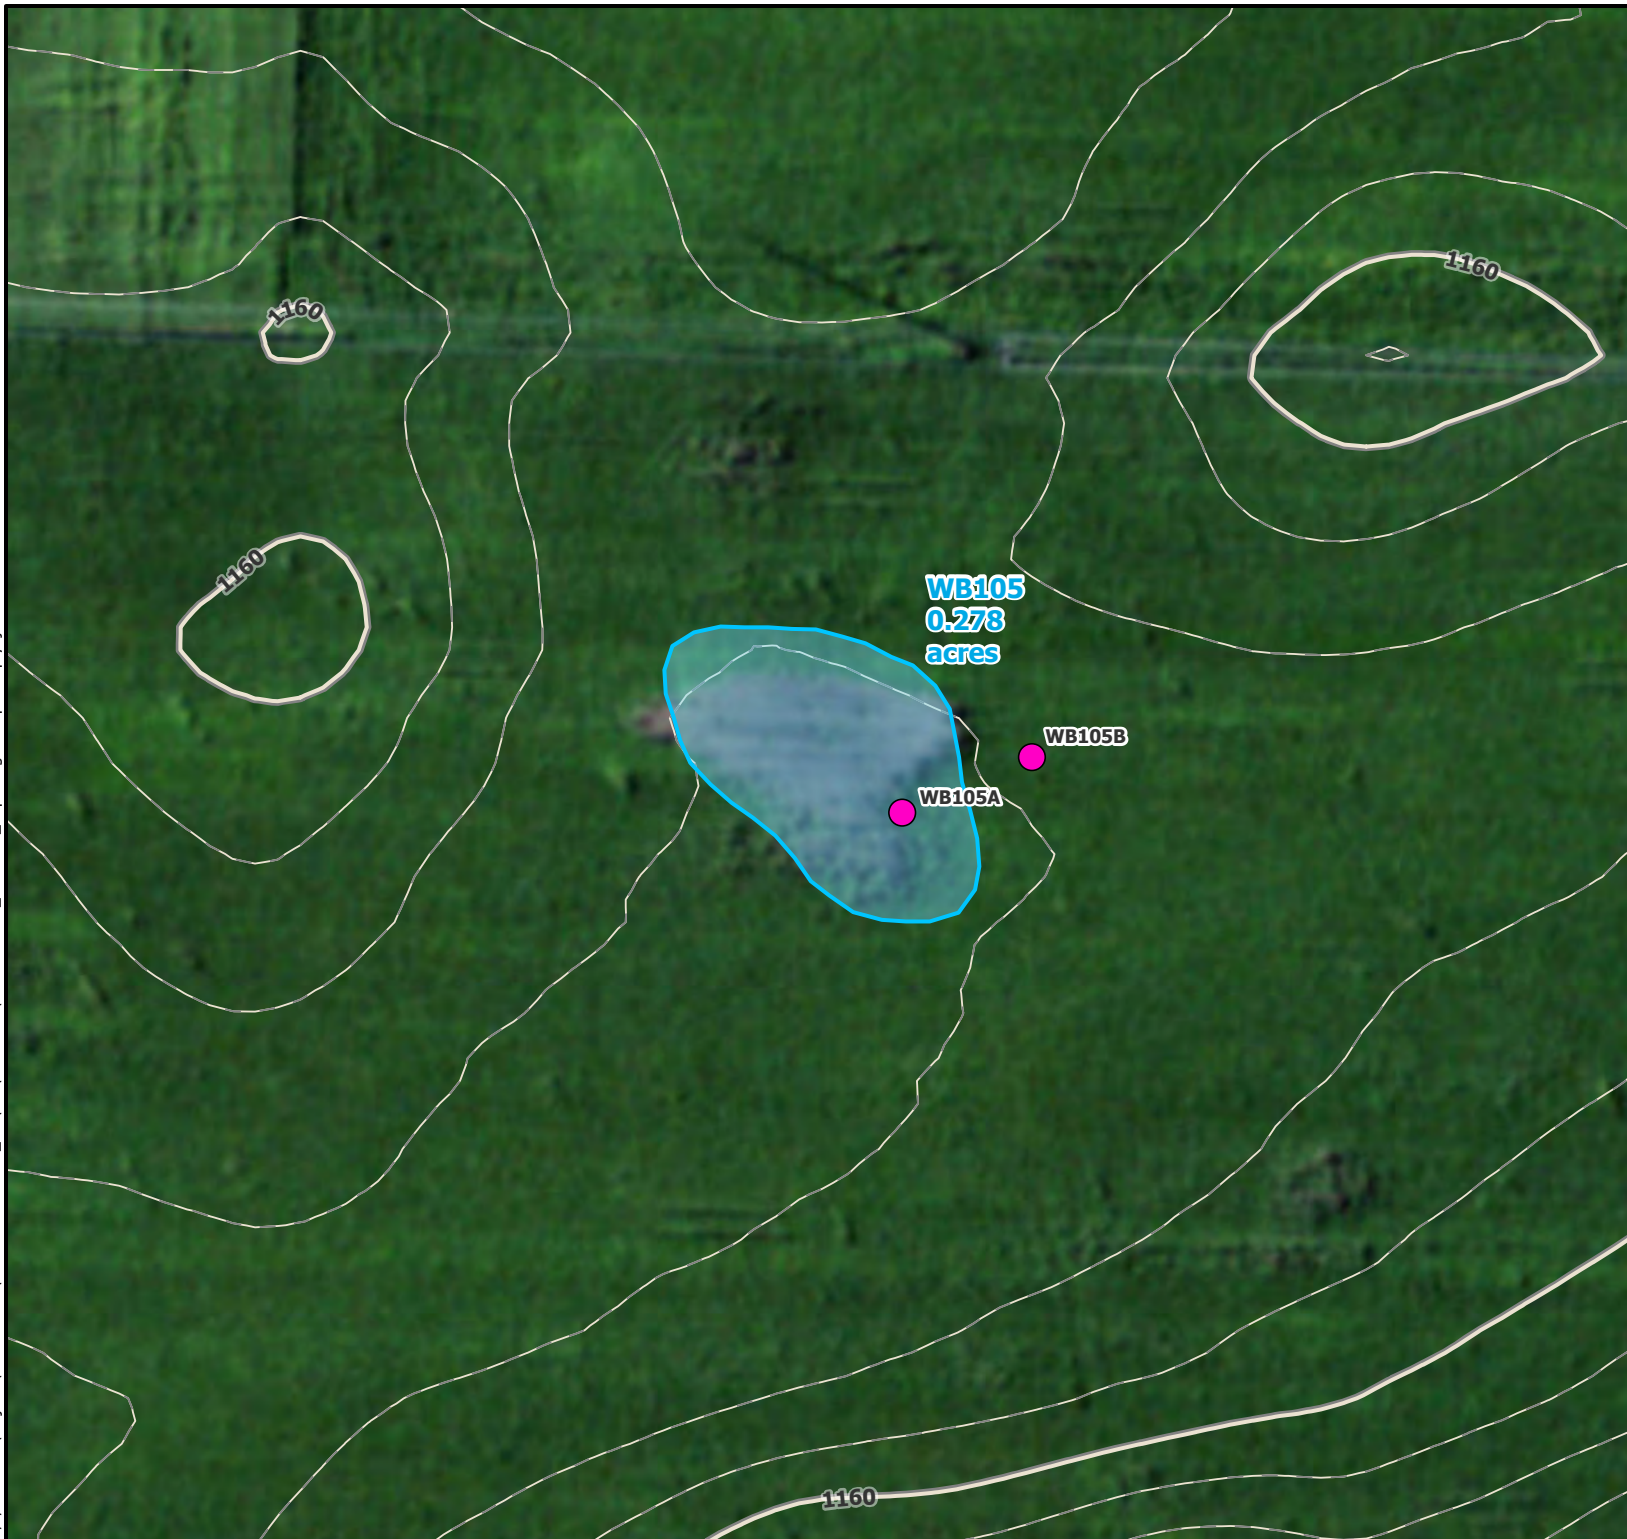
Direction: West	Photo ID: f_photo-20221026-151634.jpg	Date: 10/26/2022
Project Name: Lake Charlotte		Feature ID: WB105

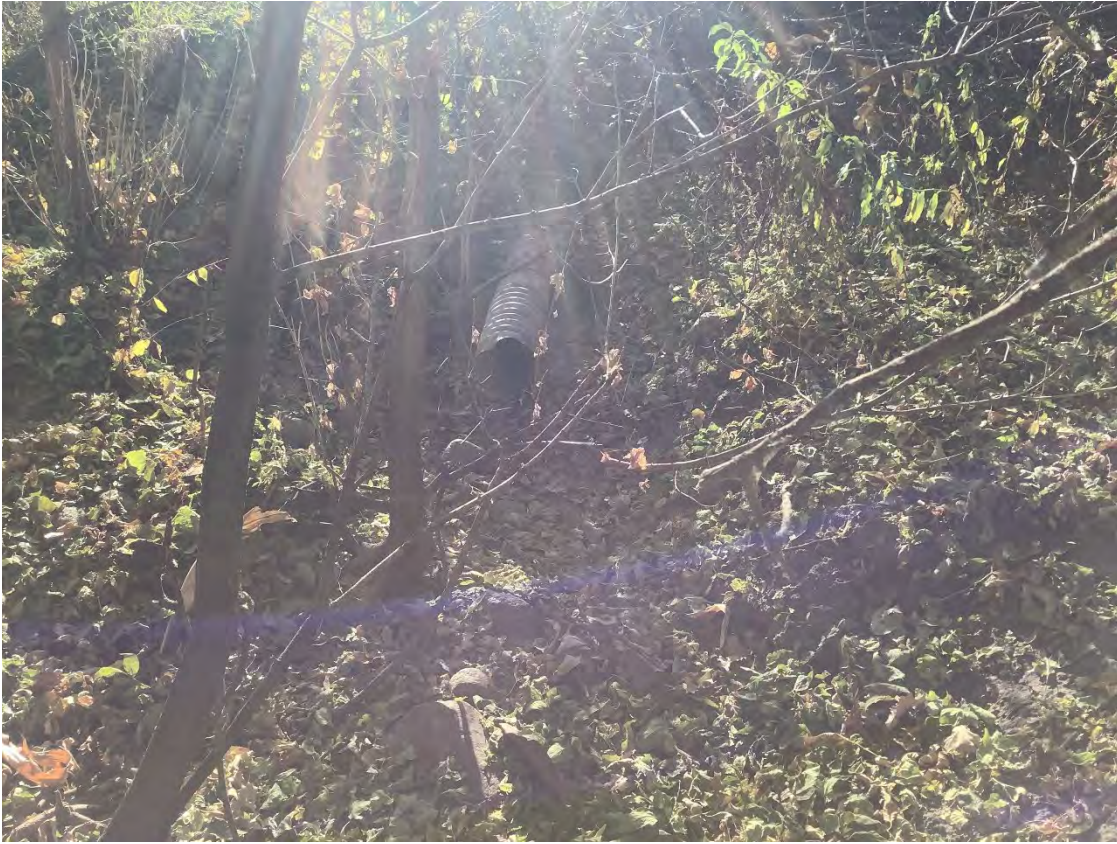
Upstream Photograph of SA001. Direction: Southwest

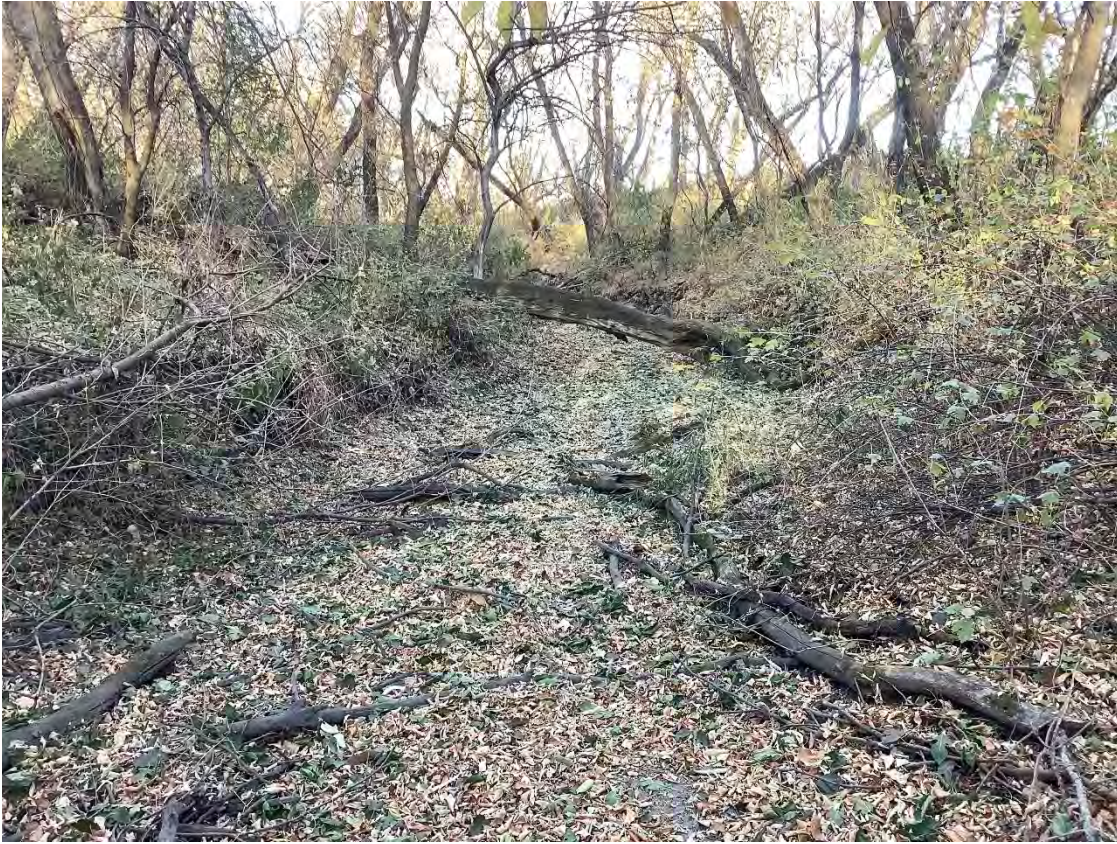
Project Name: Lake Charlotte	Survey Date: 10/18/2022	Stream ID: <b>SA005</b>
Stream Classification: R4SBC	Stream Flow Rate: Dry	Stream Water Clarity: Not Applicable
Average Width from Top of Bank: 12 feet	Average Depth from Top of Bank: 4 feet	Average Water Depth: 0 Feet
Stream Inorganic Substrate Components: <input checked="" type="checkbox"/> Clay <input checked="" type="checkbox"/> Silt <input checked="" type="checkbox"/> Sand <input checked="" type="checkbox"/> Gravel (0.1"-2.5") <input checked="" type="checkbox"/> Cobble (2.5"-10") <input checked="" type="checkbox"/> Boulder (>10") <input type="checkbox"/> Bedrock <input type="checkbox"/> Riprap/Concrete		Stream Organic Substrate Components: <input checked="" type="checkbox"/> Detritus (sticks, wood, coarse plant material) <input type="checkbox"/> Muck-Mud (very fine organic, black) <input type="checkbox"/> Marl (grey, shell fragments)
Stream Characteristics Observed: <input checked="" type="checkbox"/> Bed <input checked="" type="checkbox"/> Bank <input checked="" type="checkbox"/> Natural line impressed on the bank <input checked="" type="checkbox"/> Shelving <input type="checkbox"/> Changes in the character of soil <input checked="" type="checkbox"/> Destruction of terrestrial vegetation <input checked="" type="checkbox"/> Presence of litter and debris <input checked="" type="checkbox"/> Vegetation matted down, bent, or absent <input type="checkbox"/> Leaf litter disturbed or washed away <input checked="" type="checkbox"/> Sediment deposition <input type="checkbox"/> Water staining <input type="checkbox"/> Presence of wrack line <input checked="" type="checkbox"/> Sediment sorting <input checked="" type="checkbox"/> Scour <input type="checkbox"/> Abrupt change in plant community <input type="checkbox"/> Fish <input type="checkbox"/> Crayfish or Crayfish Burrows <input type="checkbox"/> Tadpoles

Upstream Photograph of SA005. Direction: Northeast

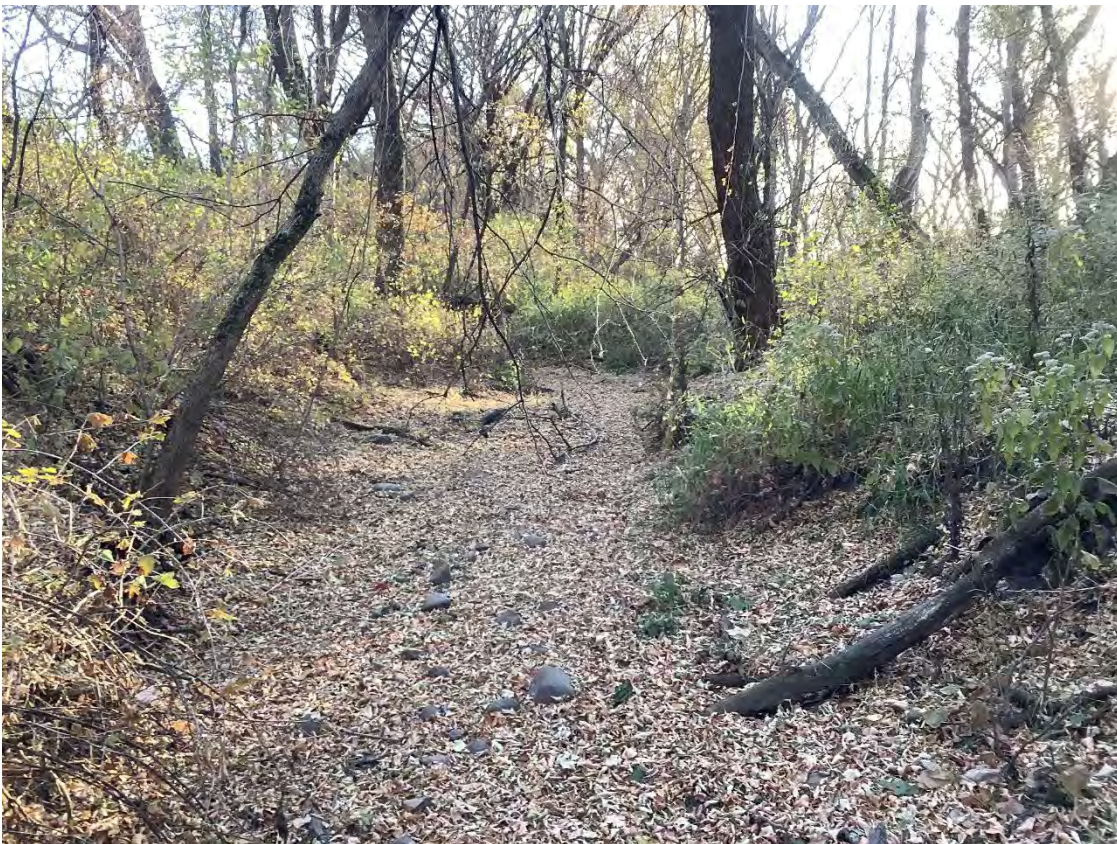
Downstream Photograph of SA005. Direction: Southwest

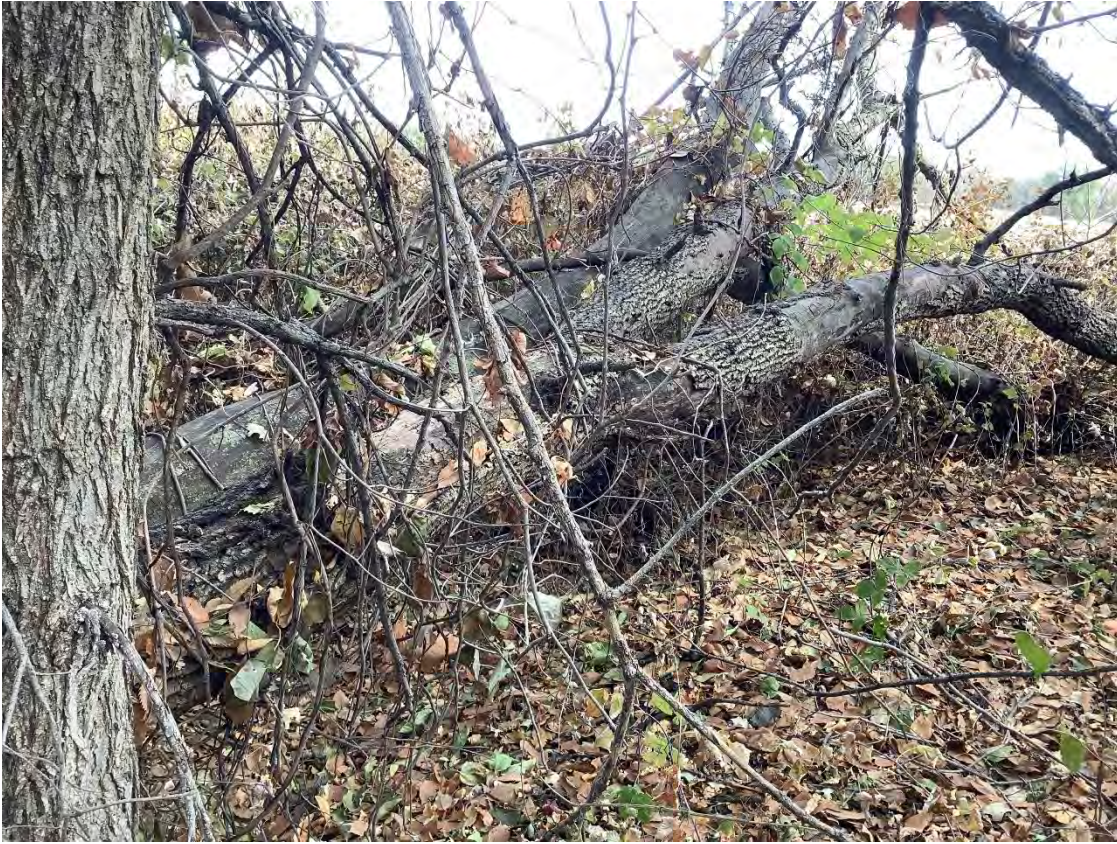
Project Name: Lake Charlotte	Survey Date: 10/19/2022	Stream ID: <b>SA016</b>
Stream Classification: R4SBA	Stream Flow Rate: Dry	Stream Water Clarity: Not Applicable
Average Width from Top of Bank: 3 feet	Average Depth from Top of Bank: 2 feet	Average Water Depth: 0 Feet
Stream Inorganic Substrate Components: <input checked="" type="checkbox"/> Clay <input checked="" type="checkbox"/> Silt <input checked="" type="checkbox"/> Sand <input checked="" type="checkbox"/> Gravel (0.1"-2.5") <input checked="" type="checkbox"/> Cobble (2.5"-10") <input checked="" type="checkbox"/> Boulder (>10") <input type="checkbox"/> Bedrock <input type="checkbox"/> Riprap/Concrete		Stream Organic Substrate Components: <input checked="" type="checkbox"/> Detritus (sticks, wood, coarse plant material) <input type="checkbox"/> Muck-Mud (very fine organic, black) <input type="checkbox"/> Marl (grey, shell fragments)
Stream Characteristics Observed: <input checked="" type="checkbox"/> Bed <input checked="" type="checkbox"/> Bank <input checked="" type="checkbox"/> Natural line impressed on the bank <input checked="" type="checkbox"/> Shelving <input type="checkbox"/> Changes in the character of soil <input checked="" type="checkbox"/> Destruction of terrestrial vegetation <input checked="" type="checkbox"/> Presence of litter and debris <input type="checkbox"/> Vegetation matted down, bent, or absent <input type="checkbox"/> Leaf litter disturbed or washed away <input type="checkbox"/> Sediment deposition <input type="checkbox"/> Water staining <input type="checkbox"/> Presence of wrack line <input type="checkbox"/> Sediment sorting <input checked="" type="checkbox"/> Scour <input type="checkbox"/> Abrupt change in plant community <input type="checkbox"/> Fish <input type="checkbox"/> Crayfish or Crayfish Burrows <input type="checkbox"/> Tadpoles

Upstream Photograph of SA016. Direction: Northeast
