Non-Wetland ID

NWA062

Project/Site:	Lake Charlotte	City/County:	Martin	Sampling Date:	10/21/2022
Applicant/Owner:	Lake Charlotte Solar, LLC	State:	MN	Sampling Point:	NWA062A
Investigator(s):	Apryl Jennrich	Section, Township, Range:	Sec.16 T103N R30W		
Landform (hillslope, terrace, etc.):	Plain	Local relief (concave, convex, none):	None		
Slope (%):	0	Lat:	43.72749	Long:	-94.43446
		Datum:	WGS84		
Soil Map Unit Name:	Canisteo-Glencoe complex, 0 to 2 percent slopes	NWI Classification:	NA

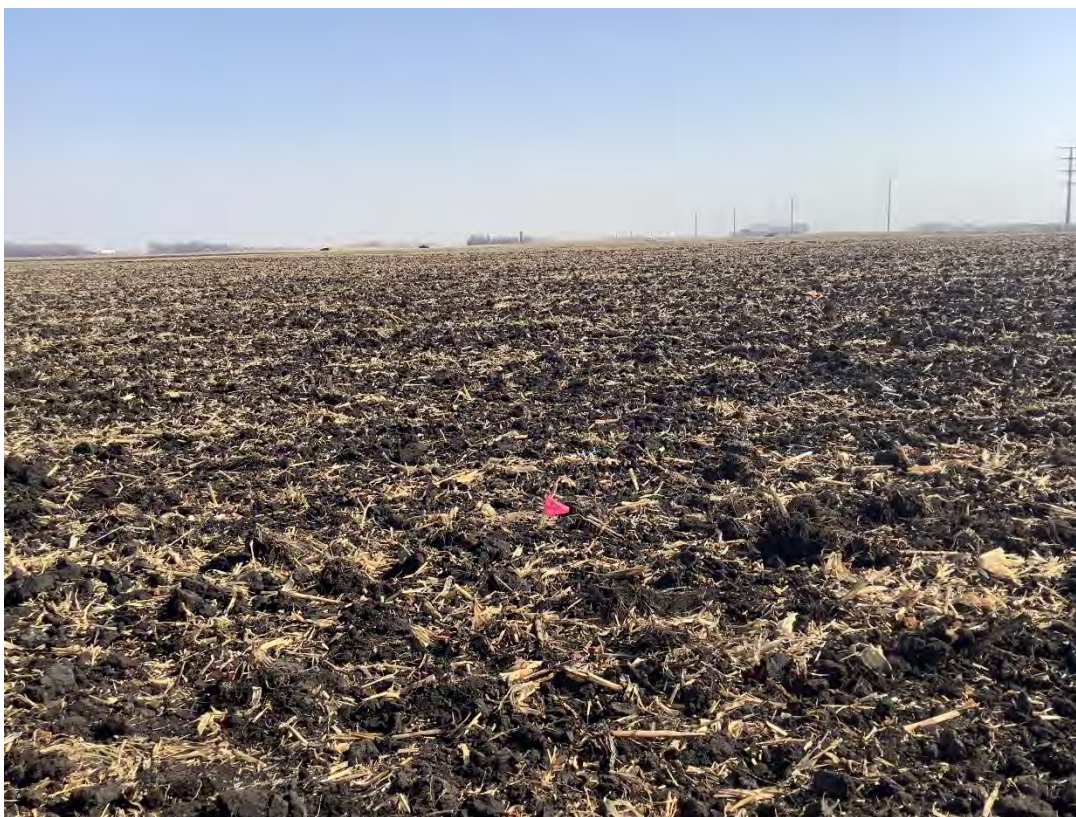
Direction: East	Photo ID: delin_photo-20221021-174545.jpg	Date: 10/21/2022
Project Name: Lake Charlotte	Feature ID: NWA062

Hydrophytic Vegetation Present?	<u>No</u>	Is the sampled area within a wetland?	<u>No</u>
Hydric Soil Present?	<u>No</u>		
Wetland Hydrology Present?	<u>No</u>		
Remarks:			
Recently tilled agricultural field. Recently harvested agricultural field.

Overview of upland sample point NWA062A.

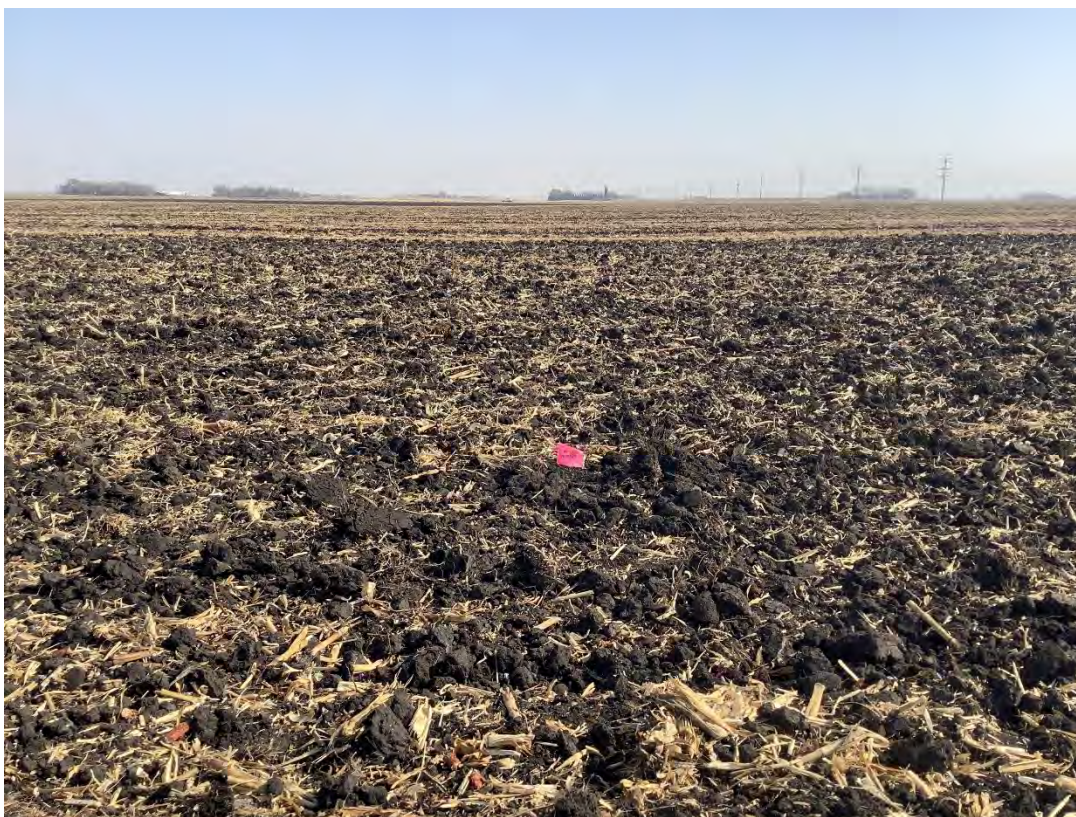
Direction: East	Photo ID: delin_photo-20221021-175400.jpg	Date: 10/21/2022
Project Name: Lake Charlotte		Feature ID: NWA063

Overview of upland sample point NWA063A.

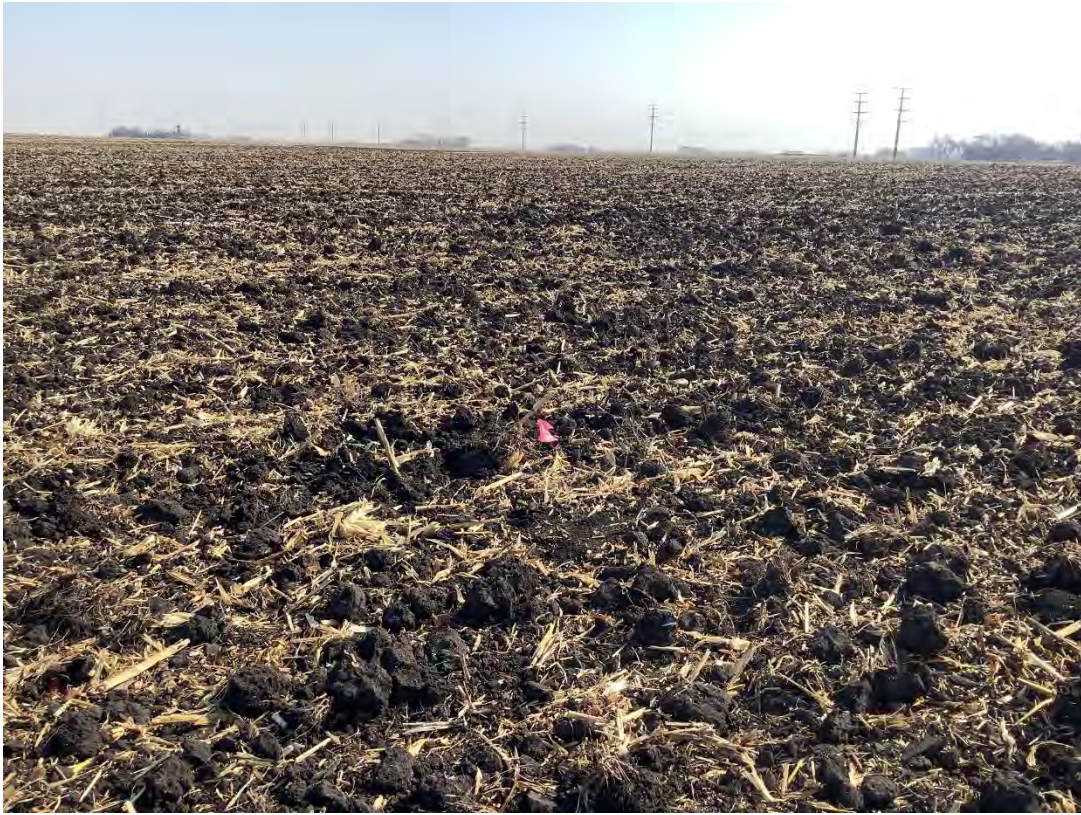
Direction: Southeast	Photo ID: delin_photo-20221021-180538.jpg	Date: 10/21/2022
Project Name: Lake Charlotte	Feature ID: NWA064

Overview of upland sample point NWA064A.

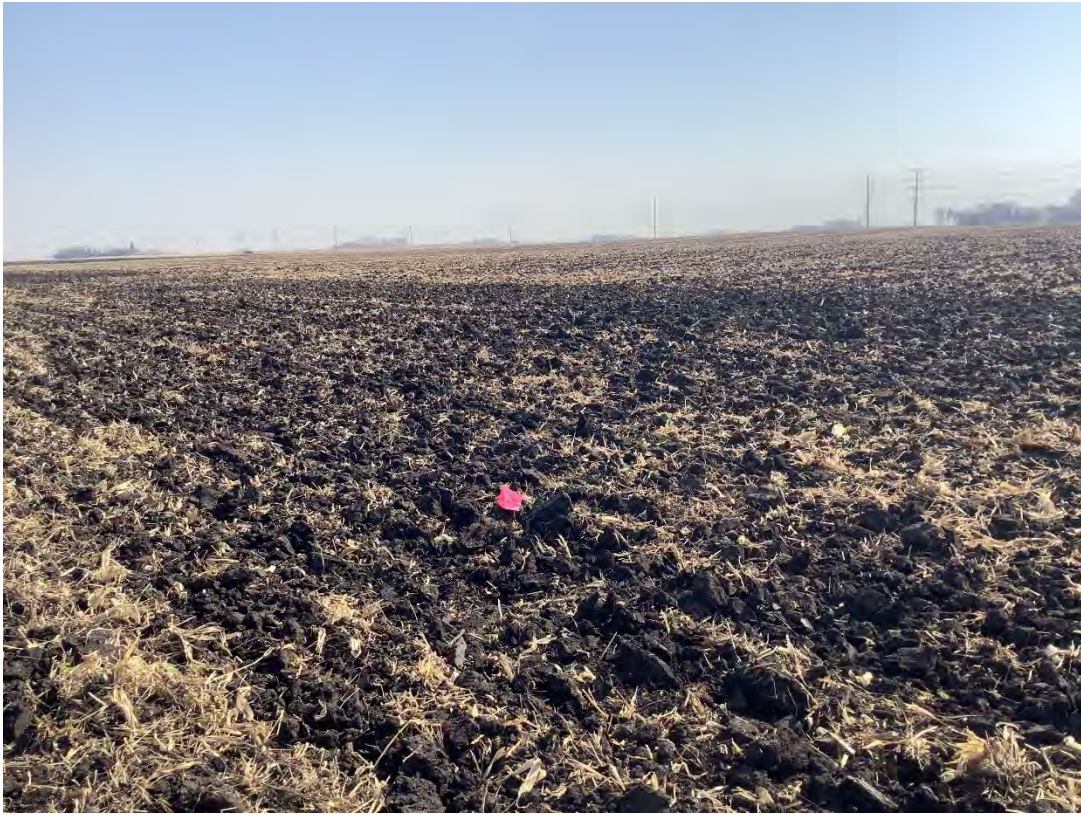
Direction: Southeast

Overview of upland sample point NWA065A.

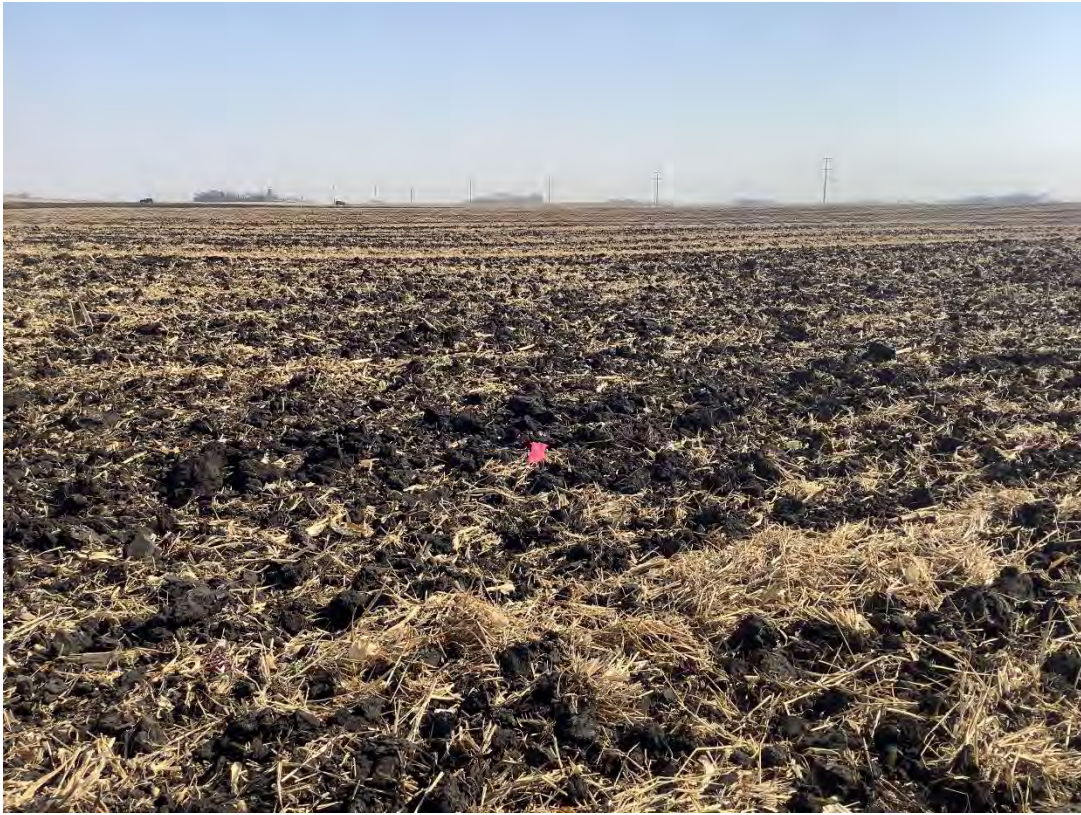
Direction: Southeast

Overview of upland sample point NWA066A.

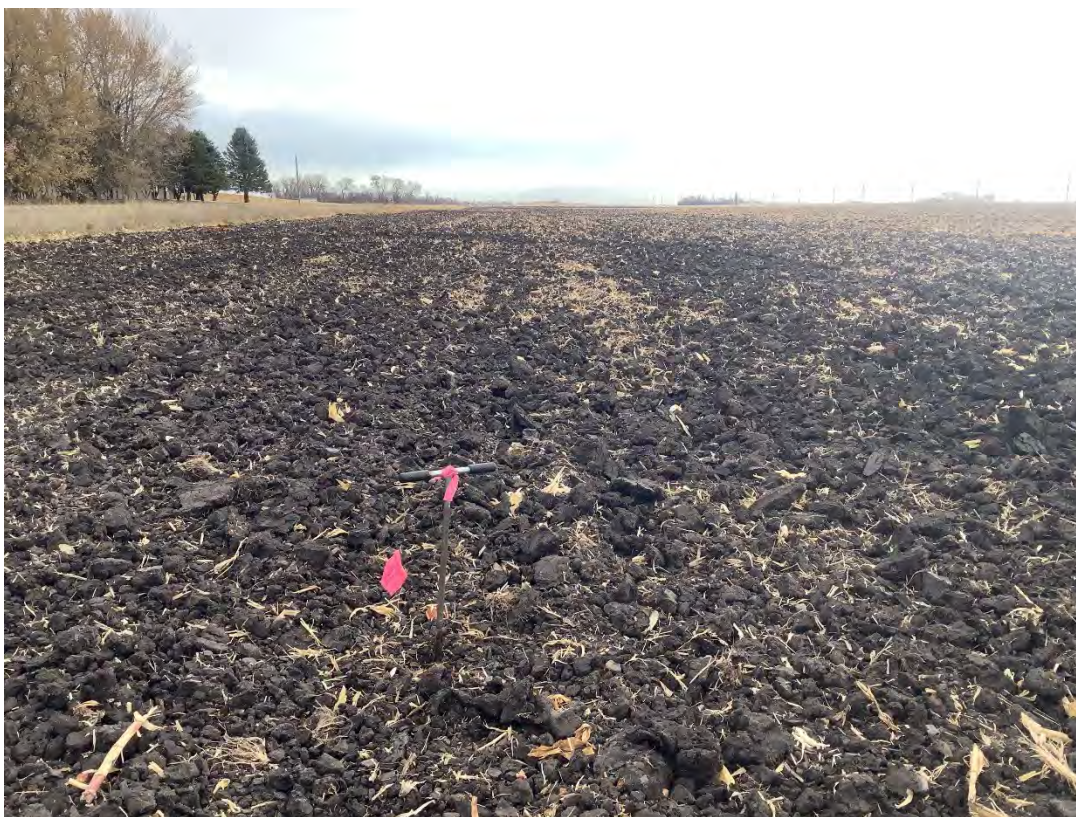
Direction: East	Photo ID: delin_photo-20221024-155645.jpg	Date: 10/24/2022
Project Name: Lake Charlotte	Feature ID: NWB067

Overview of upland sample point NWB067A.

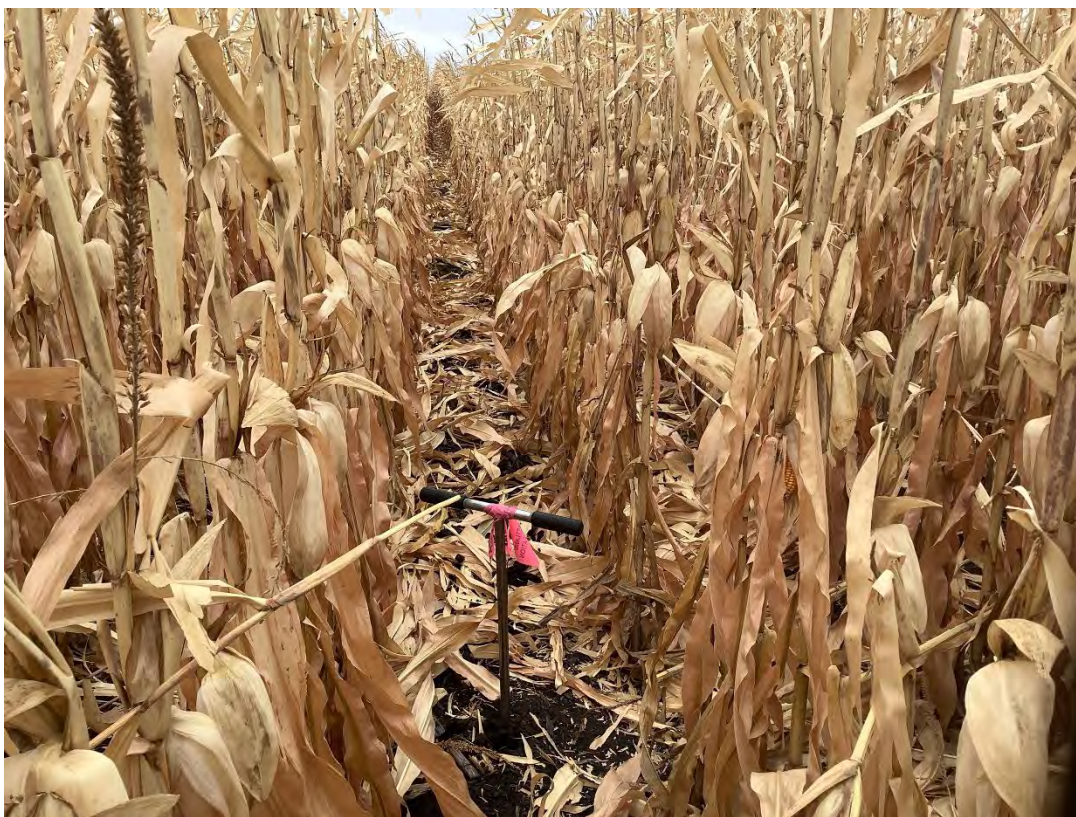
Direction: South

Overview of upland sample point NWB070A.

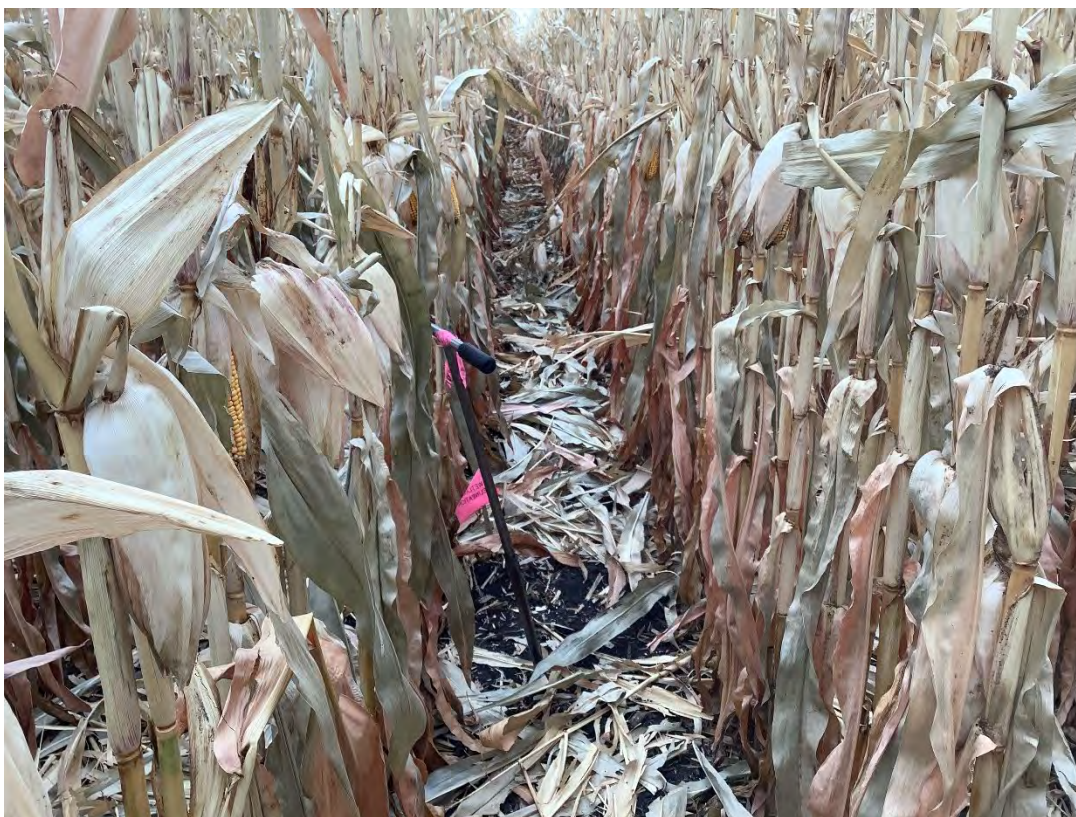
Direction: North	Photo ID: delin_photo-20221024-171423.jpg	Date: 10/24/2022
Project Name: Lake Charlotte		Feature ID: NWB071

Overview of upland sample point NWB071A.

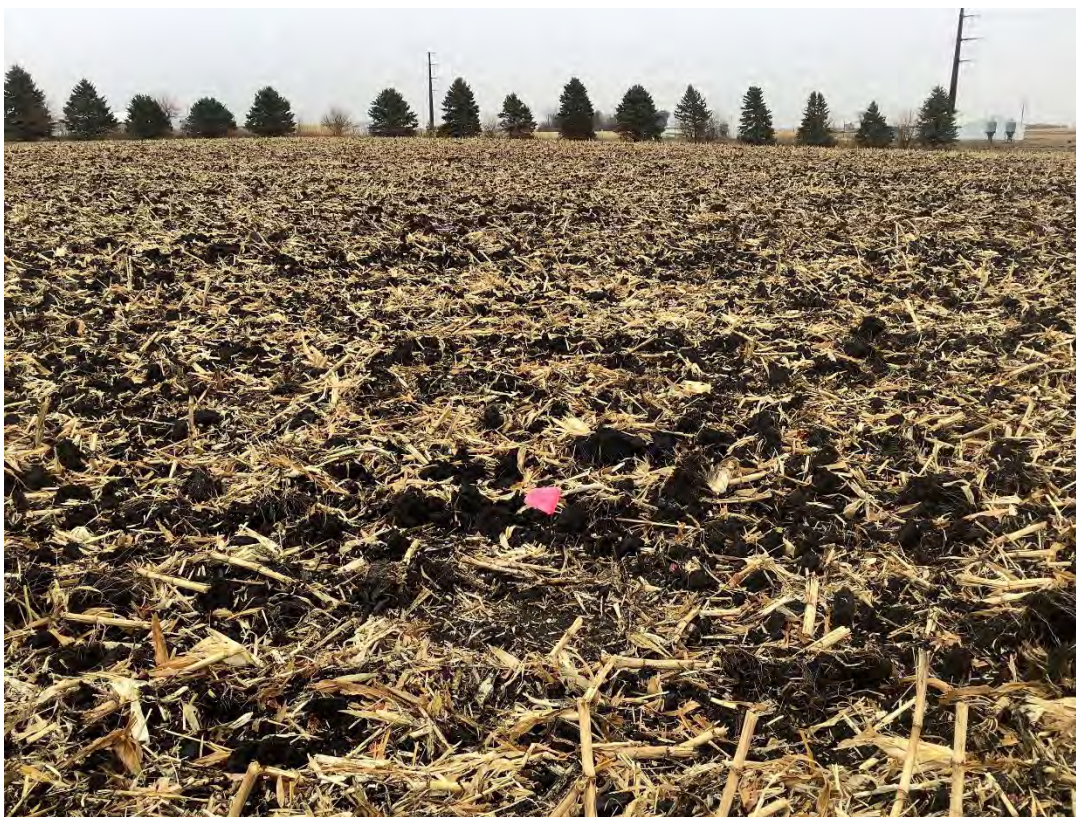
Direction: East

Overview of upland sample point NWB074A.

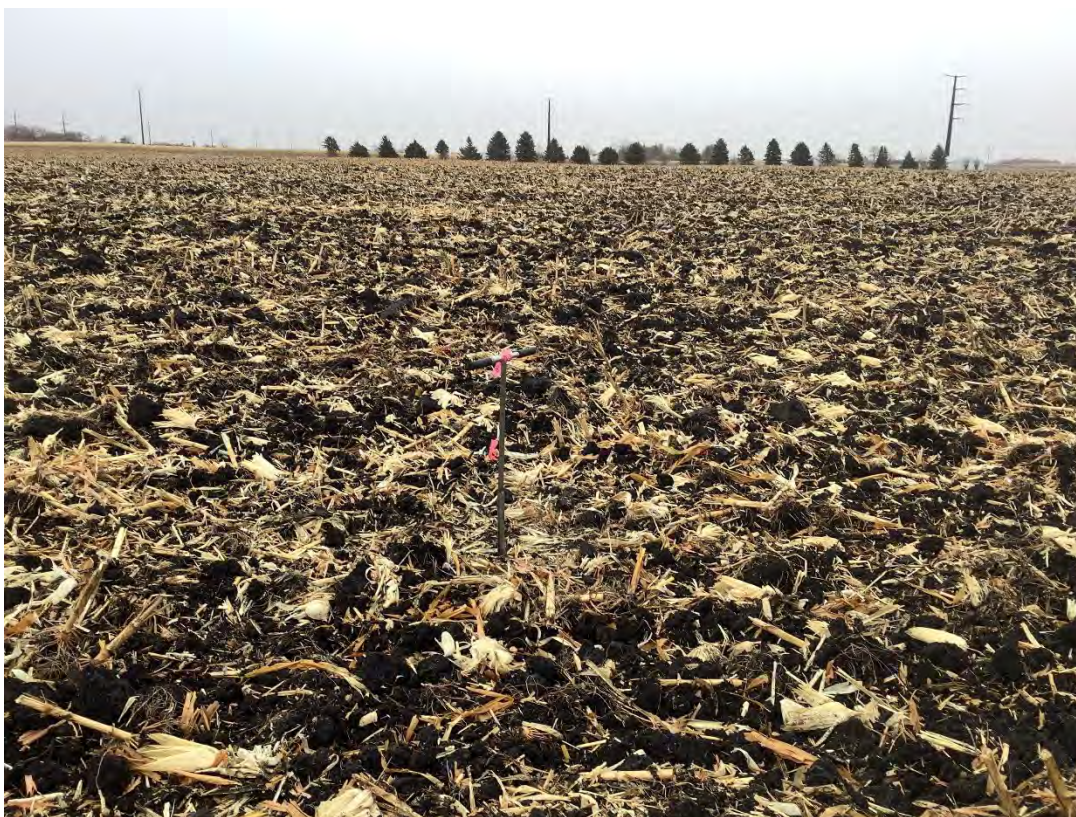
Direction: East	Photo ID: delin_photo-20221024-193059.jpg	Date: 10/24/2022
Project Name: Lake Charlotte	Feature ID: NWB075

Overview of upland sample point NWB075A.

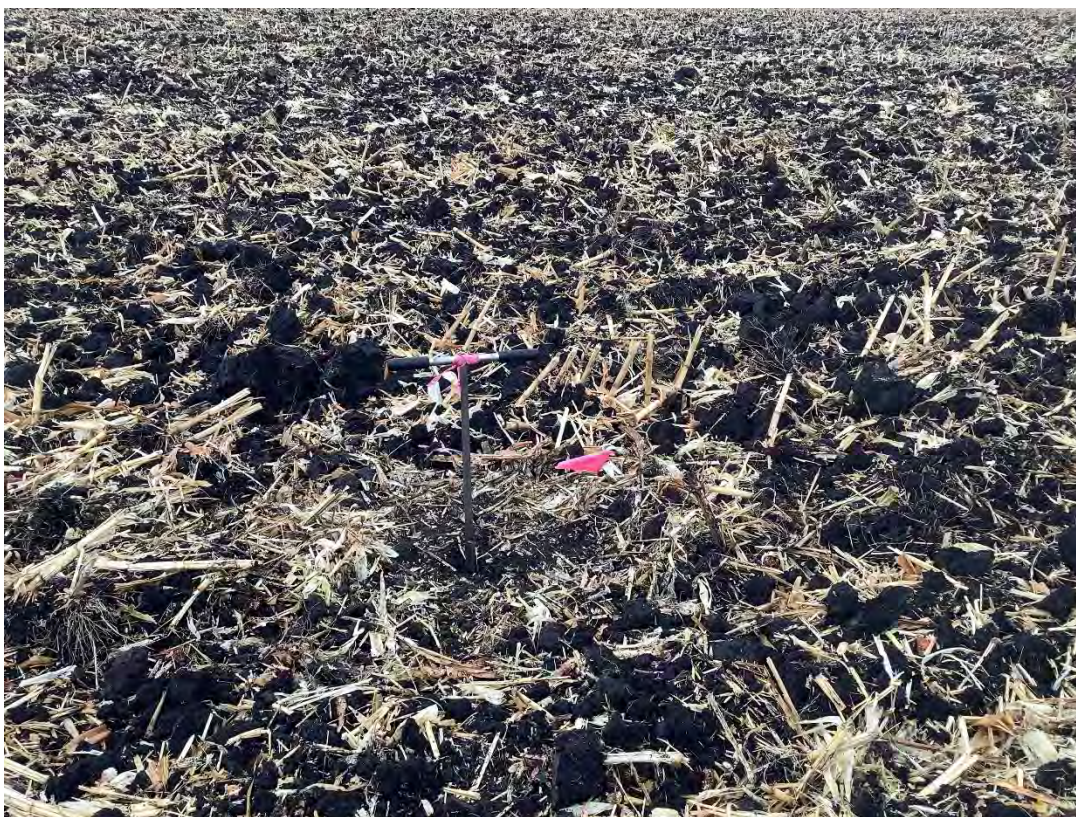
Direction: East

Overview of upland sample point NWB076A.

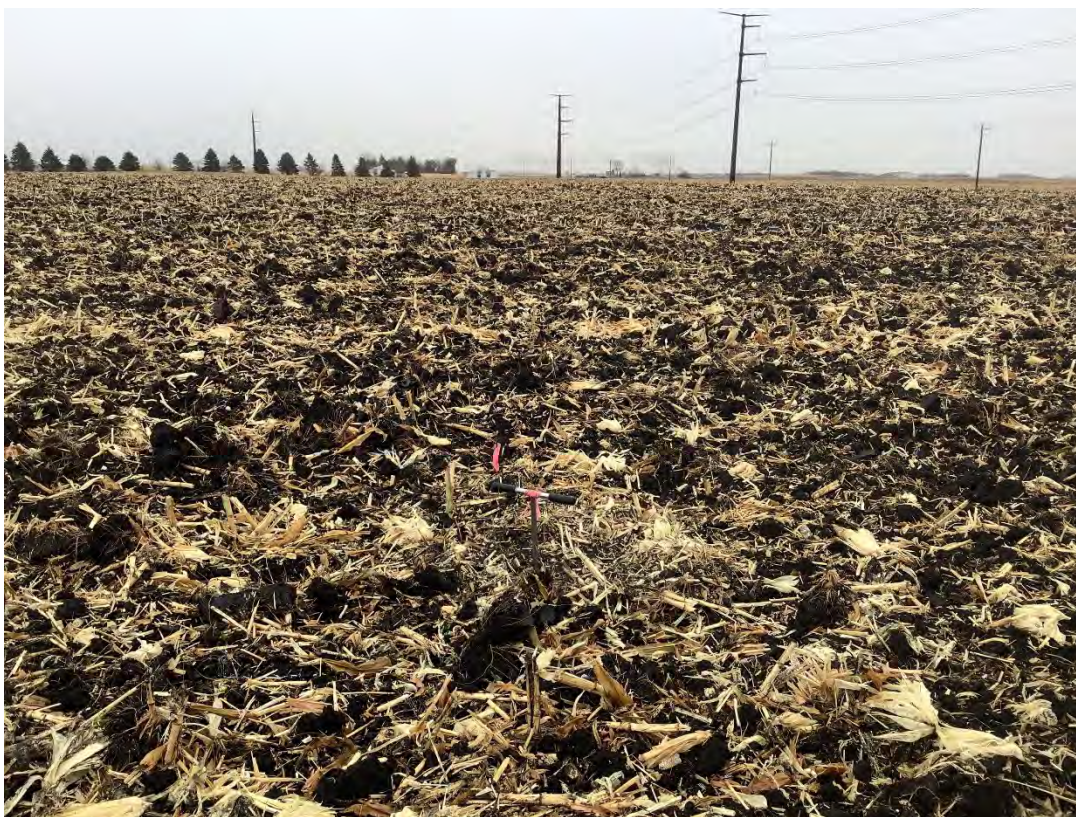
Direction: East	Photo ID: delin_photo-20221024-195839.jpg	Date: 10/24/2022
Project Name: Lake Charlotte	Feature ID: NWB077

Overview of upland sample point NWB077A.

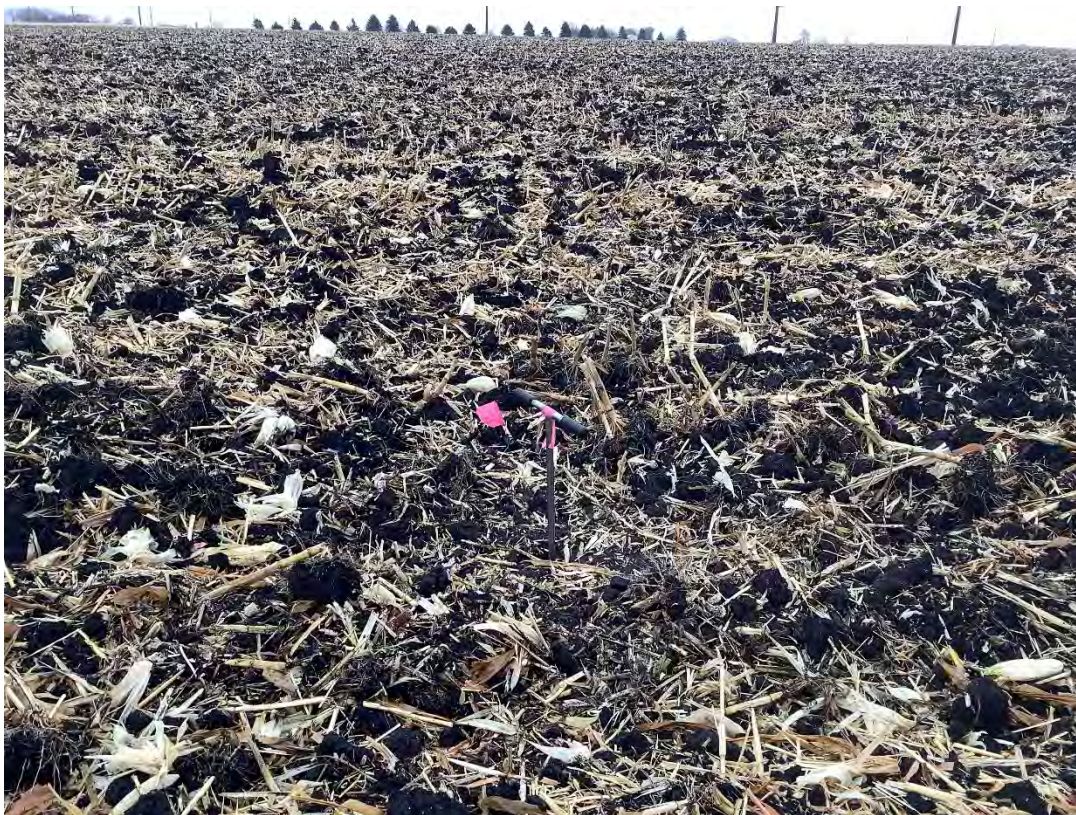
Direction: East

Overview of upland sample point NWB078A.

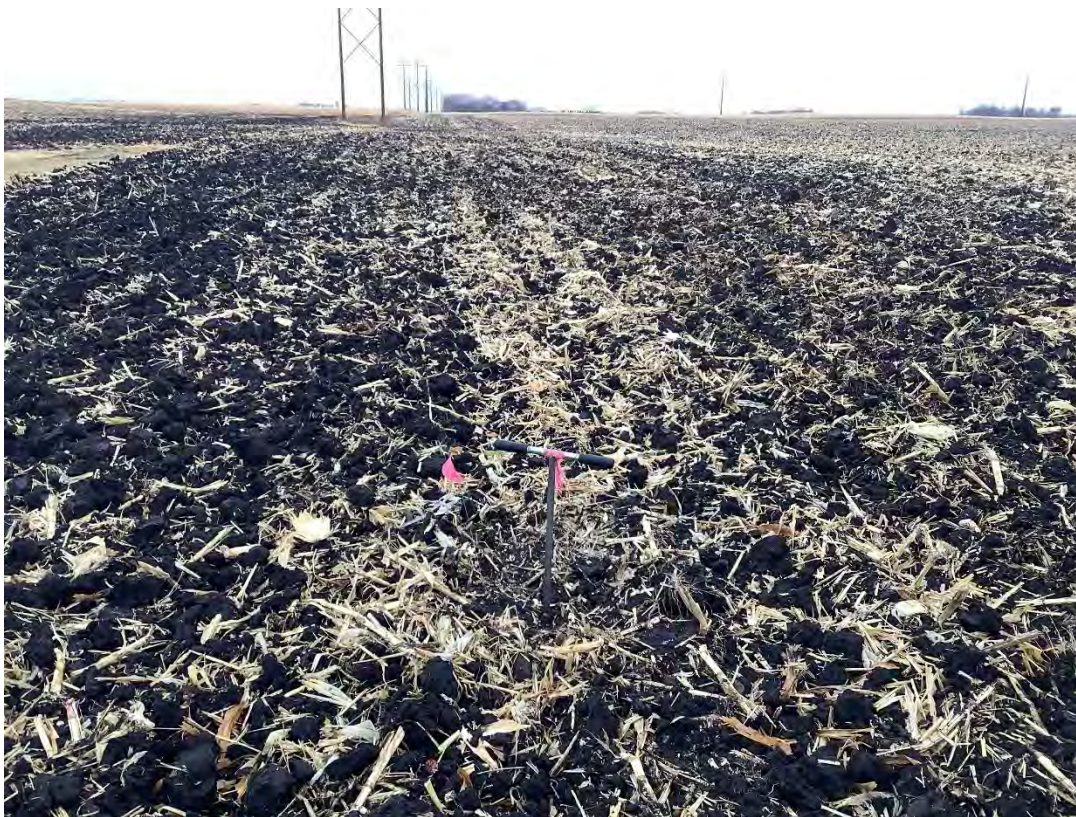
Direction: East	Photo ID: delin_photo-20221024-214019.jpg	Date: 10/24/2022
Project Name: Lake Charlotte	Feature ID: NWB082

Overview of upland sample point NWB082A.

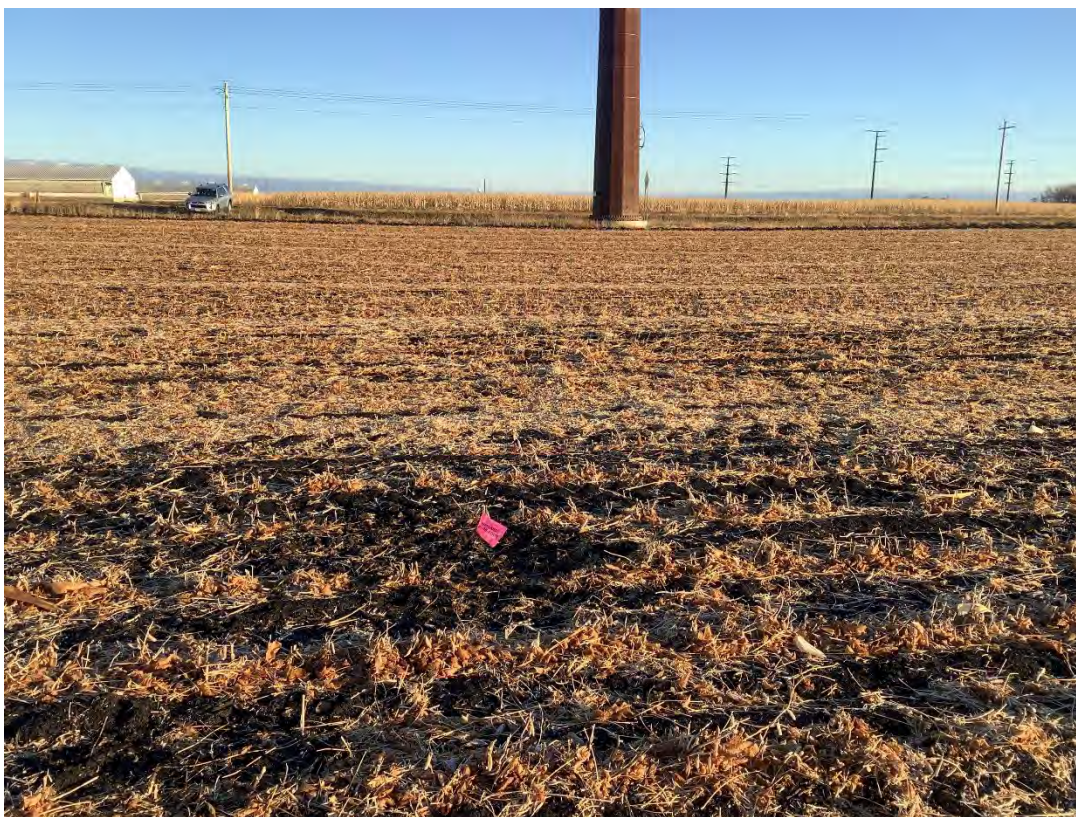
Direction: North	Photo ID: delin_photo-20221025-133312.jpg	Date: 10/25/2022
Project Name: Lake Charlotte	Feature ID: NWB083

Overview of upland sample point NWB083A.

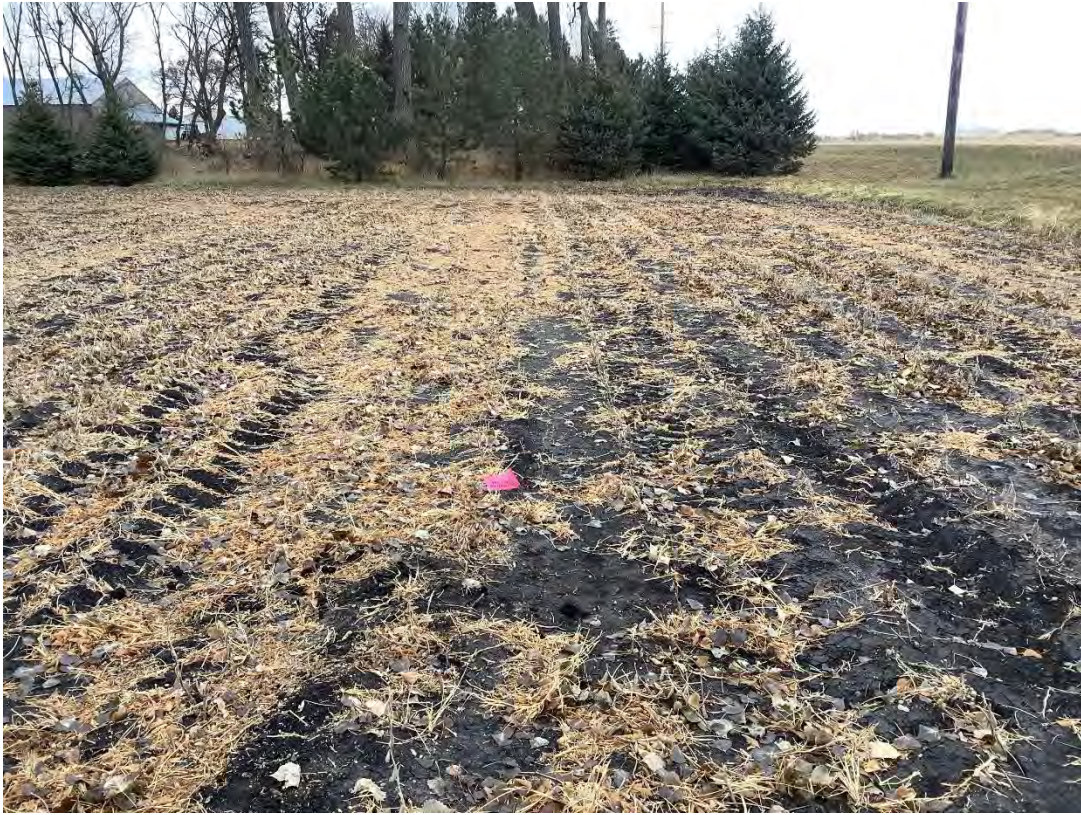
Direction: South

Overview of upland sample point NWB086A.

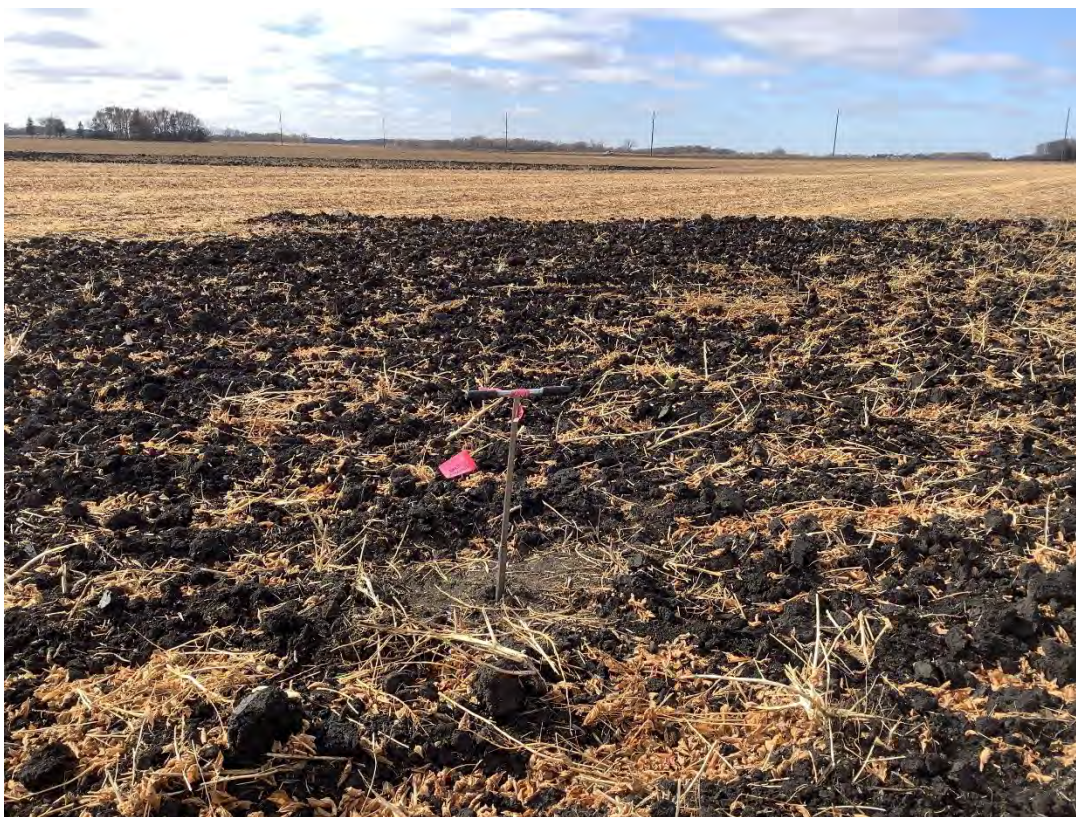
Direction: Southwest

Overview of upland sample point NWB091A.

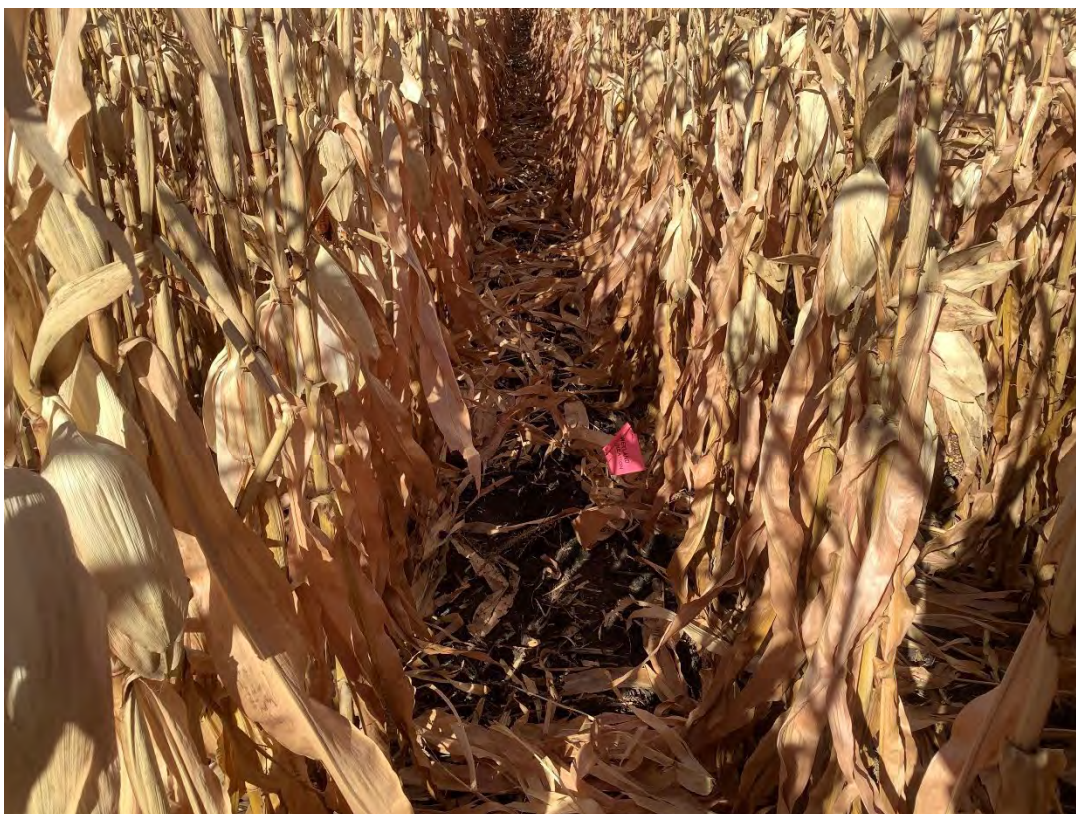
Direction: North	Photo ID: delin_photo-20221025-193242.jpg	Date: 10/25/2022
Project Name: Lake Charlotte		Feature ID: NWB093

Overview of upland sample point NWB093A.

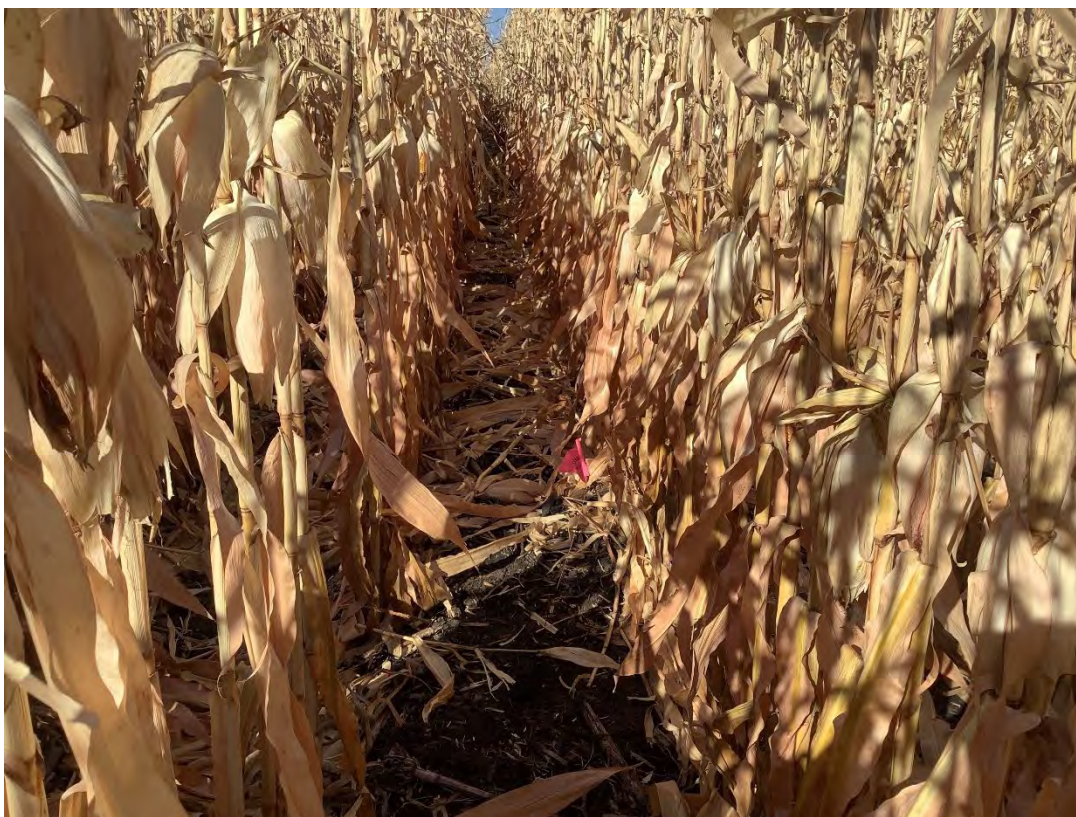
Direction: North

Overview of upland sample point NWB094A.

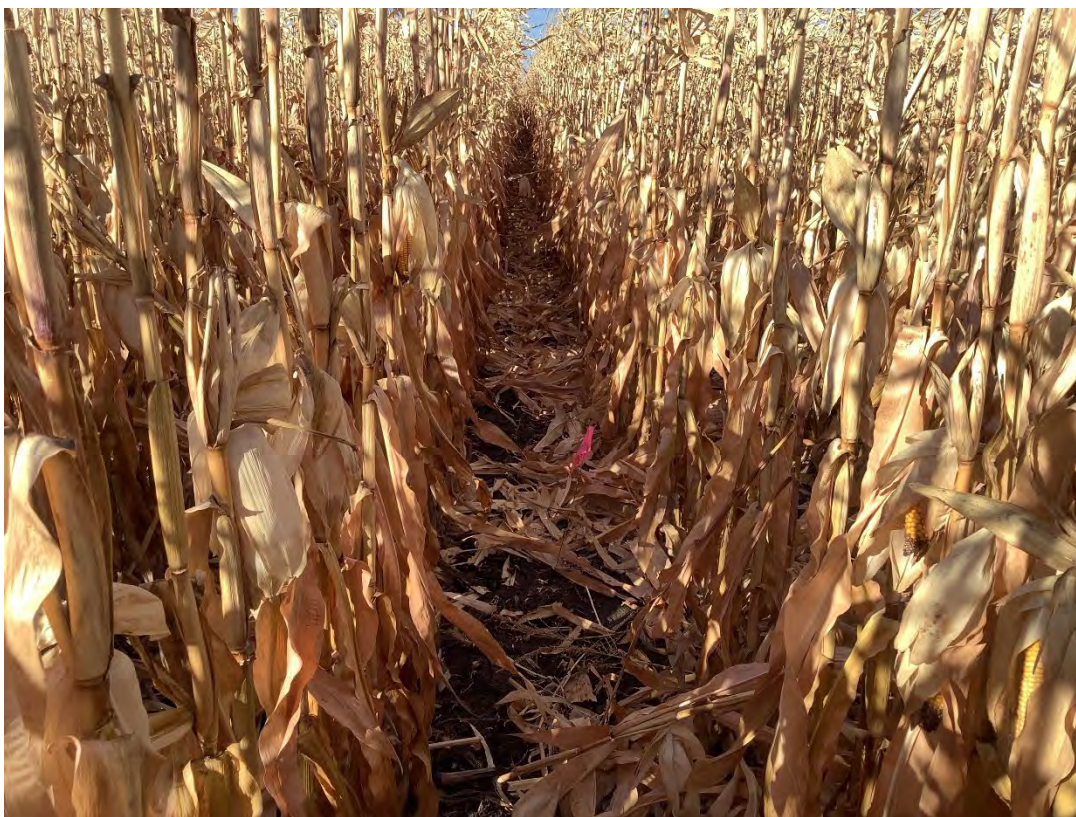
Direction: North

Overview of upland sample point NWB097A.

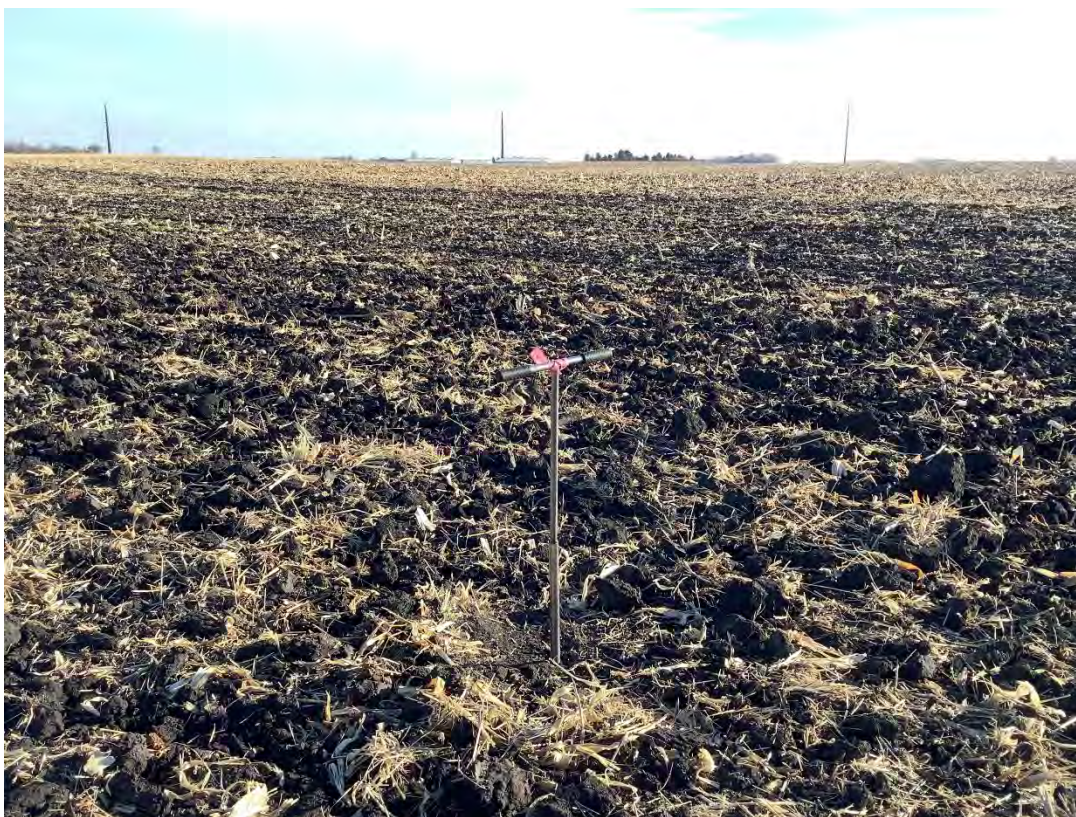
Direction: Southeast	Photo ID: delin_photo-20221025-211928.jpg	Date: 10/25/2022
Project Name: Lake Charlotte	Feature ID: NWB098

Overview of upland sample point NWB098A.

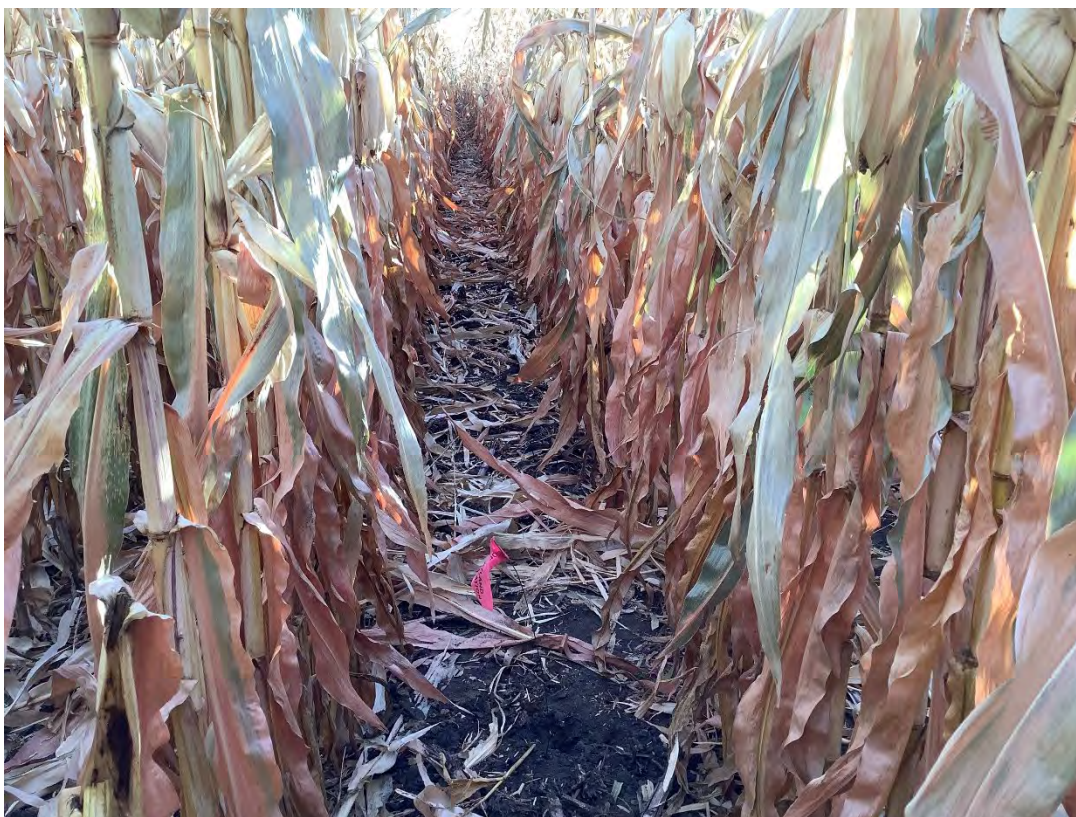
Direction: South

Overview of upland sample point NWB099A.

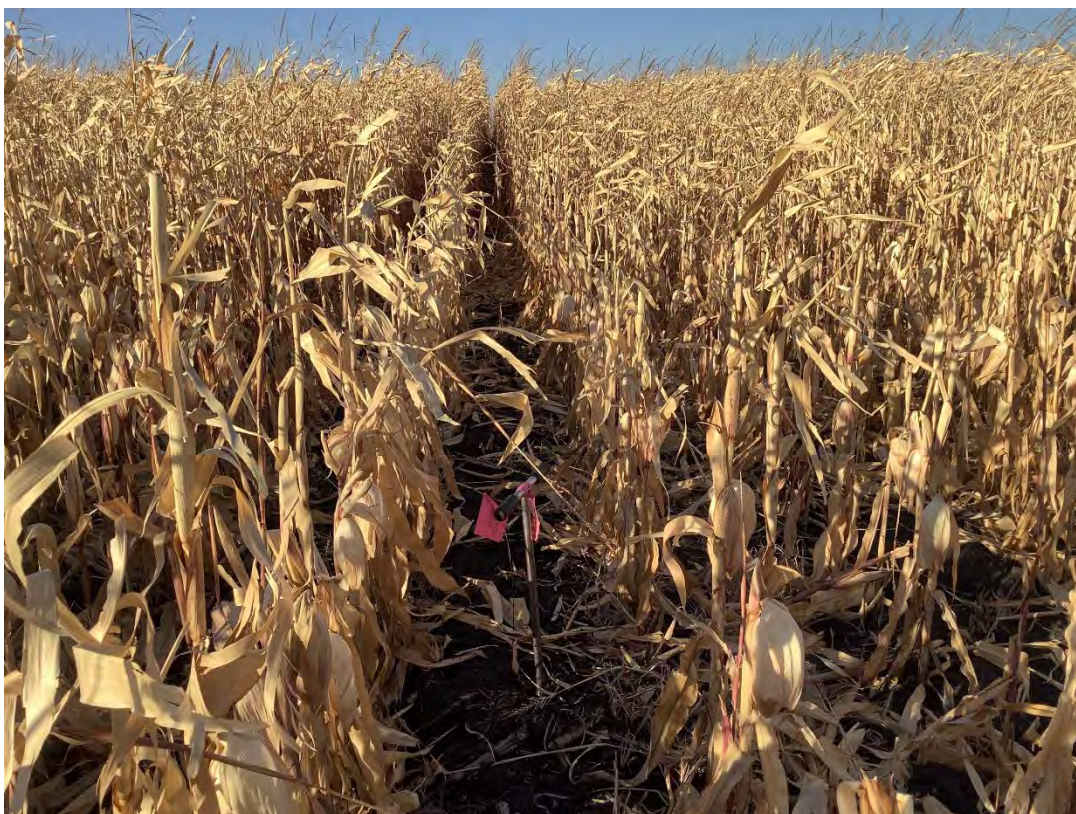
Direction: North

Overview of upland sample point NWB100A.

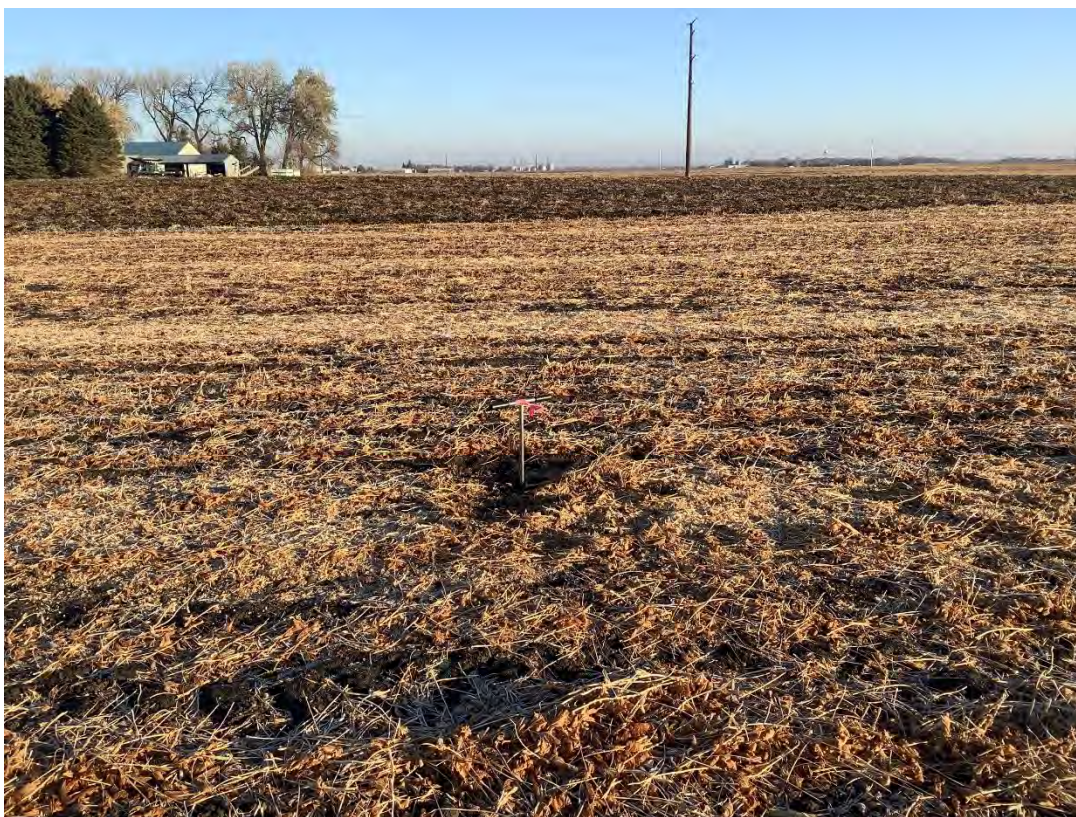
Direction: North	Photo ID: delin_photo-20221026-134832.jpg	Date: 10/26/2022
Project Name: Lake Charlotte	Feature ID: NWB101

Overview of upland sample point NWB101A.

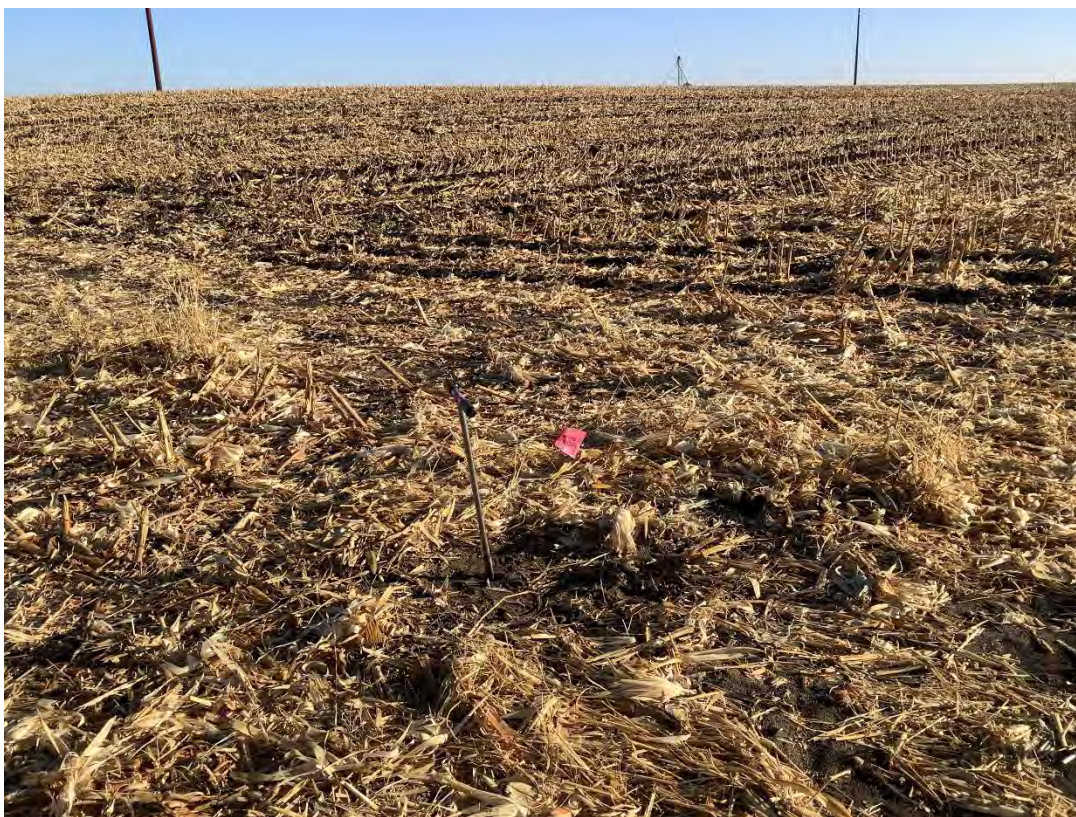
Direction: Northeast

Overview of upland sample point NWB103A.
