Non-Wetland ID

NWA062

Project/Site:	Lake Charlotte	City/County:	Martin	Sampling Date:	10/21/2022
Applicant/Owner:	Lake Charlotte Solar, LLC	State:	MN	Sampling Point:	NWA062A
Investigator(s):	Apryl Jennrich	Section, Township, Range:	Sec.16 T103N R30W		
Landform (hillslope, terrace, etc.):	Plain	Local relief (concave, convex, none):	None		
Slope (%):	0	Lat:	43.72749	Long:	-94.43446
		Datum:	WGS84		
Soil Map Unit Name:	Canisteo-Glencoe complex, 0 to 2 percent slopes	NWI Classification:	NA

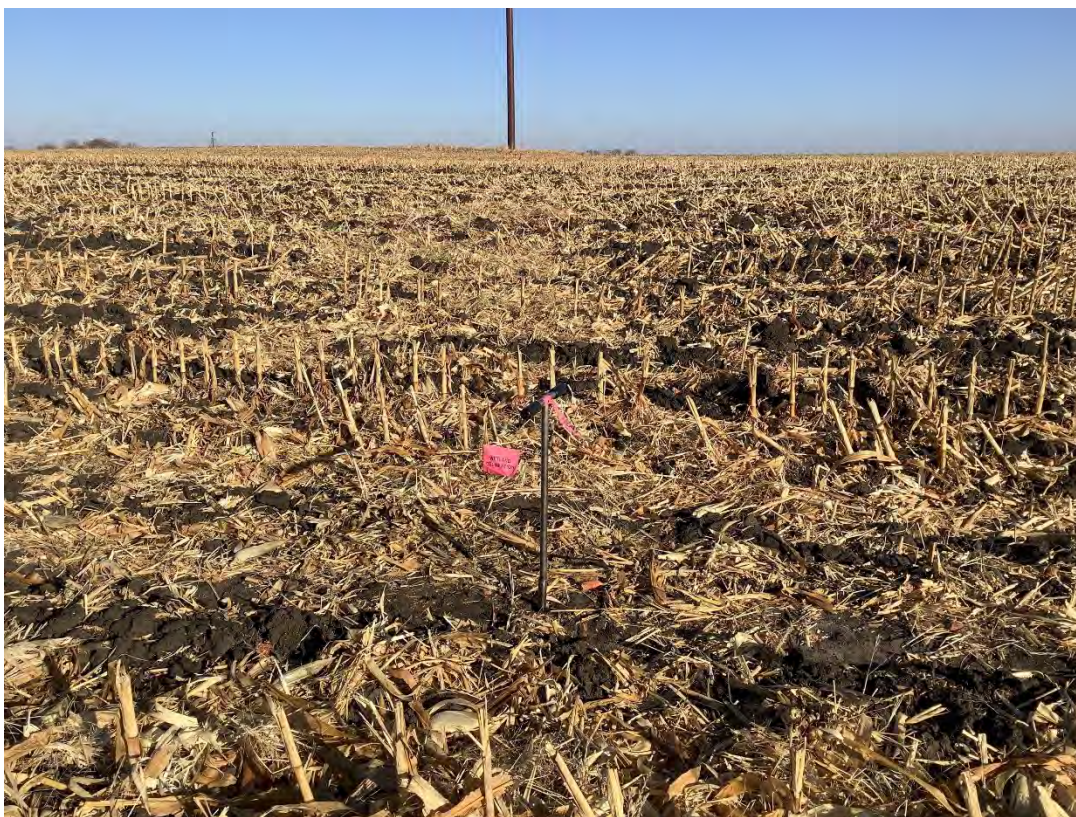
Direction: North	Photo ID: delin_photo-20221026-145400.jpg	Date: 10/26/2022
Project Name: Lake Charlotte	Feature ID: NWB104

Overview of upland sample point NWB104A.

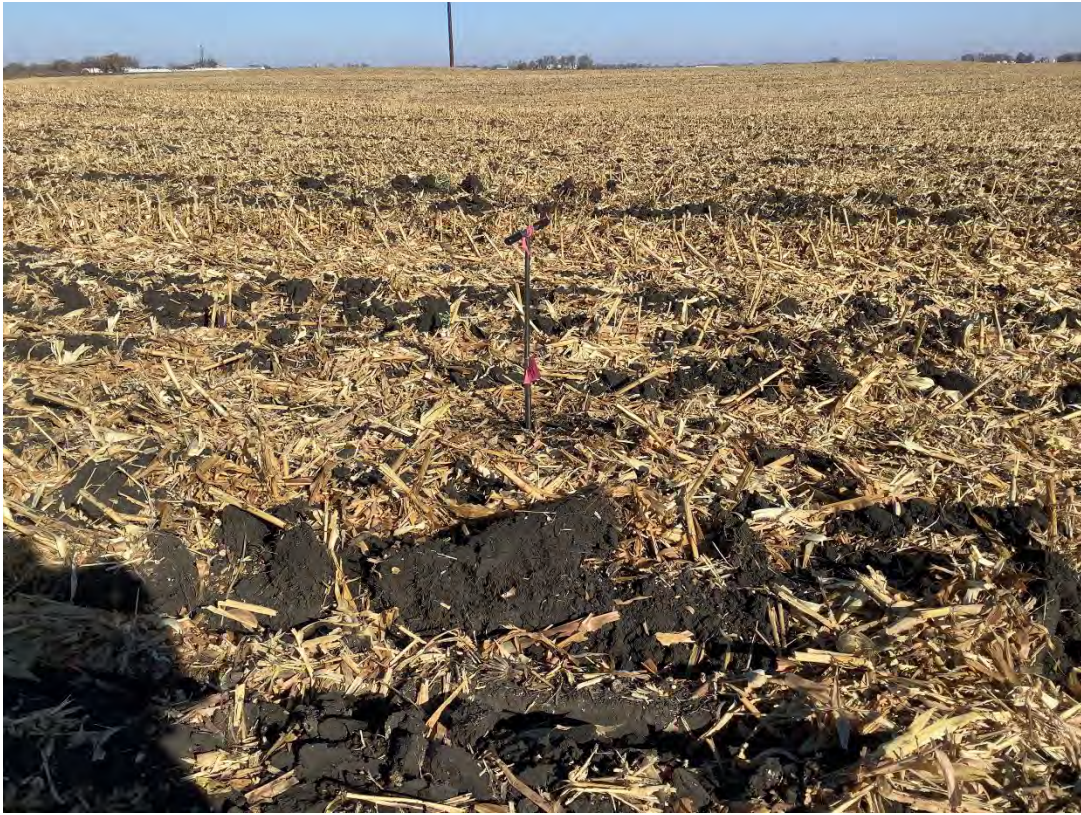
Direction: North	Photo ID: delin_photo-20221026-153653.jpg	Date: 10/26/2022
Project Name: Lake Charlotte	Feature ID: NWB106

Overview of upland sample point NWB106A.

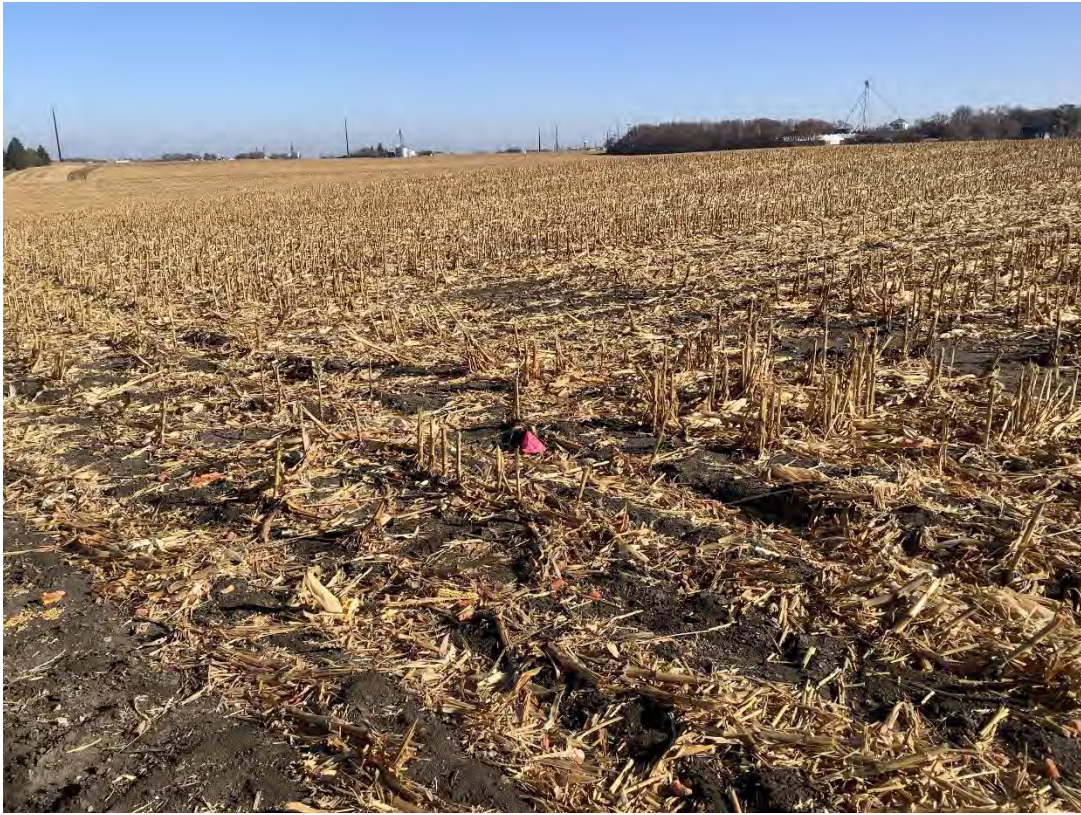
Direction: Northeast	Photo ID: delin_photo-20221026-155327.jpg	Date: 10/26/2022
Project Name: Lake Charlotte	Feature ID: NWB107

Overview of upland sample point NWB107A.

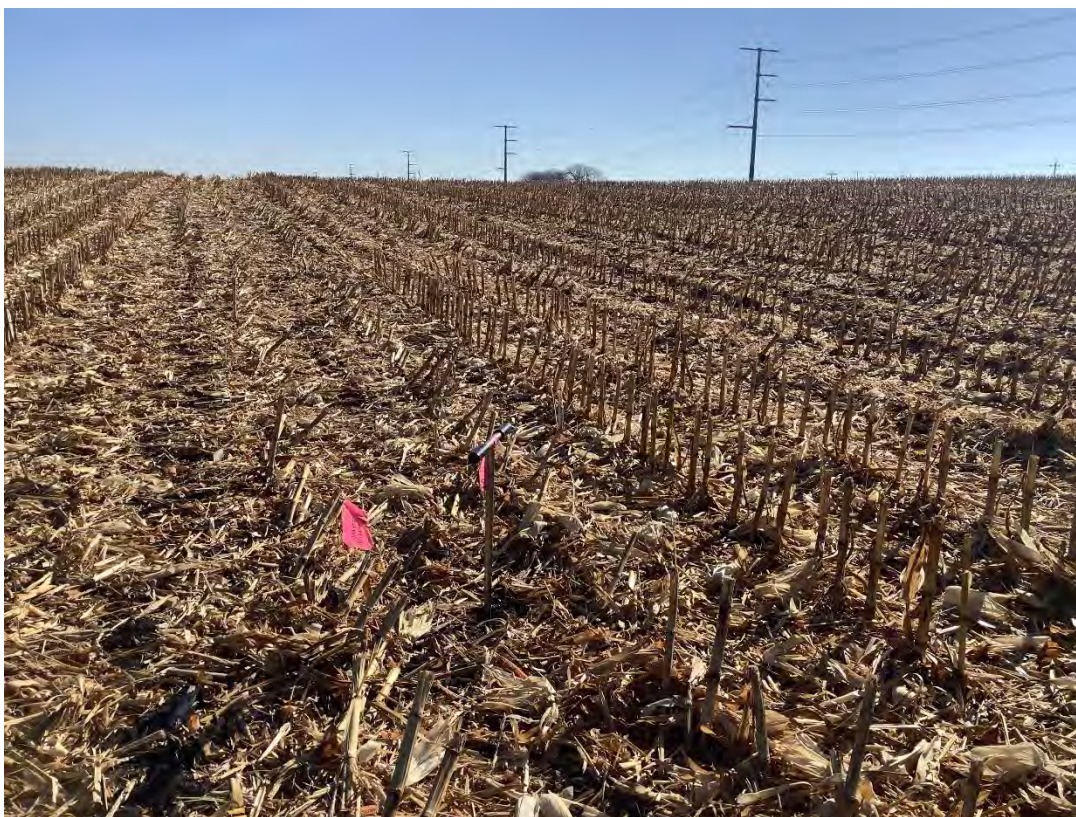
Direction: Southeast	Photo ID: delin_photo-20221026-160645.jpg	Date: 10/26/2022
Project Name: Lake Charlotte	Feature ID: NWB108

Overview of upland sample point NWB108A.

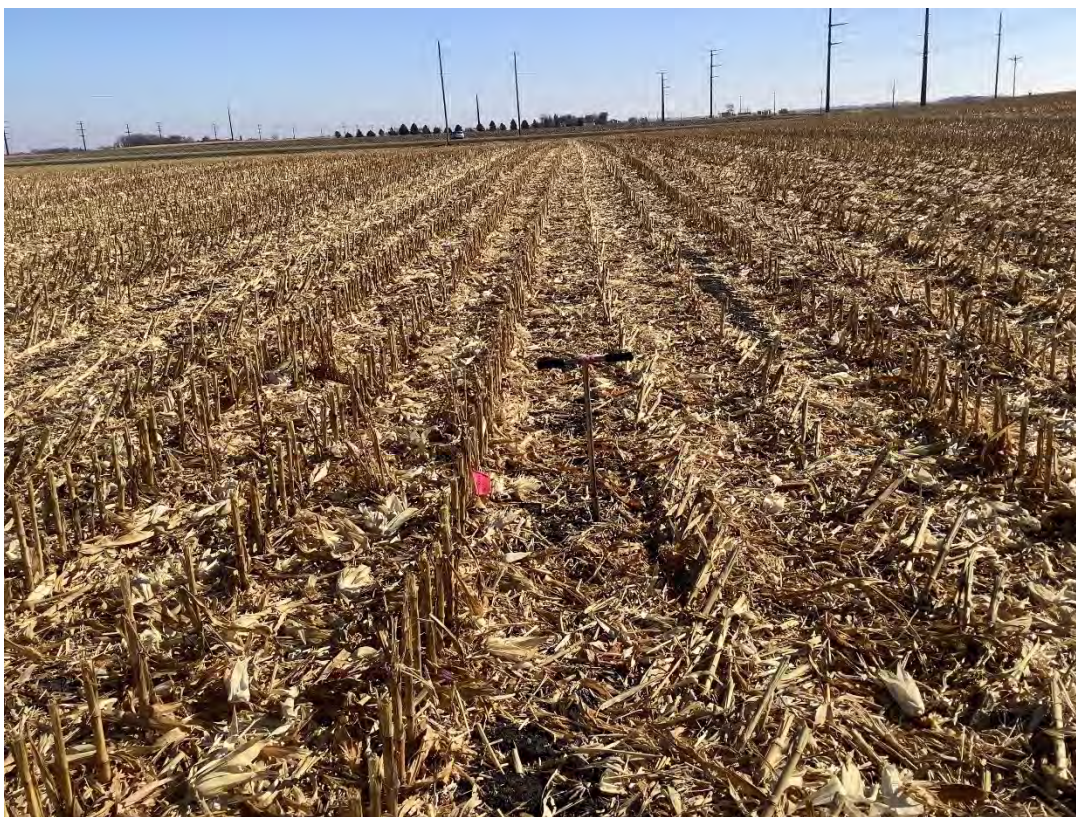
Direction: East	Photo ID: delin_photo-20221026-164539.jpg	Date: 10/26/2022
Project Name: Lake Charlotte	Feature ID: NWB110

Overview of upland sample point NWB110A.

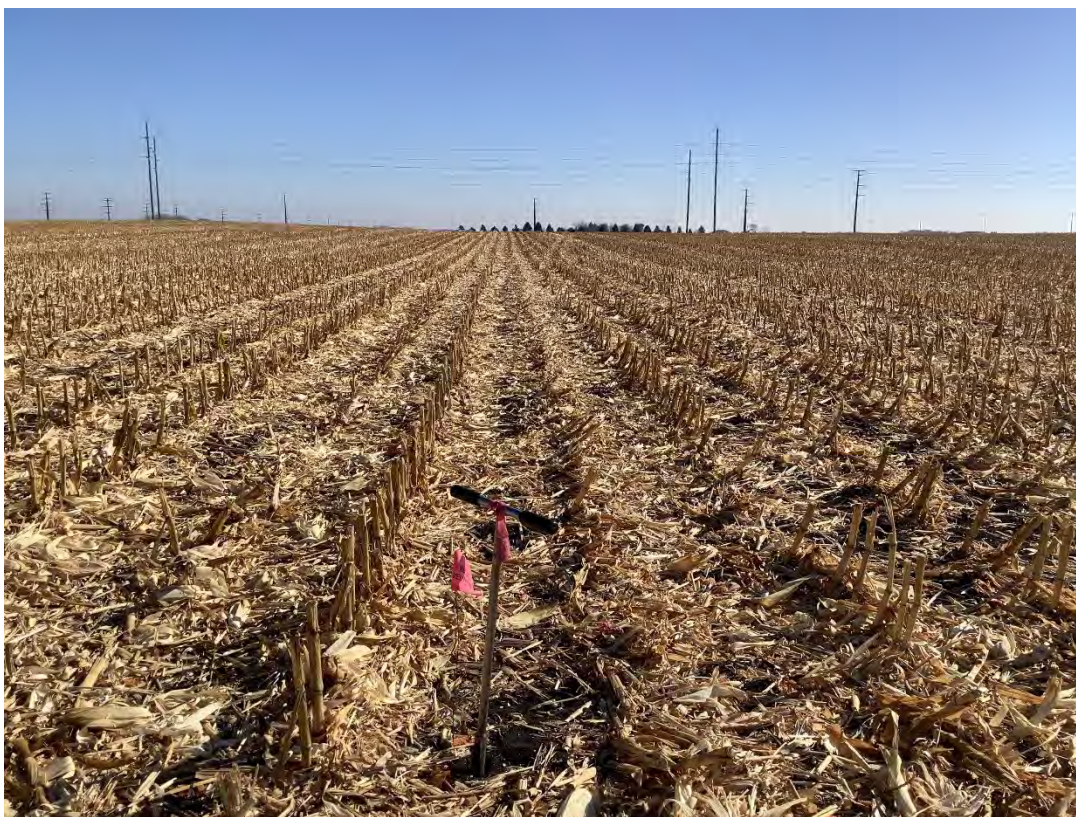
Direction: East	Photo ID: delin_photo-20221026-165925.jpg	Date: 10/26/2022
Project Name: Lake Charlotte	Feature ID: NWB111

Overview of upland sample point NWB111A.

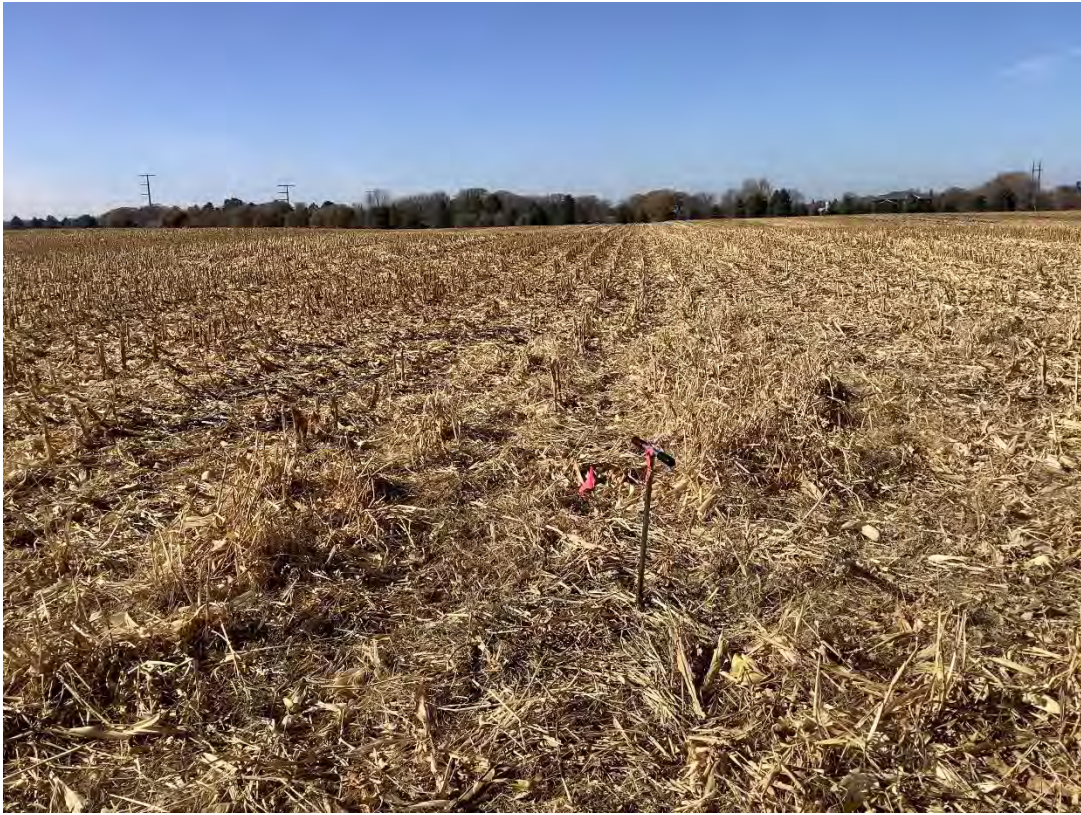
Direction: West	Photo ID: delin_photo-20221026-171300.jpg	Date: 10/26/2022
Project Name: Lake Charlotte	Feature ID: NWB112

Overview of upland sample point NWB112A.

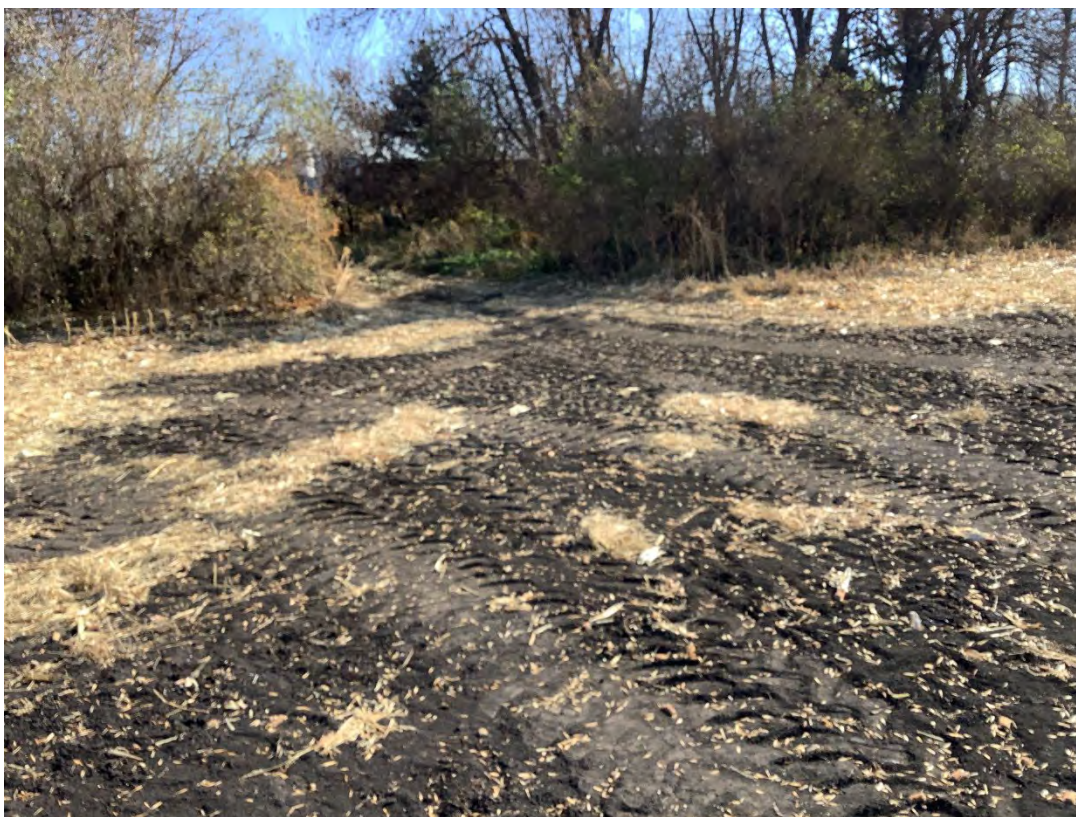
Direction: Southeast

Overview of upland sample point NWB113A.

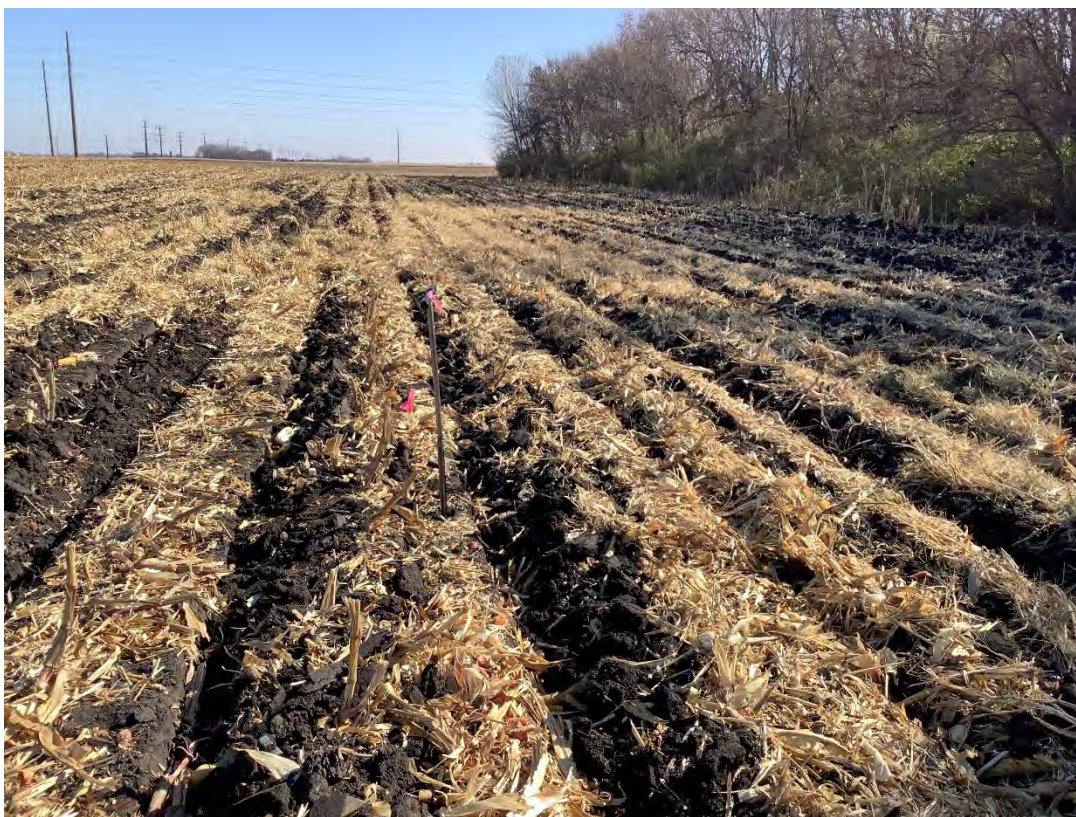
Direction: East	Photo ID: delin_photo-20221026-172637.jpg	Date: 10/26/2022
Project Name: Lake Charlotte	Feature ID: NWB114

Overview of upland sample point NWB114A.

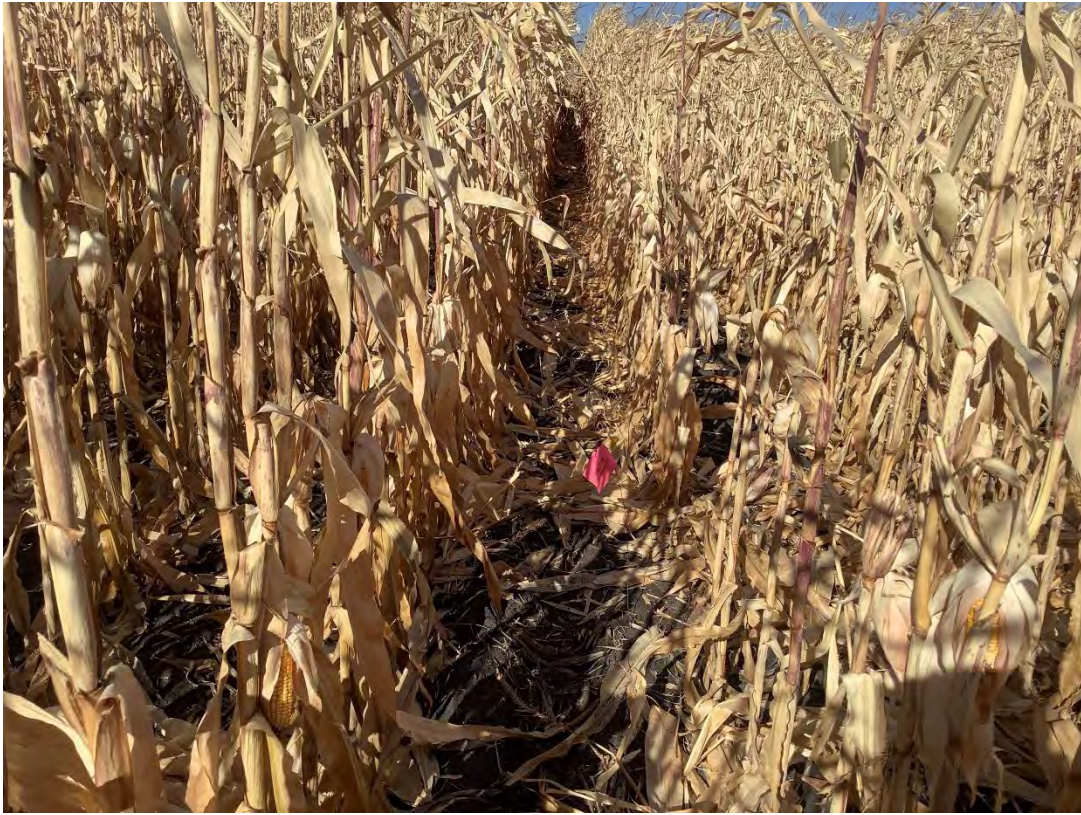
Direction: North

Overview of upland sample point NWB116A.
