Aquatic Resources Delineation Report for the Benton Solar Project, Benton County, Minnesota

Minnesota Public Utilities Commission Docket Numbers: IP7115/GS-23-423 and IP7115/ESS-24-283

AUGUST 2024

SWCA Environmental Consultants

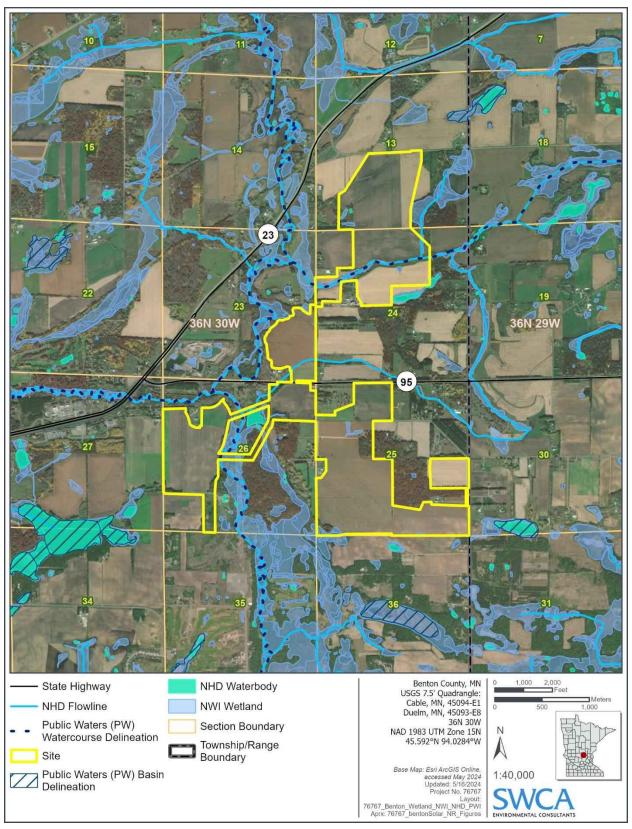
Figure A-2. National Hydrography Dataset, National Wetlands Inventory, and Public Waters Inventory data for the Site.

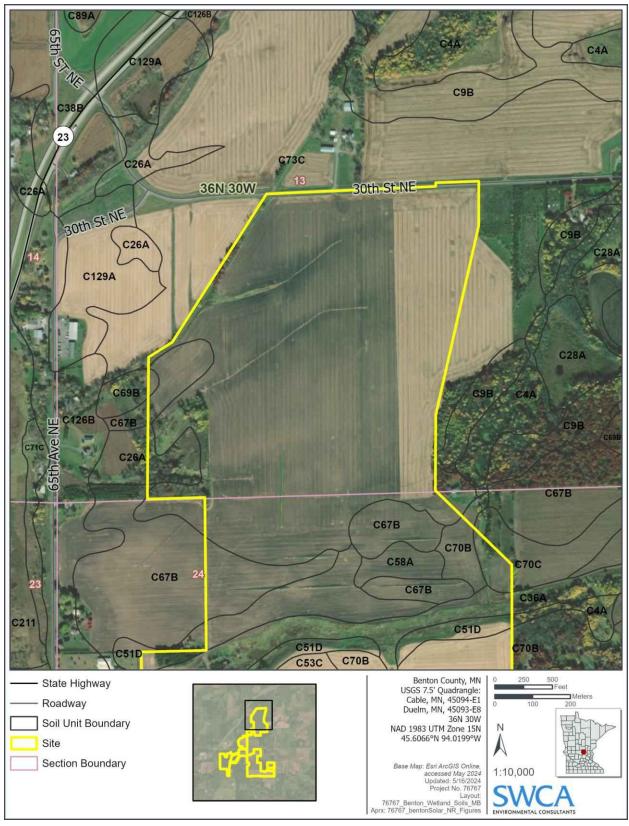
Figure A-3. Soil survey map of the Site (map 1 of 6).

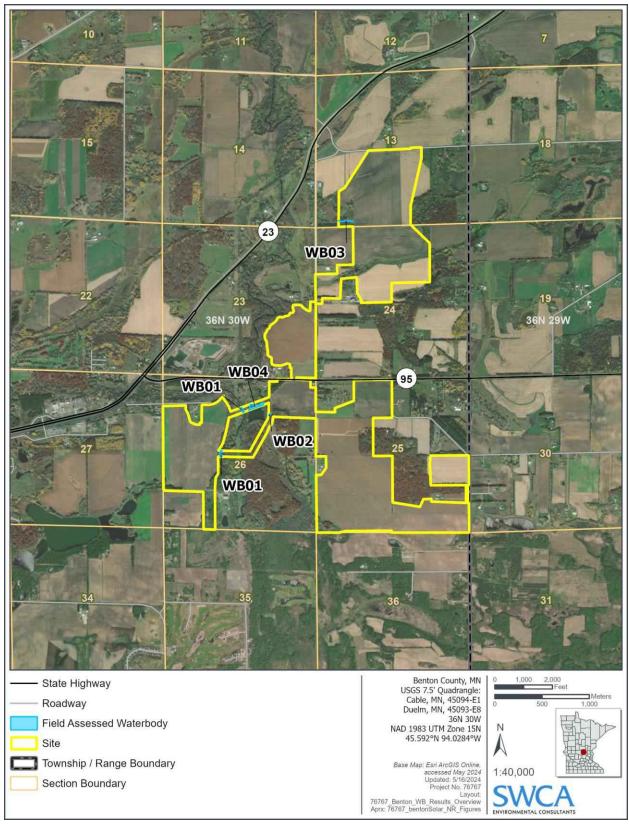
Figure A-9. Waterbodies delineated within the Site.

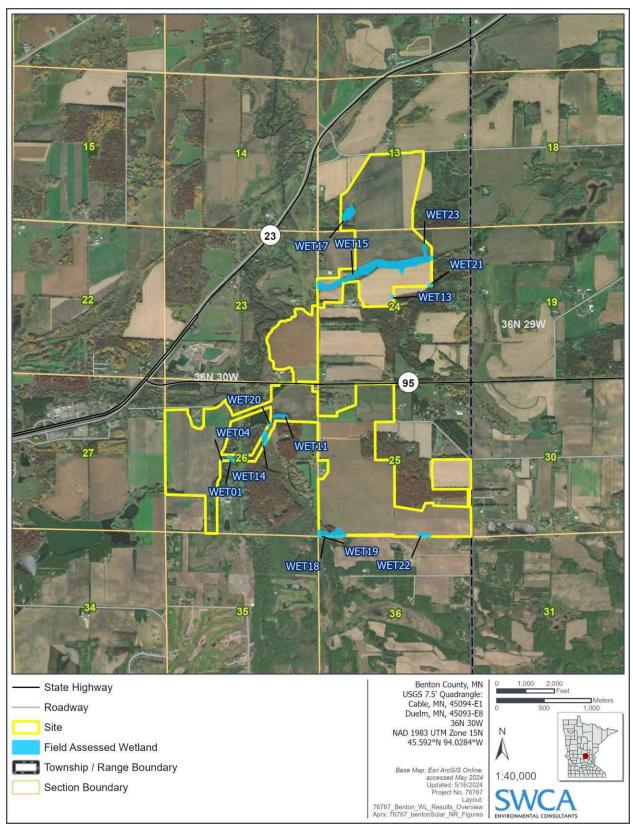
Figure A-10. Wetlands delineated within the Site.

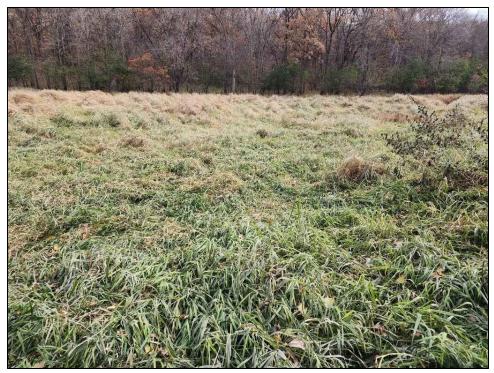
Figure C-1. Overview of the palustrine emergent wetland WET01 at DP01. Photograph taken by C. Reagan on October 24, 2022.

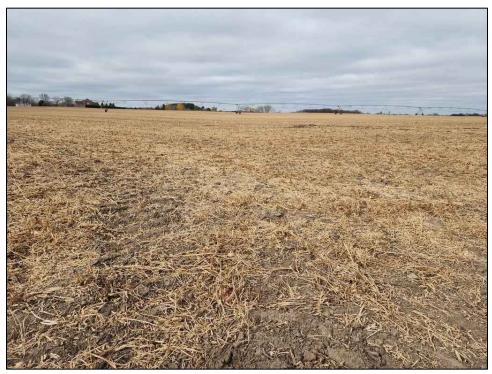
Figure C-4. Overview of the palustrine farmed wetland WET13 at DP25. Photograph taken by C. Reagan on October 25, 2022.

WET13 is a farmed wetland located in the central portion of the Site on the edge of a planted field. It is classified as a seasonally flooded basin (Type 1; Pf). Vegetation is significantly disturbed as most native vegetation has been removed and replaced with cultivated soybeans. The Problematic Hydrophytic Vegetation indicator satisfies hydrophytic vegetation criteria.

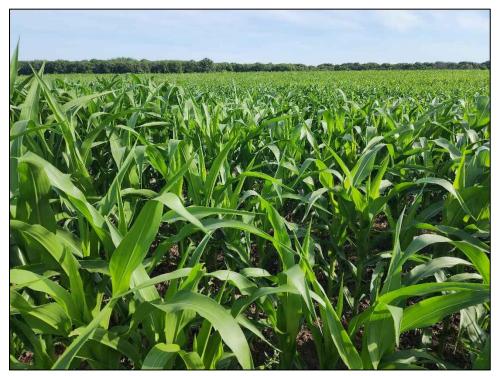
Figure C-12. Overview of the farmed wetland WET22 at DP38. Photograph taken by C. Reagan on July 7, 2023.

WET22 is a farmed wetland located in the southeastern portion of the Site on the edge of a planted field. It is classified as a temporarily flooded basin (Type 1; Pf). Vegetation is significantly disturbed as native vegetation has been removed and replaced with cultivated corn and soybeans. The natural vegetation of the wetland is problematic; however, yellow nutsedge (*Cyperus esculentus*) is present in the wetland and satisfies hydrophytic vegetation criteria.

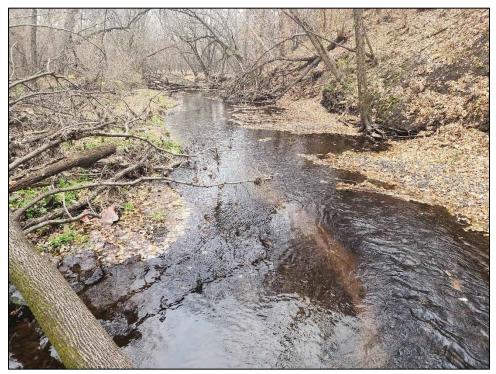
Figure C-14. Overview of the perennial waterbody WB01 (Elk River) downstream. Photograph taken by C. Reagan on June 6, 2023.

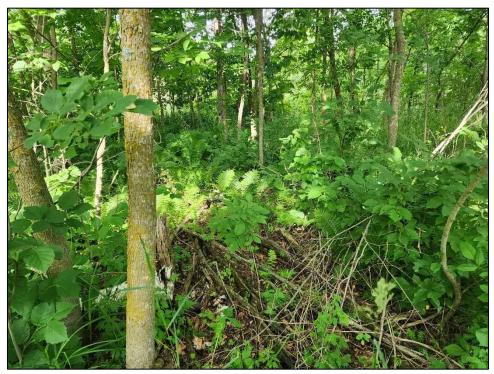
Figure C-16. Overview of the unnamed intermittent stream WB02 downstream. Photograph taken by C. Reagan on June 6, 2023.

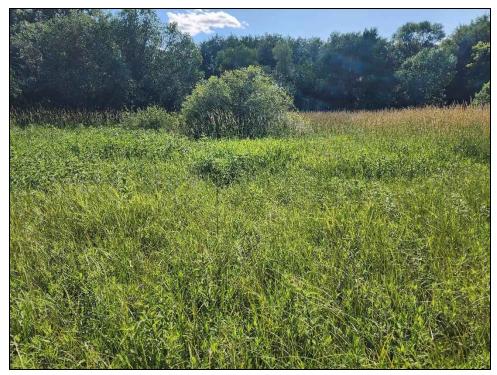
Figure C-17. Overview of the ephemeral waterbody WB03 downstream. Photograph taken by C. Reagan on July 7, 2023.

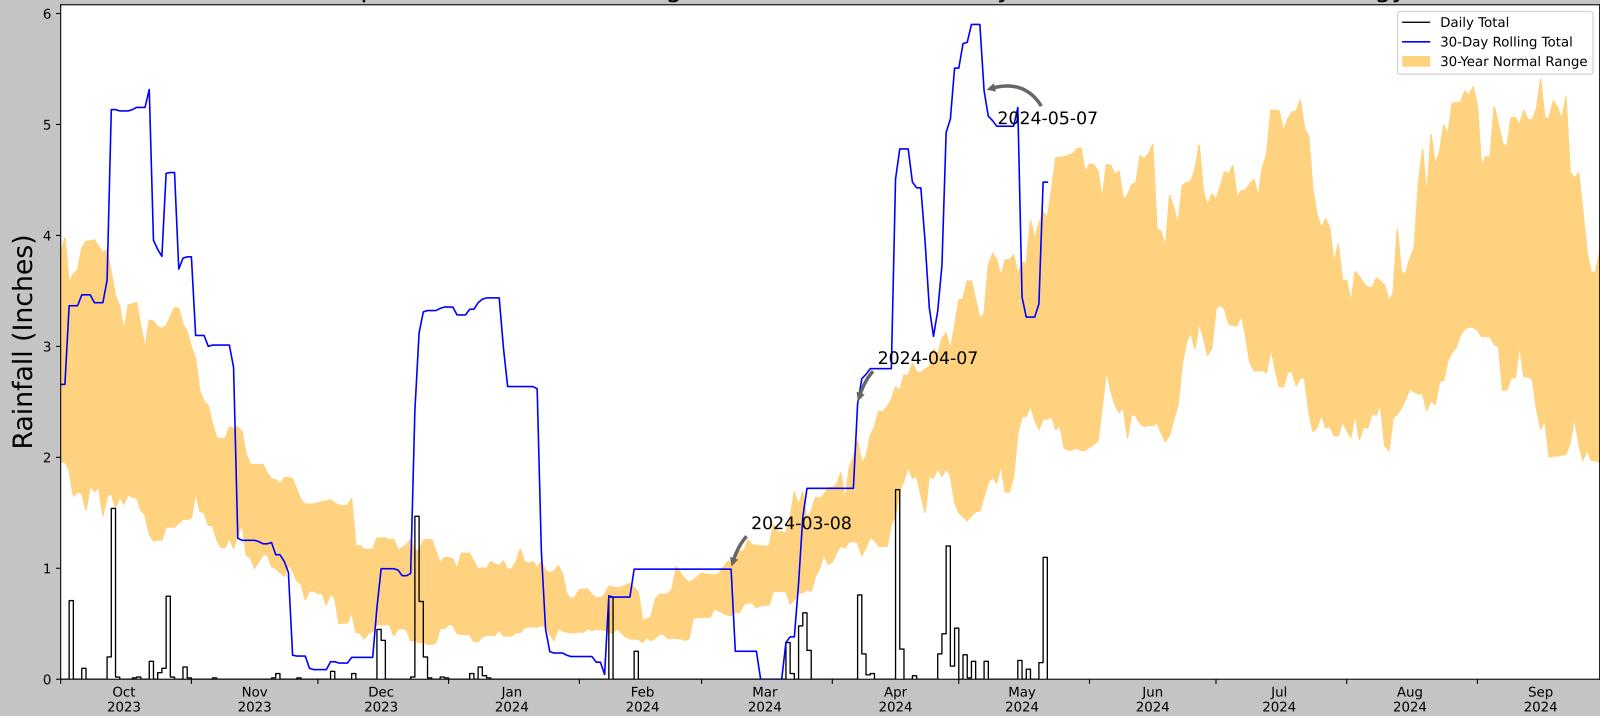
Coordinates	45.591845, -94.025181
Observation Date	2024-05-07
Elevation (ft)	1044.047
Drought Index (PDSI)	Moderate drought (2024-04)
WebWIMP H ₂ O Balance	Wet Season

30 Days Ending	30 th %ile (in)	70 th %ile (in)	Observed (in)	Wetness Condition	Condition Value	Month Weight	Product
2024-05-07	1.648819	3.294488	5.30315	Wet	3	3	9
2024-04-07	1.231102	2.14685	2.480315	Wet	3	2	6
2024-03-08	0.573622	1.067717	0.992126	Normal	2	1	2
Result							Wetter than Normal - 17

The APT (USACE 2021) displays precipitation data for monthly periods. The associated report (Appendix D) shows that the October 2022 field survey dates occurred in drier than normal field conditions. The June 2023 field survey dates occurred in normal field conditions; the July 2023 field survey dates occurred in drier than normal field conditions; and the APT score for the final May 2024 field survey indicated that field conditions were wetter than normal (see Appendix D).

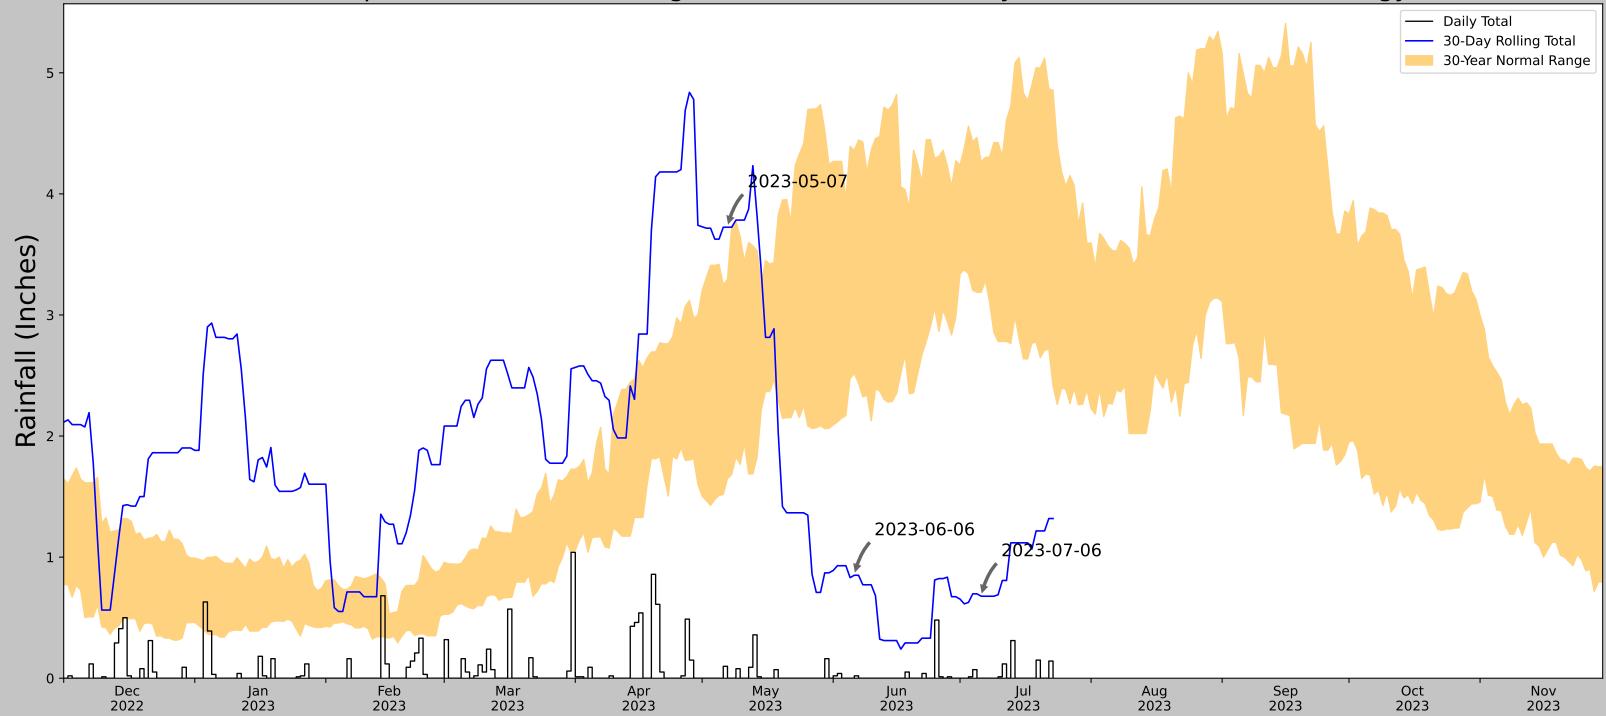
Coordinates	45.591845, -94.025181
Observation Date	2023-07-06
Elevation (ft)	1044.047
Drought Index (PDSI)	Moderate drought (2023-06)
WebWIMP H ₂ O Balance	Dry Season

_		
30 Days Ending	30 th %ile (in)	70 th %ile (in)	Observed (in)	Wetness Condition	Condition Value	Month Weight	Product
2023-07-06	3.187008	4.26378	0.677165	Dry	1	3	3
2023-06-06	2.514961	4.359449	0.850394	Dry	1	2	2
2023-05-07	1.648819	3.294488	3.72441	Wet	3	1	3
Result							Drier than Normal - 8

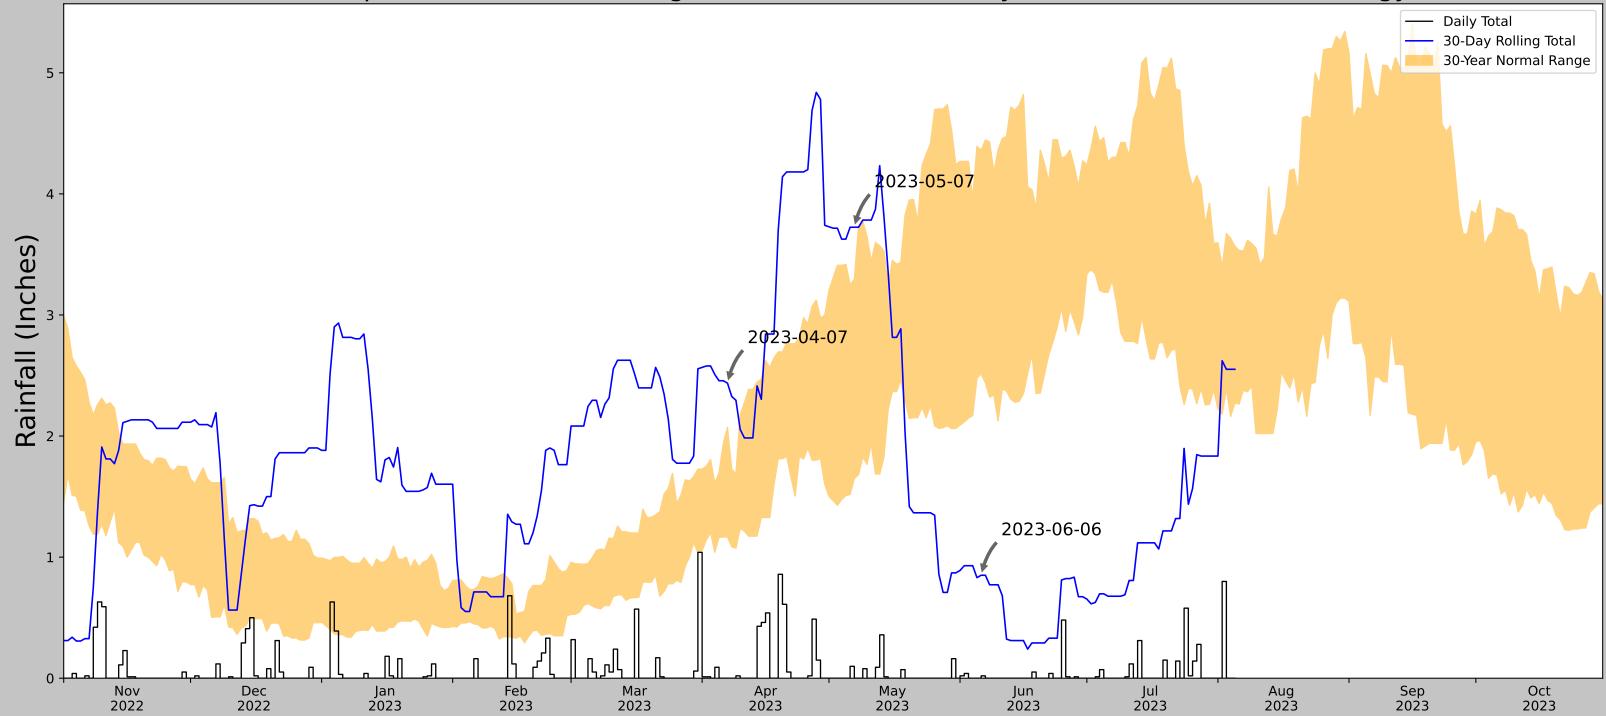
Coordinates	45.591845, -94.025181
Observation Date	2023-06-06
Elevation (ft)	1044.047
Drought Index (PDSI)	Moderate drought
WebWIMP H ₂ O Balance	Dry Season

30 Days Ending	30 th %ile (in)	70 th %ile (in)	Observed (in)	Wetness Condition	Condition Value	Month Weight	Product
2023-06-06	2.514961	4.359449	0.850394	Dry	1	3	3
2023-05-07	1.648819	3.294488	3.72441	Wet	3	2	6
2023-04-07	1.166535	2.07126	2.437008	Wet	3	1	3
Result							Normal Conditions - 12

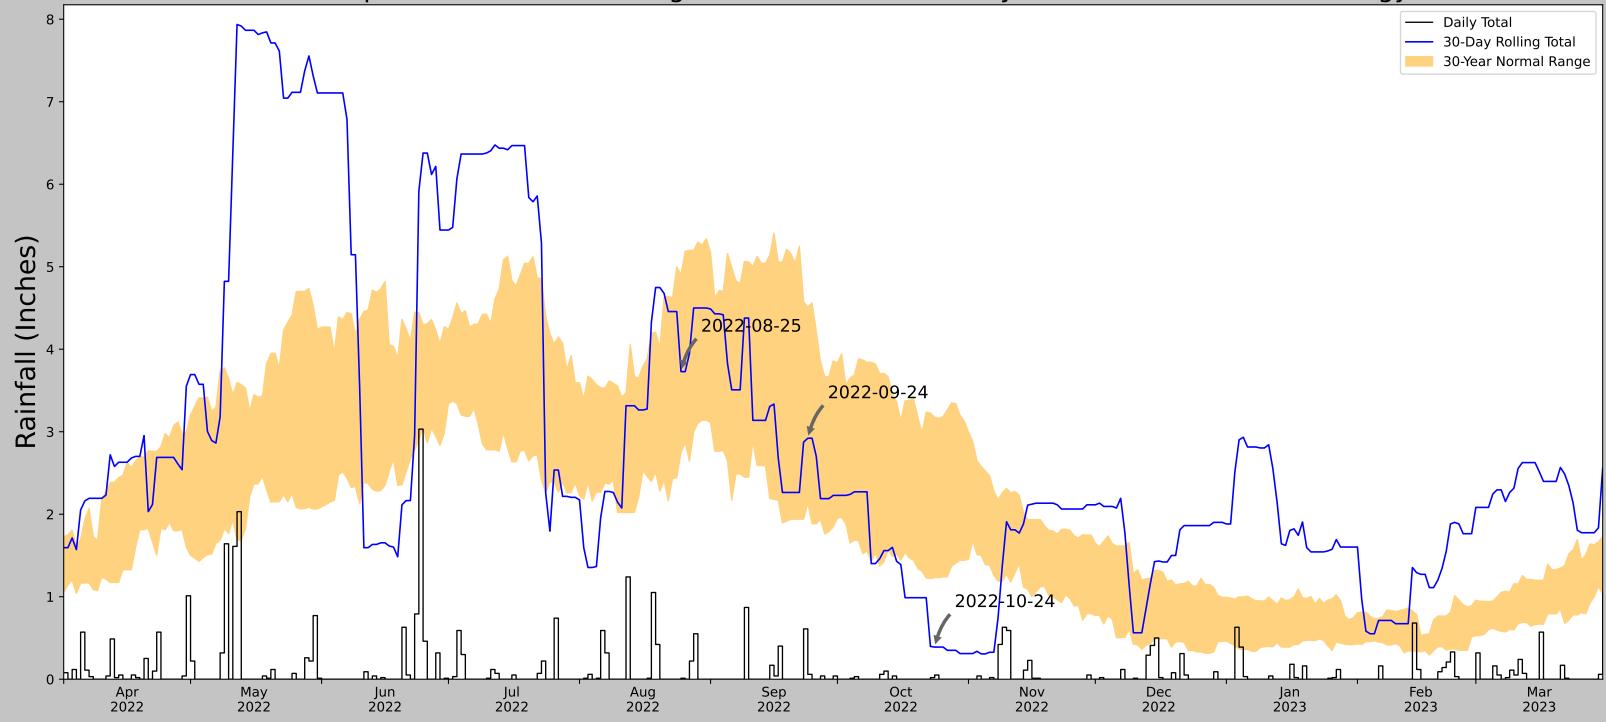
Coordinates	45.591845, -94.025181
Observation Date	2022-10-24
Elevation (ft)	1044.047
Drought Index (PDSI)	Severe drought
WebWIMP H ₂ O Balance	Wet Season

30 Days Ending	30 th %ile (in)	70 th %ile (in)	Observed (in)	Wetness Condition	Condition Value	Month Weight	Product
2022-10-24	1.23189	3.175591	0.389764	Dry	1	3	3
2022-09-24	2.137795	4.511811	2.92126	Normal	2	2	4
2022-08-25	2.748425	4.904725	3.728347	Normal	2	1	2
Result							Drier than Normal - 9
