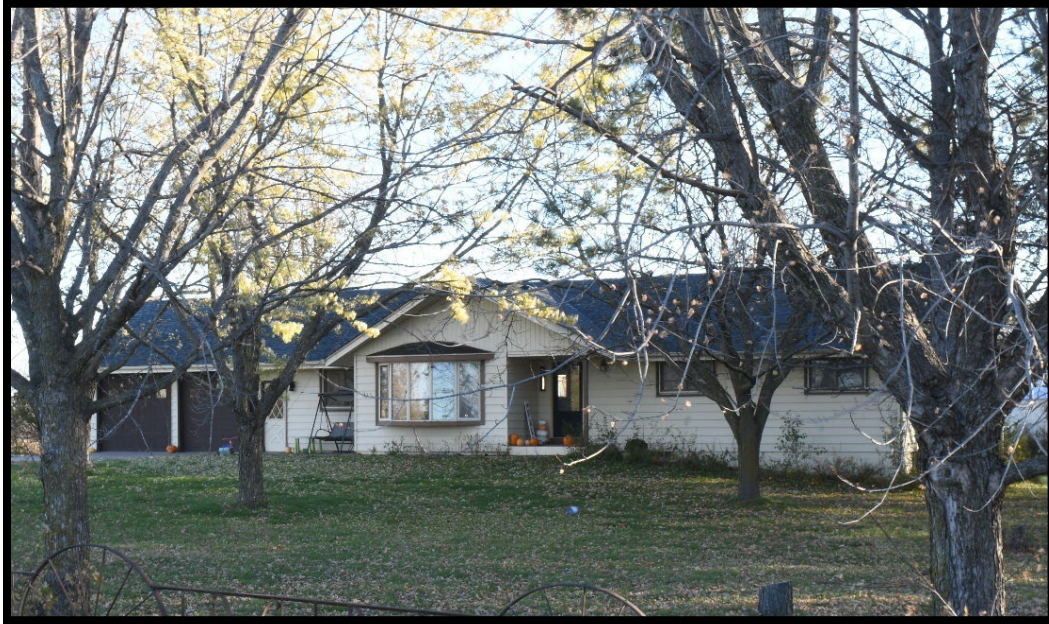
Plate 53. House, looking east.

This 5.15-acre parcel contains a house (primary resource), three equipment barns, and a shed. The one-story, circa 1975 Ranch house has a cross gable roof. The roof is covered with asphalt shingles and walls are clad with vinyl siding, with vertical siding in the gable ends. The house has G-G-D-W-WWWWW-D-W-W fenestration with sliding windows. A centrally located bay window has casement windows. A concrete step accesses the recessed front door, which is tucked under the front gable roof line. An integral two-car garage is located on the north elevation and has paneled metal rolltop doors with a row of fixed lights. The foundation is not visible from the right-of-way.

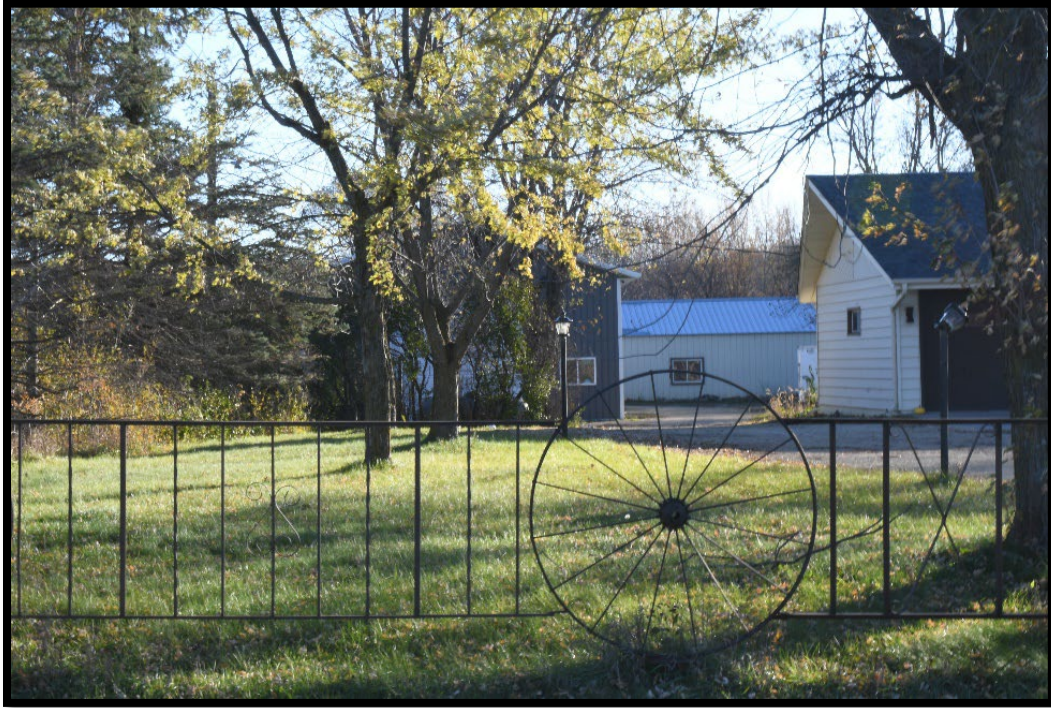
Plate 54. Equipment barns, looking east.

Three equipment barns of varying sizes are located east and northeast of the primary resource. Historic aerial photographs indicate that these were constructed between 1984 and 1991. Their front gable roofs are covered with metal panels and its walls are metal. Sliding doors are located in the south elevation. There is a wood shed northeast of the primary resource.

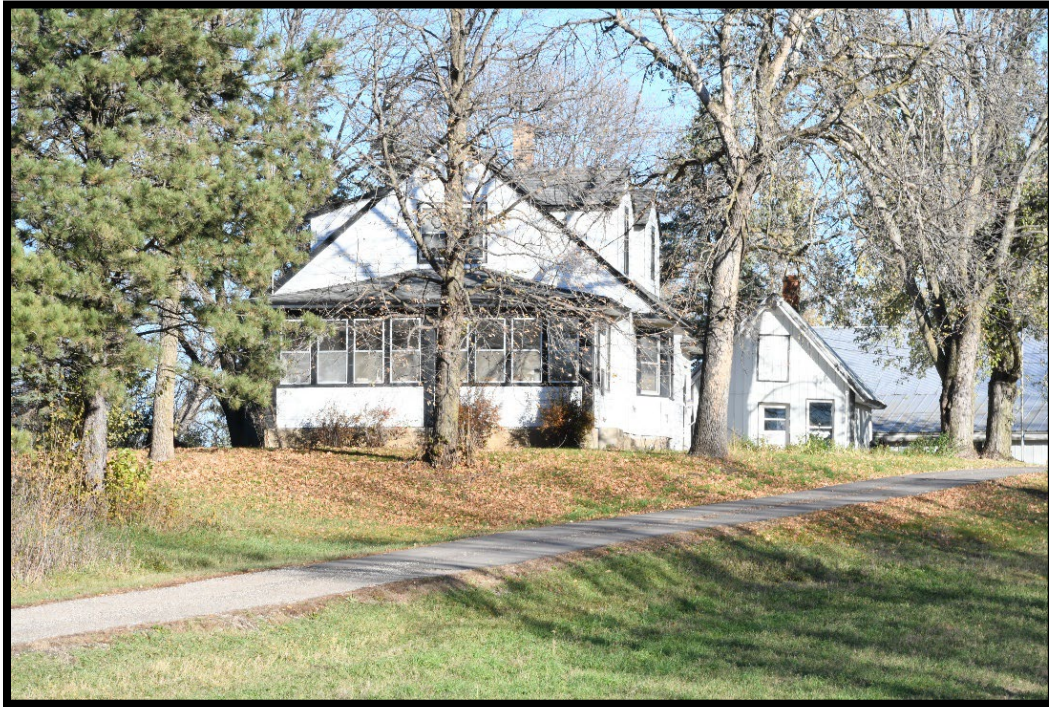
Plate 56. House and outbuilding, looking north.

This 78.9-acre parcel contains a house (primary resource), a barn, an outbuilding, two equipment barns, two sheds, and a silo. The one-and-one-half-story, circa 1910 house has a front gable roof. There are two gable roof dormers on the east (main) elevation and a shed roof dormer on the west (rear) elevation. The roof is covered with asphalt shingles and walls are clad with vinyl siding. The house has a bay window on the east elevation and a hipped roof enclosed porch on the south elevation. Windows are 1/1. There is an interior brick chimney. The house rests on a poured concrete foundation.

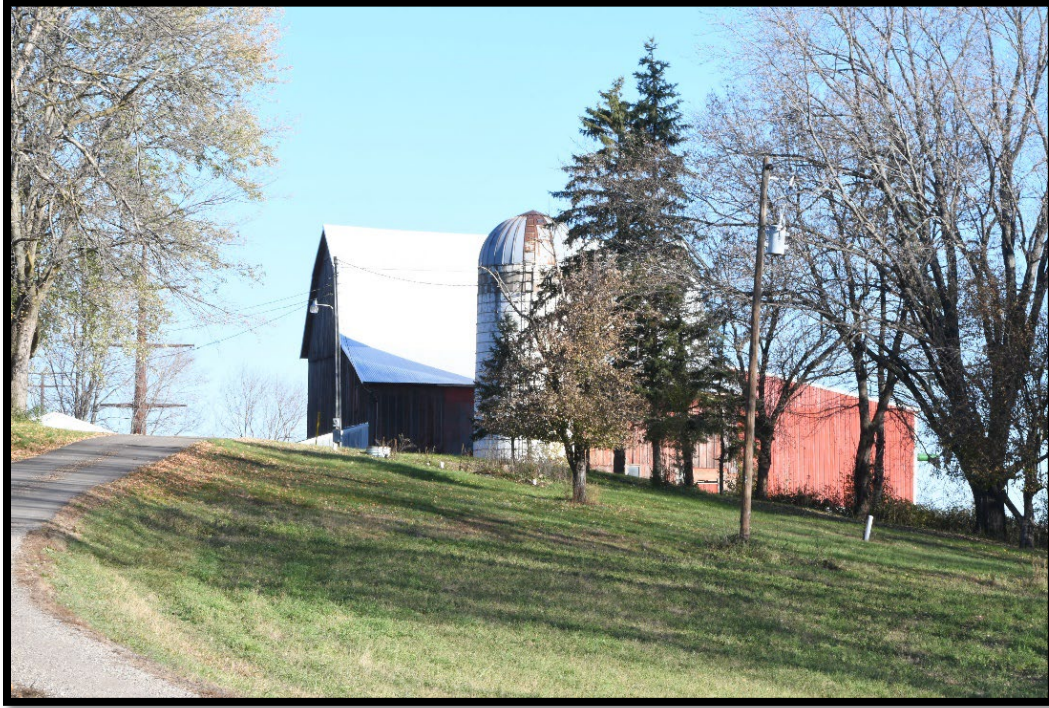
Plate 57. Barn and silo, looking north.

A gambrel roof barn is located northeast of the primary resource. It has shed roof additions to the south and east elevations. Its roof is covered in metal panels and walls are vertical board-and-batten wood siding. The east addition has metal siding. There is a concrete stave silo immediately south of the barn. North of the primary resource is an outbuilding with a steeply pitched front gable roof. Walls are clad with vertical siding and there is an interior brick chimney. A front gable equipment barn with a shed roof

addition on the south elevation is located north of the primary resource. It has a roof covered with metal panels and walls clad in metal. The other equipment barn and sheds are not fully visible from the right-of-way.

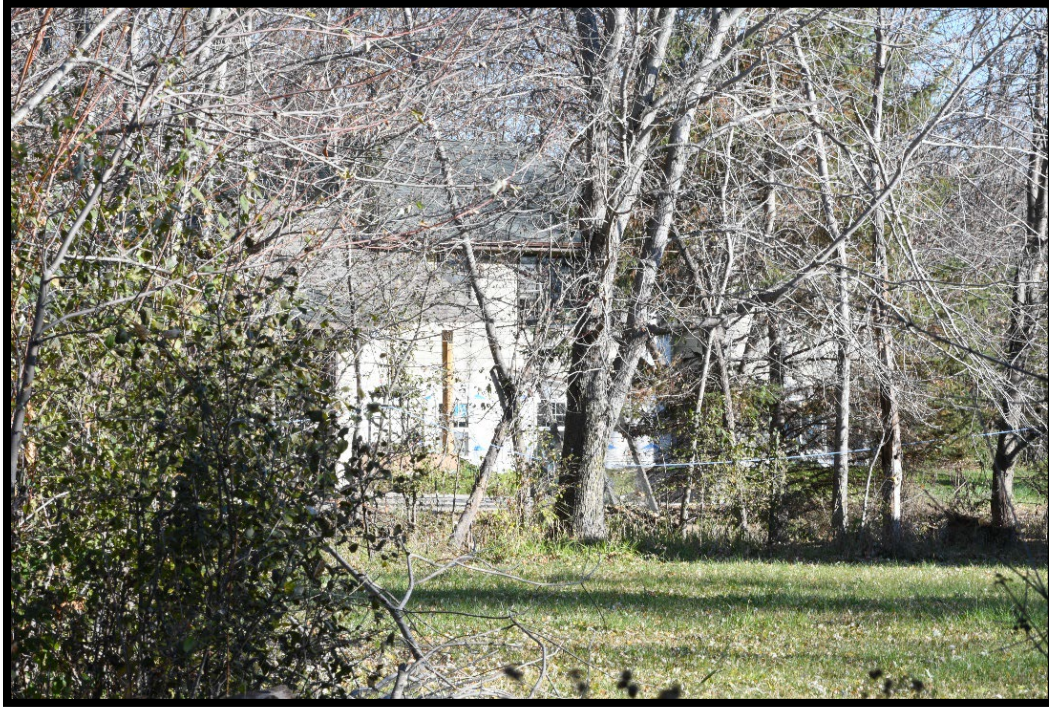
Plate 58. House, looking north.

This 20.44-acre parcel contains a house (primary resource) and several agricultural outbuildings in a ruined condition. The south branch of the Vermillion River flows through this parcel. The circa 1974 Split-Level house has a hipped roof covered with asphalt shingles. Walls are clad with metal siding. The house has D-W-WWW-D-W fenestration with 1/1 windows. A circa 2020 hipped roof porch wraps around the west elevation. Due to overgrown vegetation and its distance from the right-of-way, no further assessments can be made.

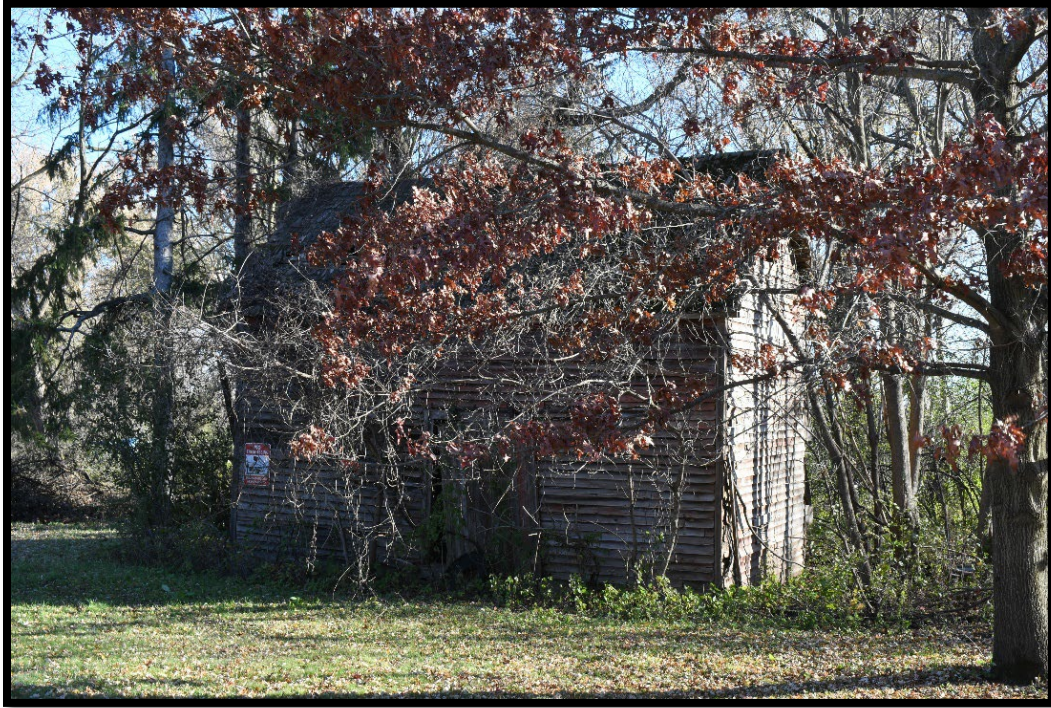
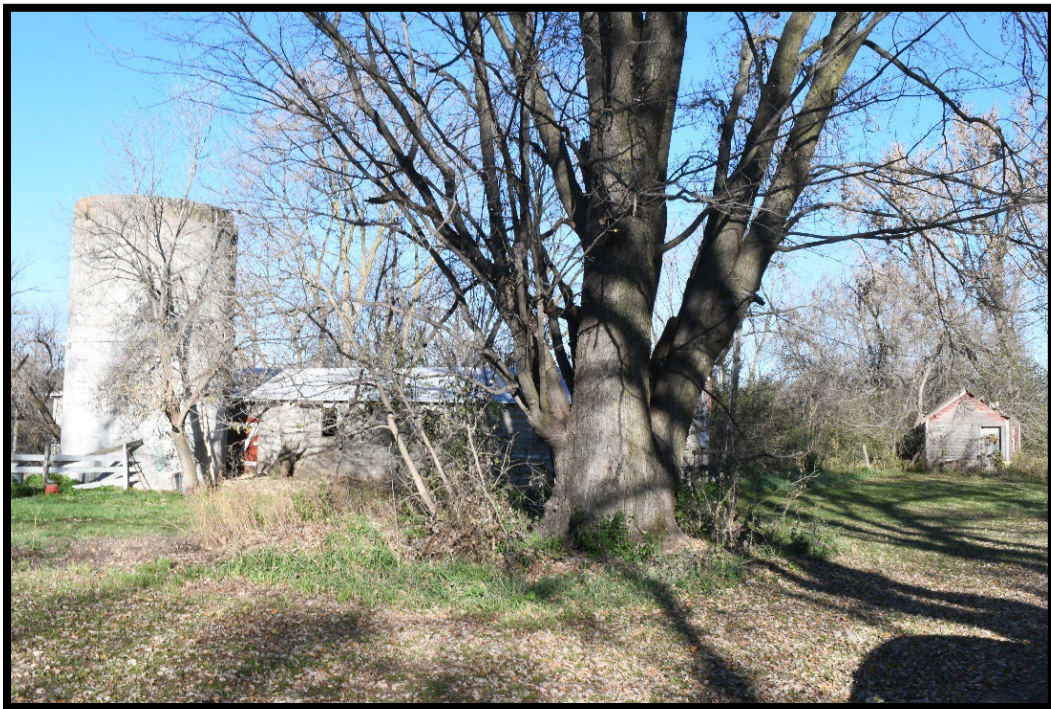
The parcel also contains the ruins of an agricultural cluster including: two wood gable roof sheds, a two-story wood carriage house, a plywood shed, a wood equipment shed, a concrete stave silo base, and a shed roof barn.

Plate 59. Carriage house.

Plate 60. Silo and outbuildings.

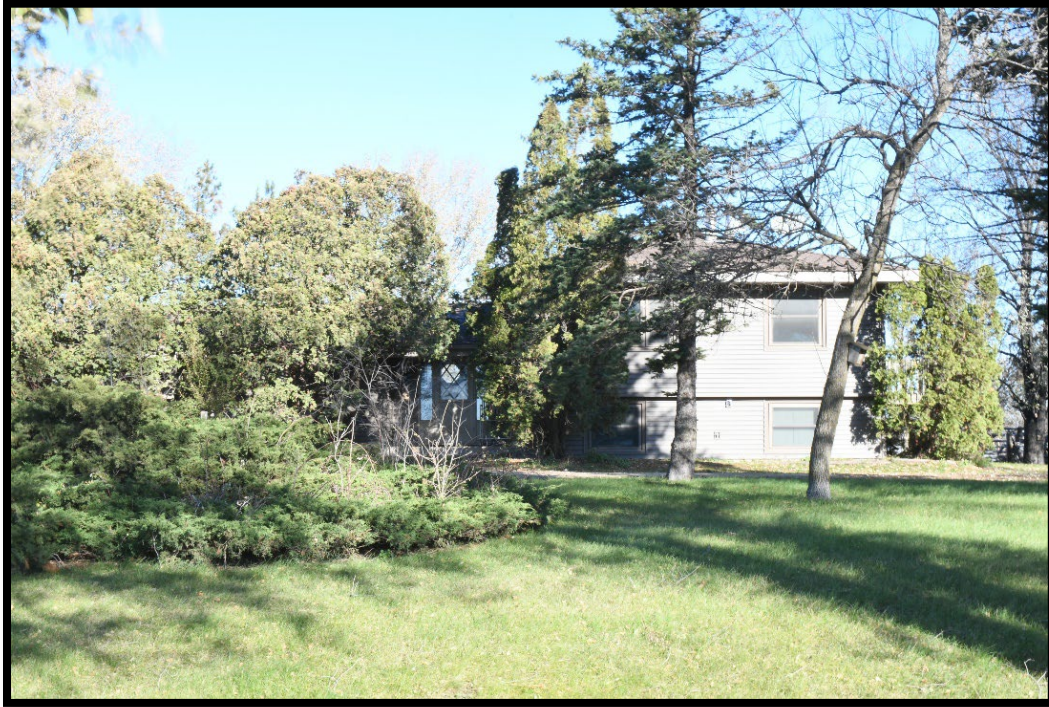
Plate 61. House, looking north.

This three-acre parcel contains a house, an equipment barn, and an open-sided shed/hayfeeder. The circa 1973 Tri-Level Split house has a hipped roof with a side gable wing. The roof is covered with asphalt shingles and walls are clad with vinyl siding. The house has 1/1 vinyl windows. A concrete step accesses the front door, which is tucked under the side gable roof line. This door is flanked by sidelights. The attached two-car garage with paneled metal rolltop doors is located on the west elevation. There is a raised wood deck on the upper level of the east elevation. The foundation is not visible from the right-of-way.

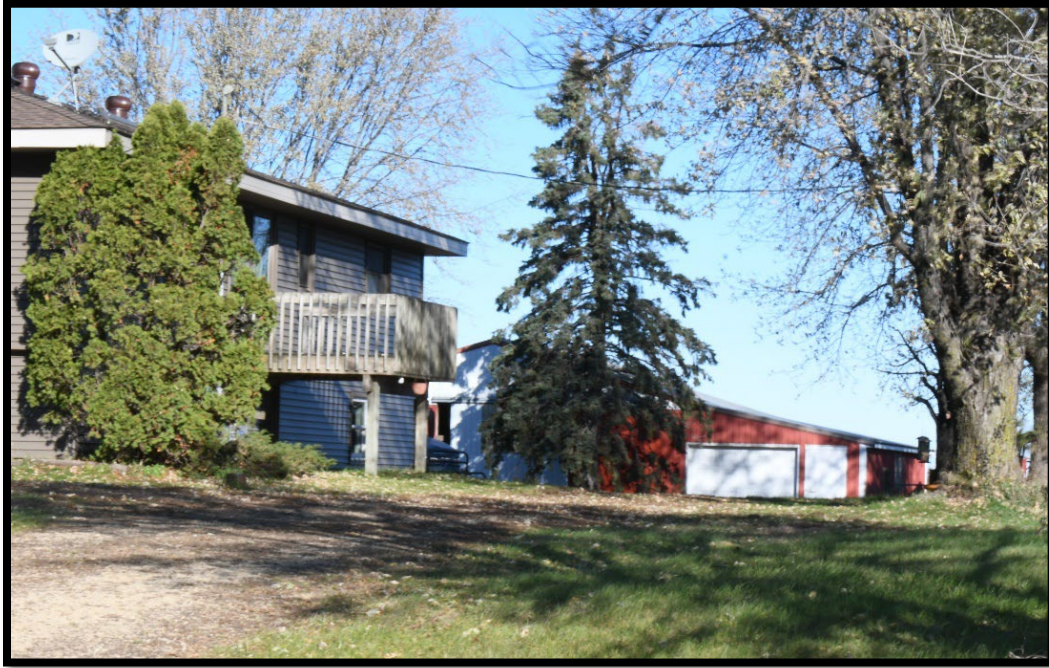
Plate 62. House and equipment barn, looking north.

A circa 1979 equipment barn is located north of the primary resource. Its front gable roof is covered with metal panels and its walls are metal. There is a sliding door in the south elevation.

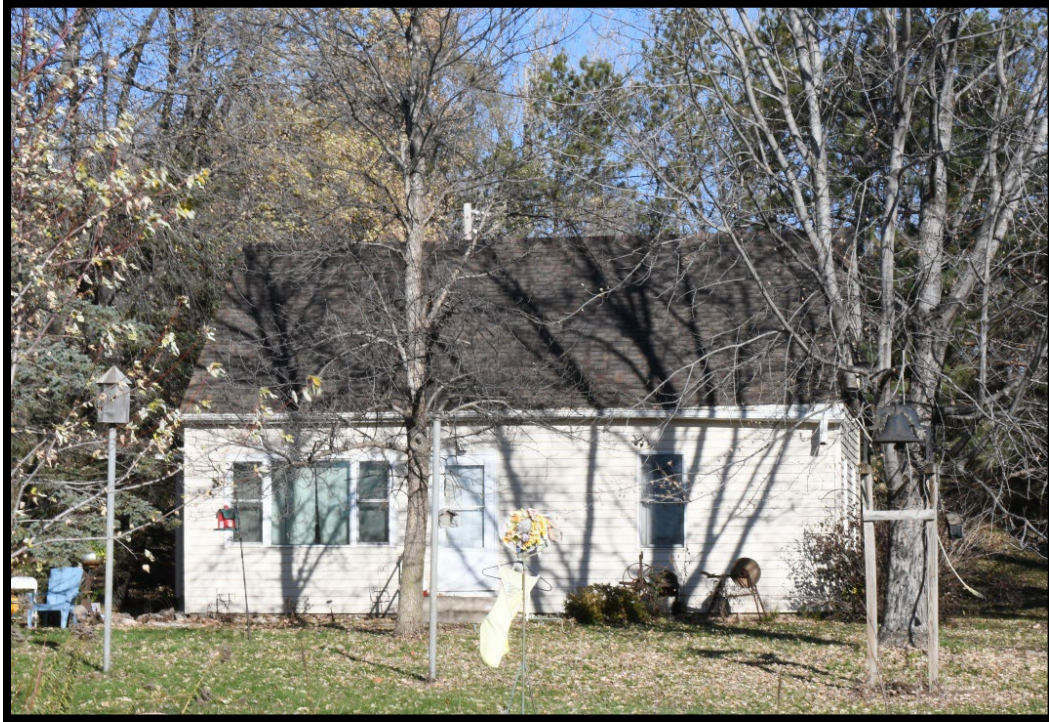
Plate 64. House, looking north.

This four-acre parcel contains a house (primary resource), two equipment barns, and a shed. The one-and-one-half-story, circa 1950 Minimal Traditional house has a side gable roof. The roof is covered with asphalt shingles and walls are clad with vinyl siding. The house has WWW-D-W fenestration with 1/1 windows. Two concrete steps access the front door. The foundation is not visible from the right-of-way.

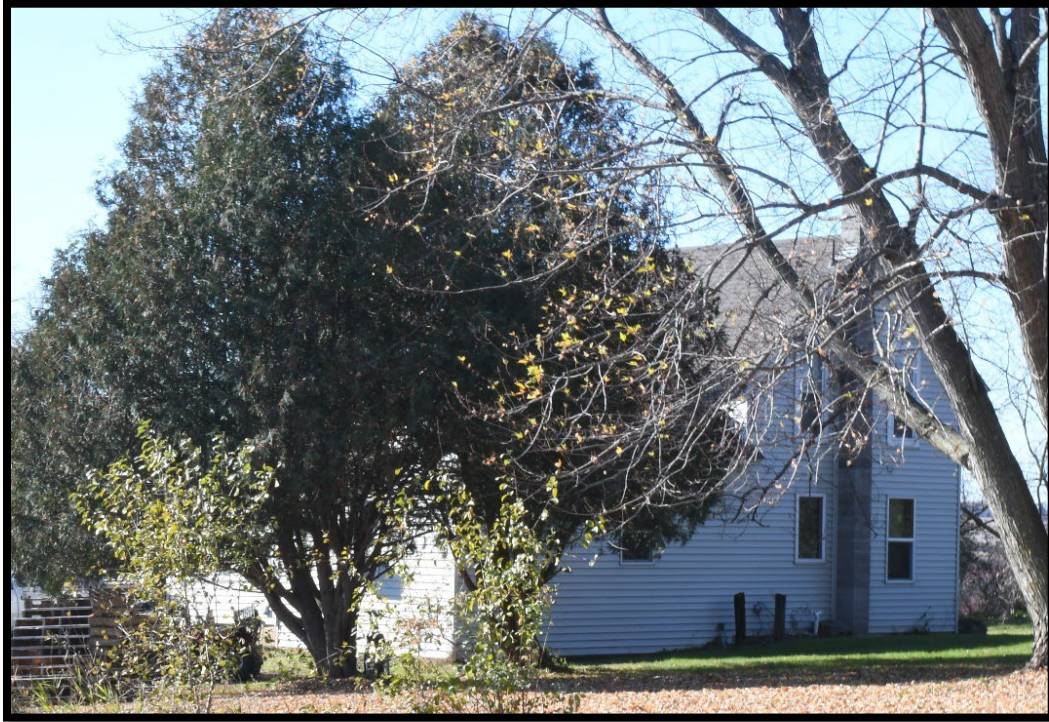
Plate 66. House, looking southwest.

This 156.05-acre parcel contains a house (primary resource) and a shed. The circa 1890 one-and-one-half Upright-and-Wing house has a cross gable roof. The roof is covered with asphalt shingles and walls are clad with vinyl siding. The house has 1/1 windows. There are exterior concrete block chimneys on the north and west elevations. The foundation is not visible from the right-of-way.

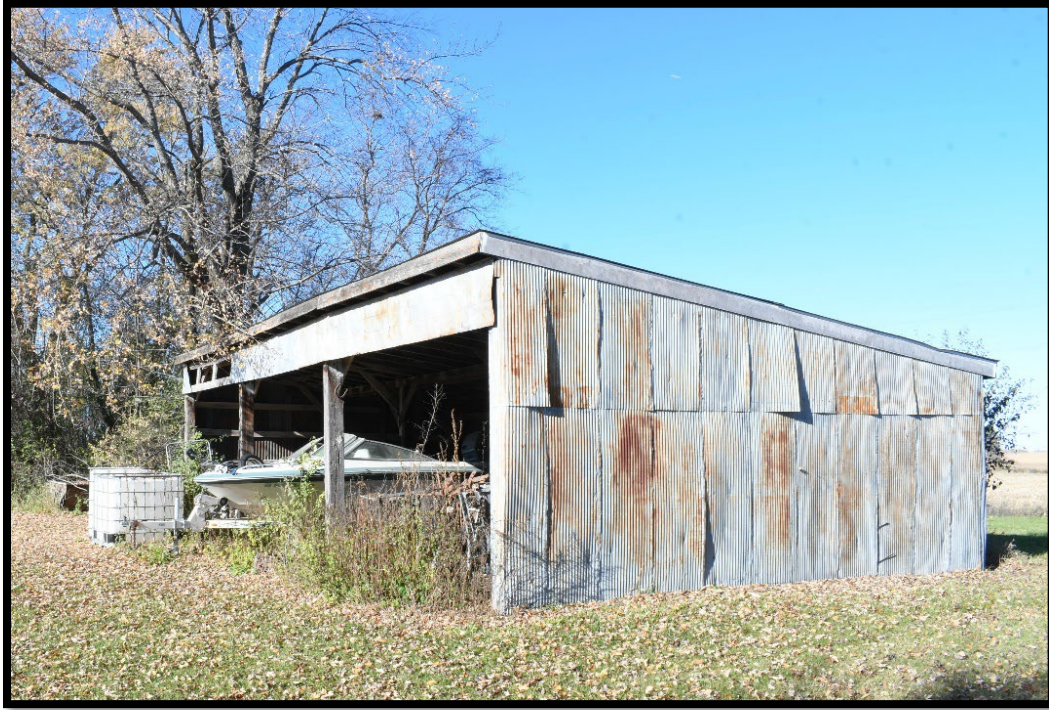
Plate 67. Machine Shed, looking north.

An open-sided machine shed is located northeast of the primary resource. Its shed roof is covered with metal panels and its walls are corrugated metal panels. A concrete stave silo base is located on the parcel.

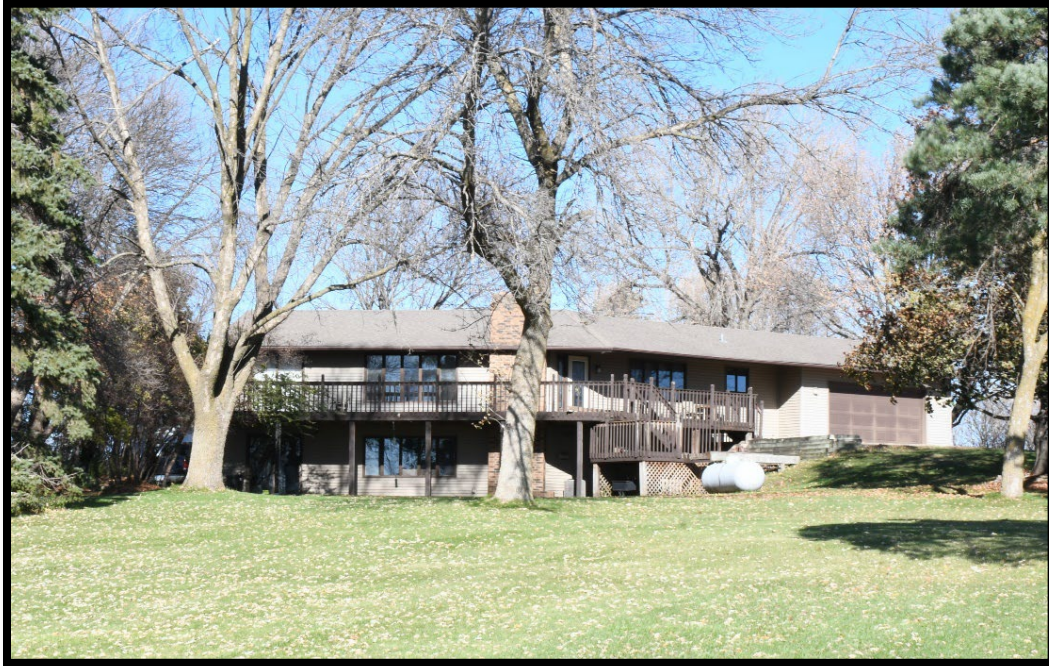
Plate 69. House, looking north.

This 6.12-acre parcel contains a house (primary resource) and an equipment barn. The single-story, circa 1975 Ranch house is comprised of two angled wings, one of which has a walk-out basement. The side gable roof is covered with asphalt shingles and walls are clad with vinyl siding. The house has DD-WWWWW-D-WWWWW-WW-G fenestration with casement windows. A raised full-length wood deck supported by wood posts accesses the front door, which is tucked under the side gable roof line. This door is flanked by a sidelight. The attached two-car garage is located on the east elevation. The foundation is not visible from the right-of-way.

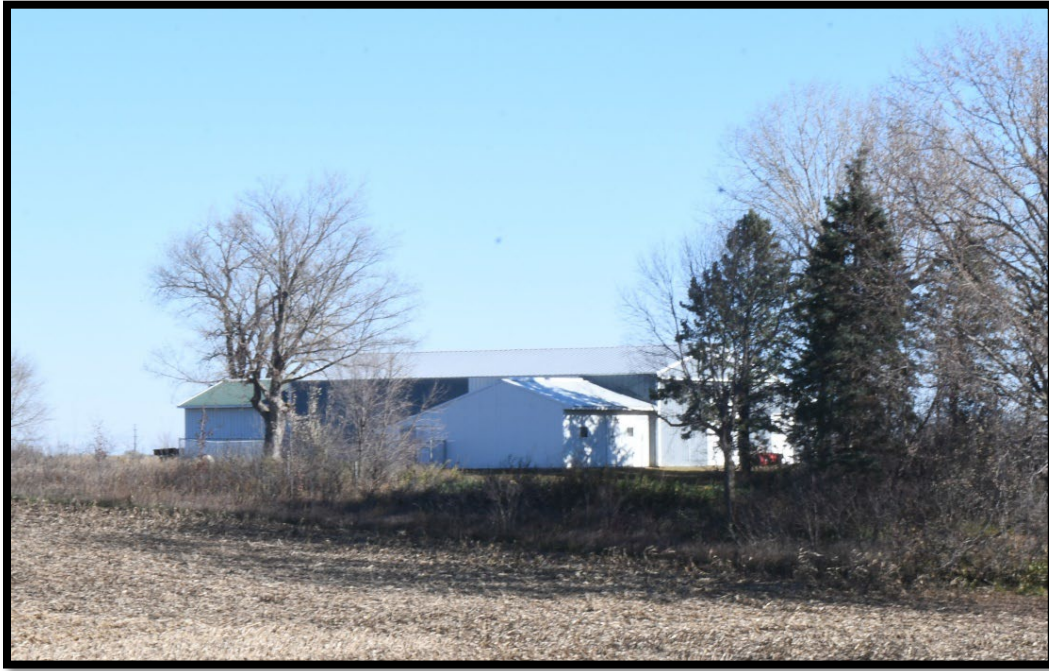
Plate 70. Equipment barn, looking northeast.

A circa 1984 equipment barn is located north of the primary resource. Its side gable roof is covered with metal panels and its walls are metal. There is a sliding door and a garage door in the south elevation. There is a gable roof addition on the west elevation.

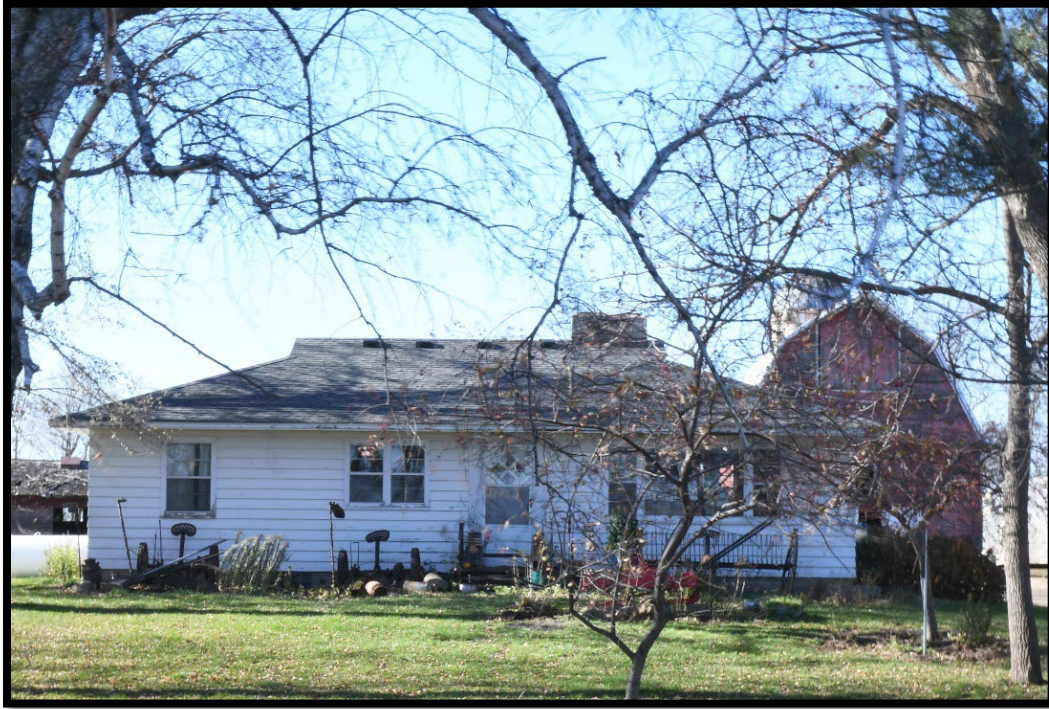
Plate 71. House and barn, looking west.

This five-acre parcel contains a house (primary resource), a barn, silo, four sheds, a corn crib, and two equipment barns. The single-story, circa 1954 house has a Dutch gable roof. The roof is covered with asphalt shingles and walls are clad with horizontal siding. The house has W-WW-D-WWW fenestration with 2/3 wood windows with horizontal muntins. There are glass block basement windows. A concrete step accesses a wood front door with diamond-shaped fixed window. There is an interior brick chimney. The house rests on a concrete block foundation.

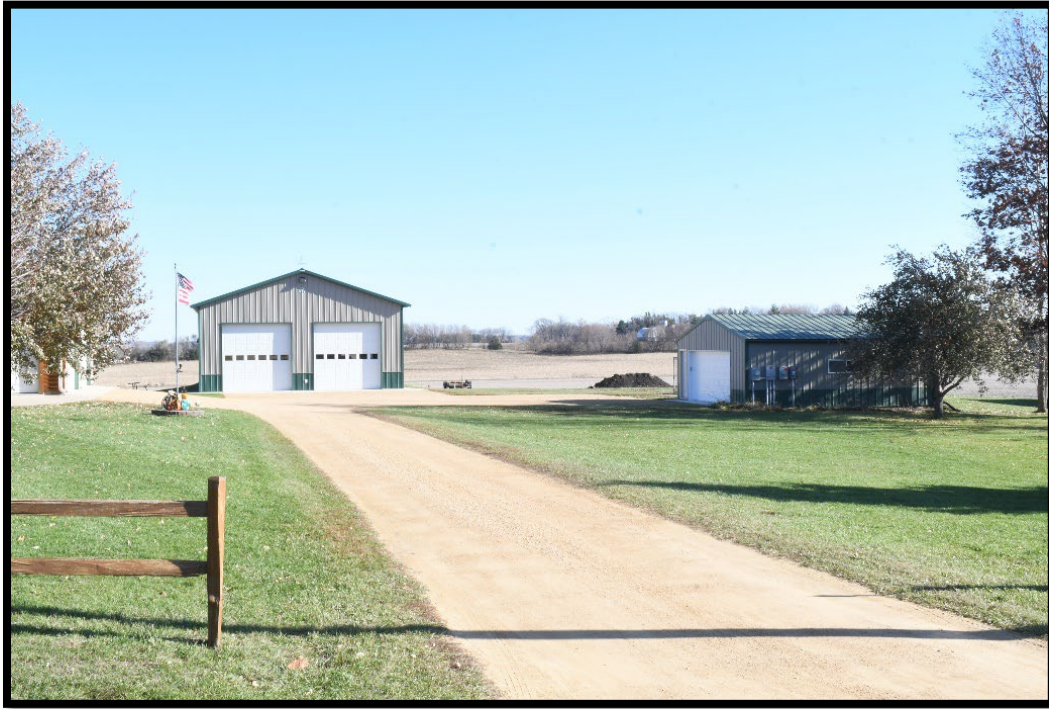
Plate 77. Equipment barn and garage, looking east.

A circa 2000 Morton equipment barn is located southeast of the primary resource. Its front gable roof is covered with metal panels and walls are clad with vertical metal. Two paneled metal roll top garage doors with a row of fixed lights are located in the west elevation. A metal grain bin is located east of this equipment barn. A one bay garage is located south of the primary resource. Its front gable roof is covered

with metal panels and walls are metal. There is a paneled metal rolltop garage door and a pedestrian door on the north elevation.

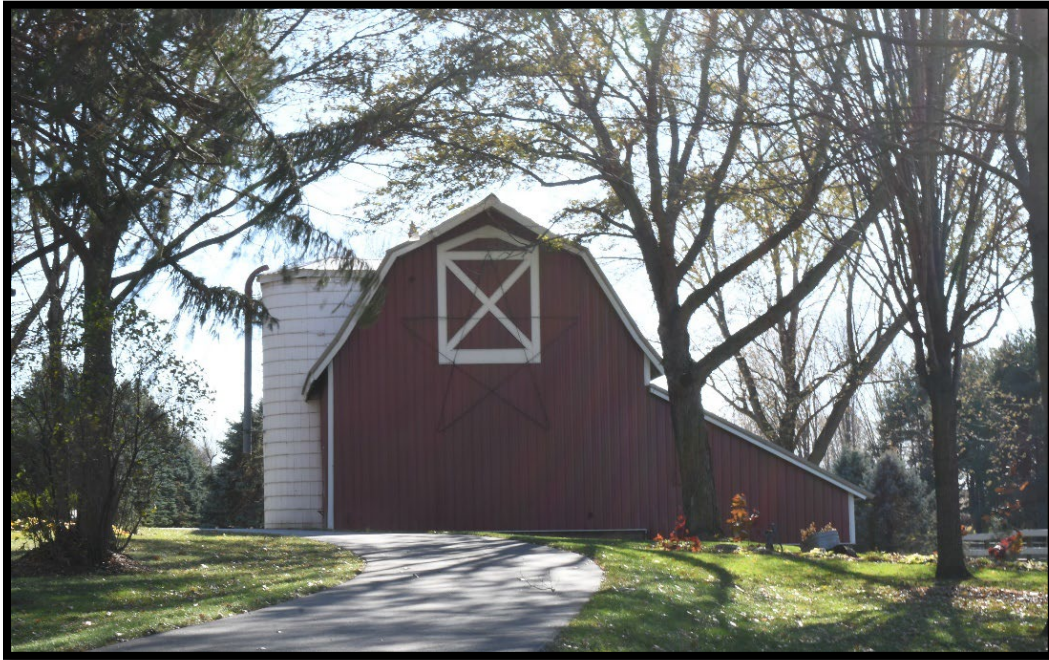
Plate 79. Barn and silo, looking south.

A barn is located southwest of the primary resource. Its gambrel roof is covered with metal panels and its walls are clad with vertical metal siding. There is a shed roof addition to the west elevation. A concrete stave silo is located at the barn's east elevation. Southeast of the primary resource is a shed with a broken gable roof covered with metal siding. Walls are clad with vertical board-and-batten wood siding. A circa

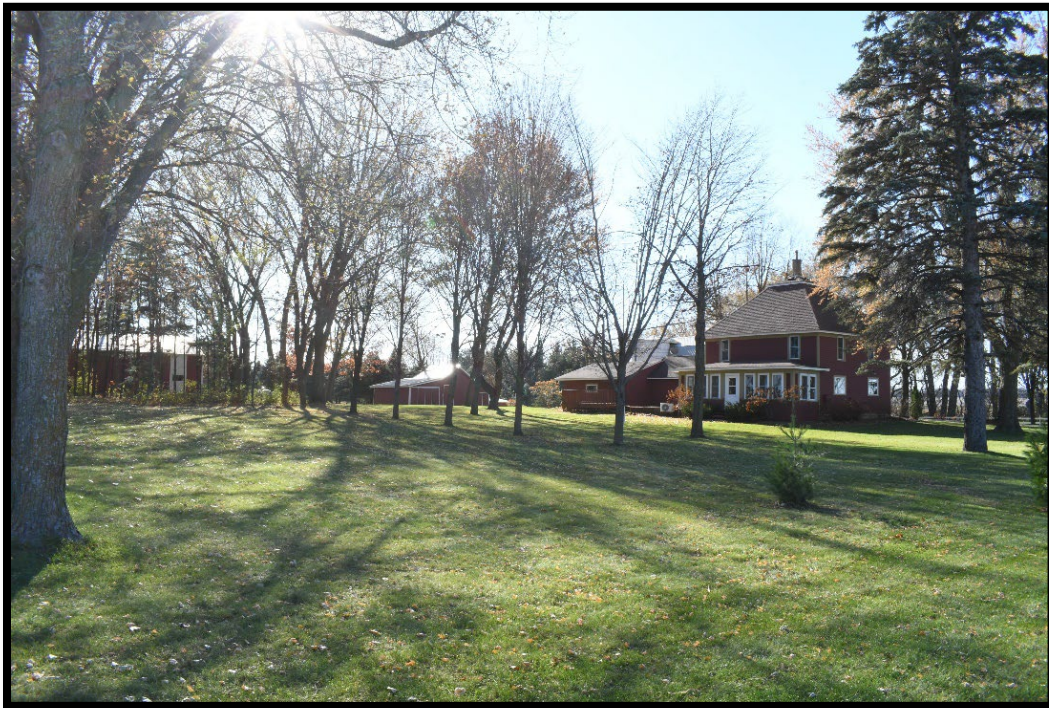
Plate 80. Equipment barn, shed, and house, looking southwest.

1991 front gable equipment barn is located southeast of the primary resource. Its roof is covered with metal panels and walls are metal.

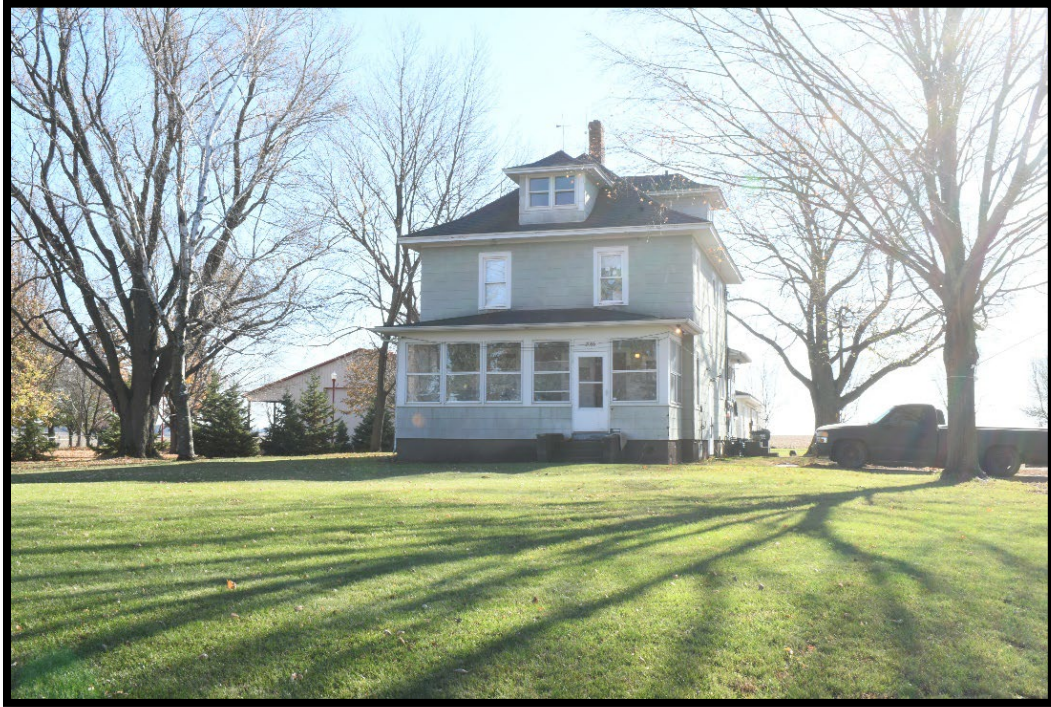
Plate 81. House, looking south.

This 115.13-acre parcel contains a house (primary resource) and a detached garage. The 2.5 story, circa 1918 American Foursquare has a hipped roof with flared eaves. The roof is covered with asphalt shingles and walls are clad with asbestos siding. An interior brick chimney is located along the ridge of the roof. A roof dormer is located on the north and west elevations. The front porch has been enclosed. The dwelling contains 1/1 vinyl windows. A single-story rear addition is attached to the south elevation. The dwelling rests on a parged foundation.

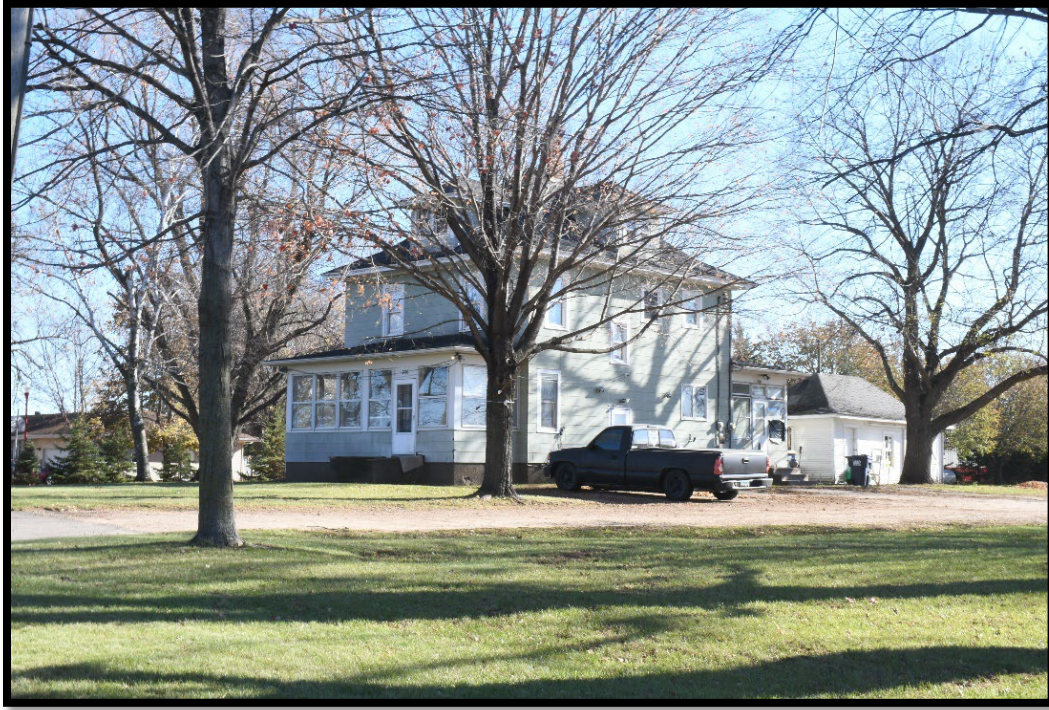
Plate 82. House and garage, looking southeast.

Located to the south of the primary resource is a detached garage. The garage is clad in wood siding and has a hipped roof with flared eaves covered with asphalt shingles.

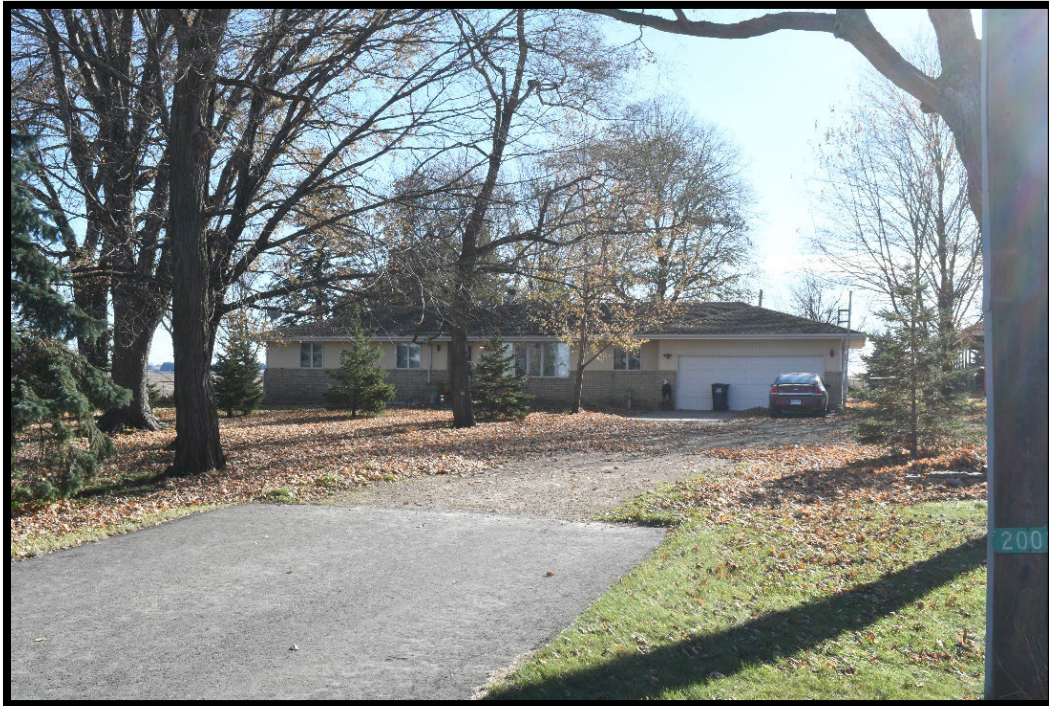
Plate 83. House, looking south.

This 2.16-acre parcel contains a house (primary resource) and an equipment barn. The one-story, circa 1966 Ranch house has a cross hipped roof. The roof is covered with asphalt shingles and walls are clad with vinyl siding and brick veneer. The house has WW-WW-D-WWWWW-WW-G fenestration with casement windows covered by metal storm windows. The door is recessed under the roof. The foundation was not visible at the time of the survey.

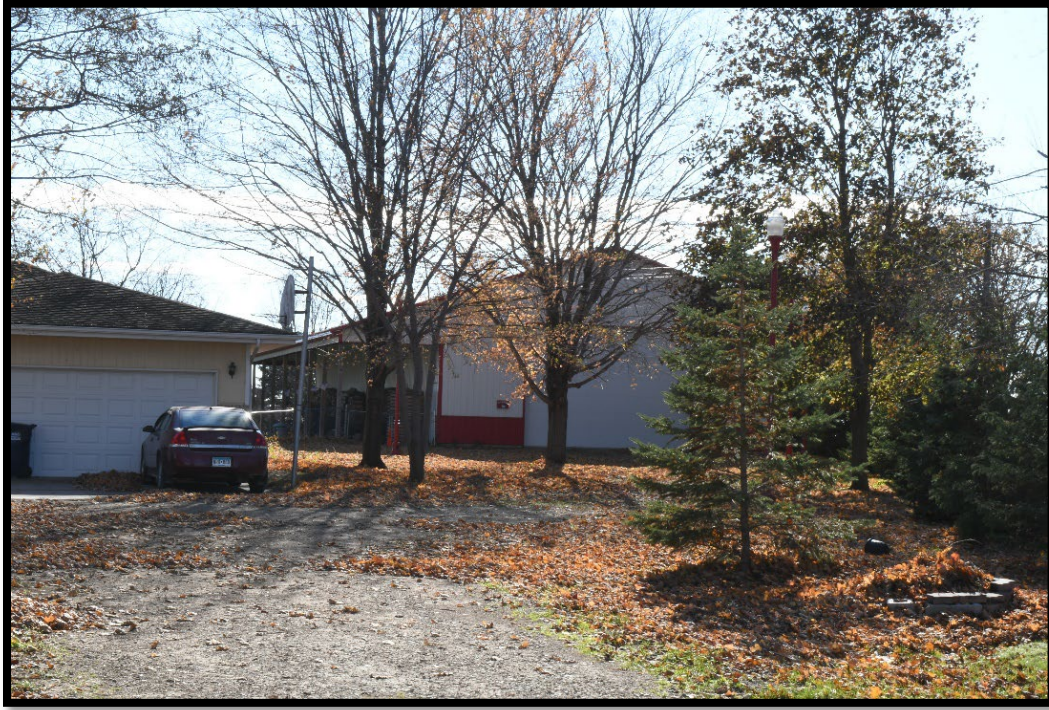
Plate 84. Barn, looking south.

Located to the southwest of the primary resource is a circa 2010 equipment barn. The barn is clad in metal siding and has a front gable roof covered with metal panels. The north elevation contains a rolltop door.

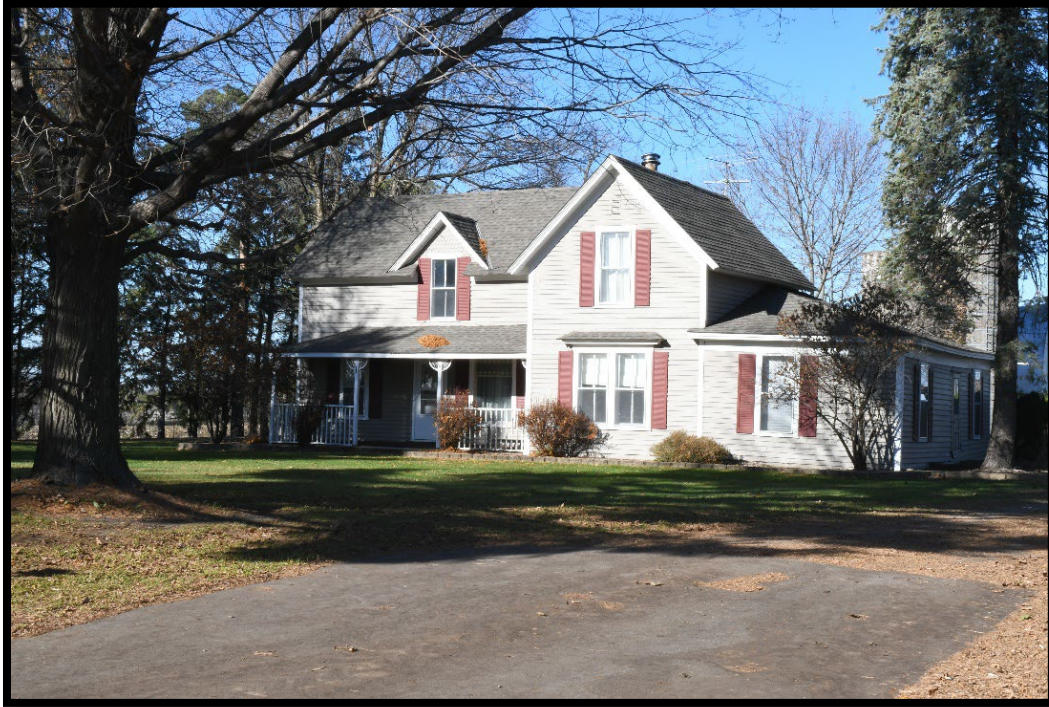
Plate 85. House, looking northwest.

This 59.02-acre parcel contains a house (primary resource), two silos, a barn, and a shed. The two-story, circa 1880 Gabled Ell house has a cross gable roof. The roof is covered with asphalt shingles and the walls are clad with wood siding. The house has W-D-W-WW-W fenestration with 2/2 wood windows flanked by non-operation shutters. The door is located under a covered porch topped with a half-hipped roof. A single-story addition is attached to the east elevation and a single story rear addition is attached to the north elevation. The foundation was not visible at the time of the survey.

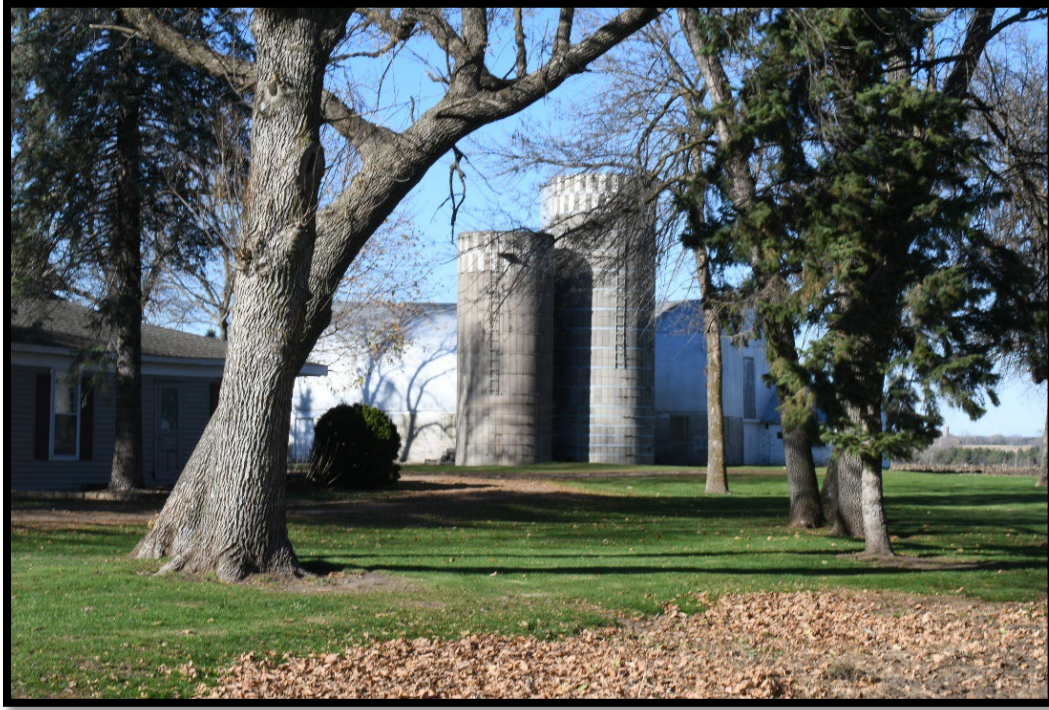
Plate 86. Silos and barn, looking northwest.

All secondary resources are located to the north of the primary resource. The shed is located near the primary resource. It is topped with a front gable roof covered with asphalt shingles. Further north are two concrete stave silos. The arched barn rests on a raised concrete block foundation. This barn may have served as a dairy barn originally. A single-story frame addition is attached to the east elevation.

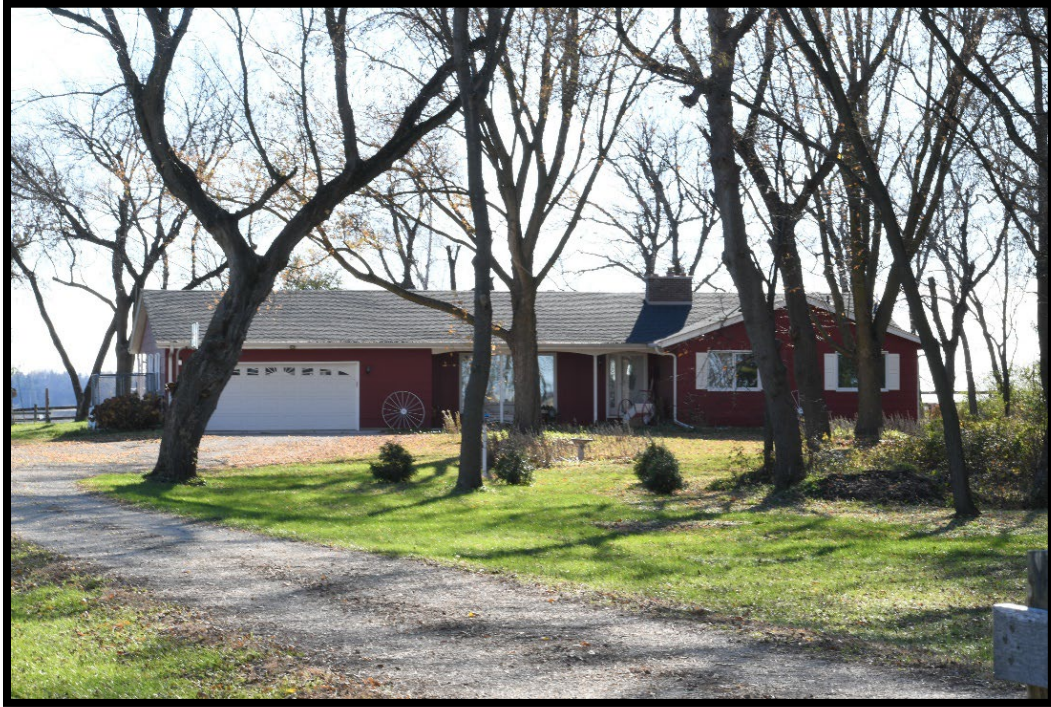
Plate 87. House, looking south.

This 16.6-acre parcel contains a house (primary resource), a shed, and a barn. The one-story, circa 1969 Ranch house has a cross gable roof. The roof is covered with asphalt shingles and walls are clad with metal siding. The house has G-WWW-D-W-W fenestration with casement and sliding windows constructed of an undetermined material. The non-historic door is flanked by one sidelight. An interior brick chimney is located near the ridge of the roof. The foundation was not visible at the time of the survey.

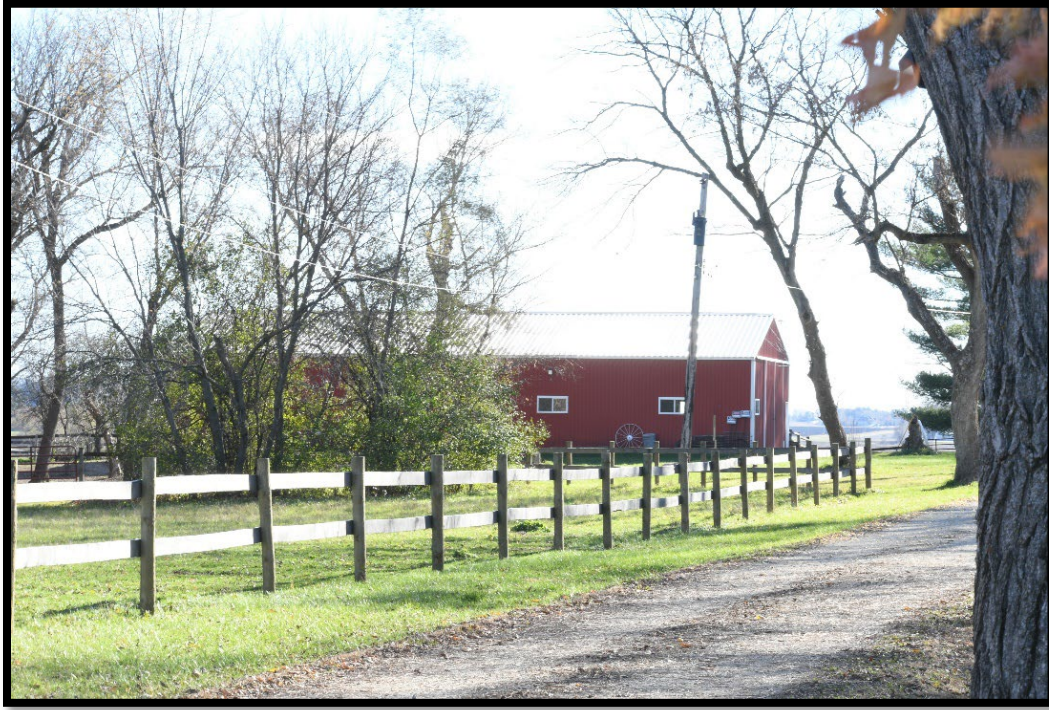
Plate 88. Barn, looking north.

Located on the property is a frame shed clad in metal siding. It is currently used for log storage. To the east of the primary resource is a circa 1975 barn clad in metal siding and topped with a front gable roof.
