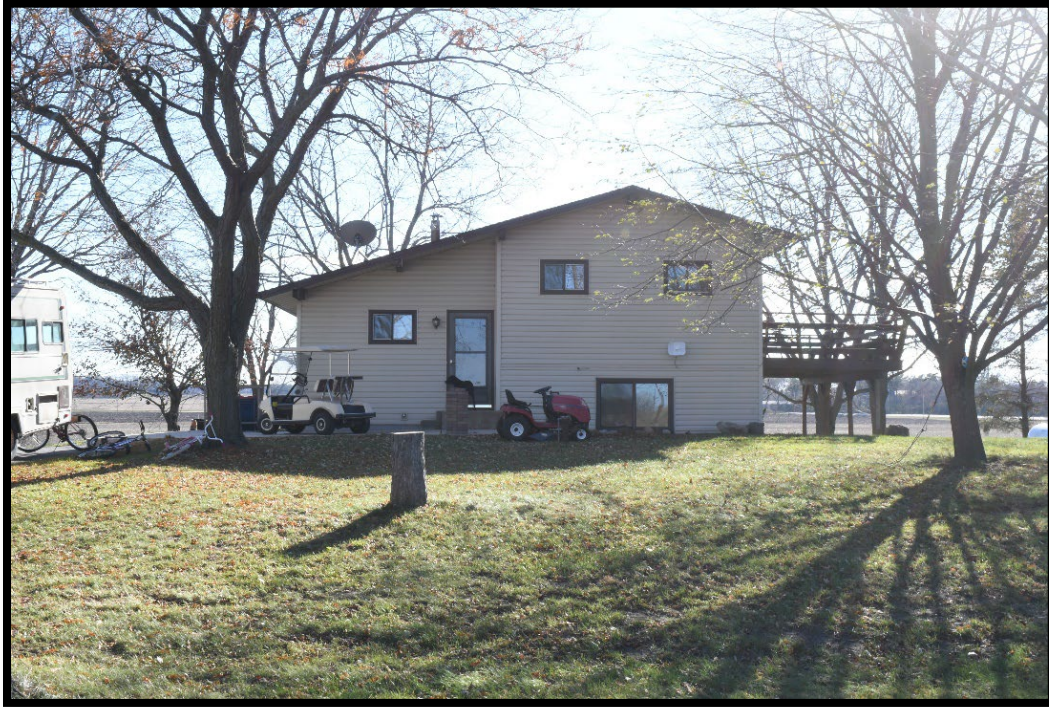
Plate 89. House, looking south.

This 1.49-acre parcel contains a house (primary resource), a frame shed, and a garage. The Tri-Level, circa 1976 house has a front gable roof with exposed rafter tails. The roof is covered with asphalt shingles and the walls are clad with vinyl siding. The house has W-D-W fenestration with sliding windows constructed of an undetermined material. Two concrete steps access the door from the side, which is tucked under the front gable roof line. An exterior concrete block chimney is located along the rear elevation. The foundation was not visible at the time of the survey. A wood deck addition is located along the west elevation.

There is a frame shed located northeast of the primary resource. A detached garage is located west of the primary resource. The garage is clad in vinyl siding and has a front gable roof covered with asphalt shingles. It contains two roll top doors and rests on a concrete block foundation.

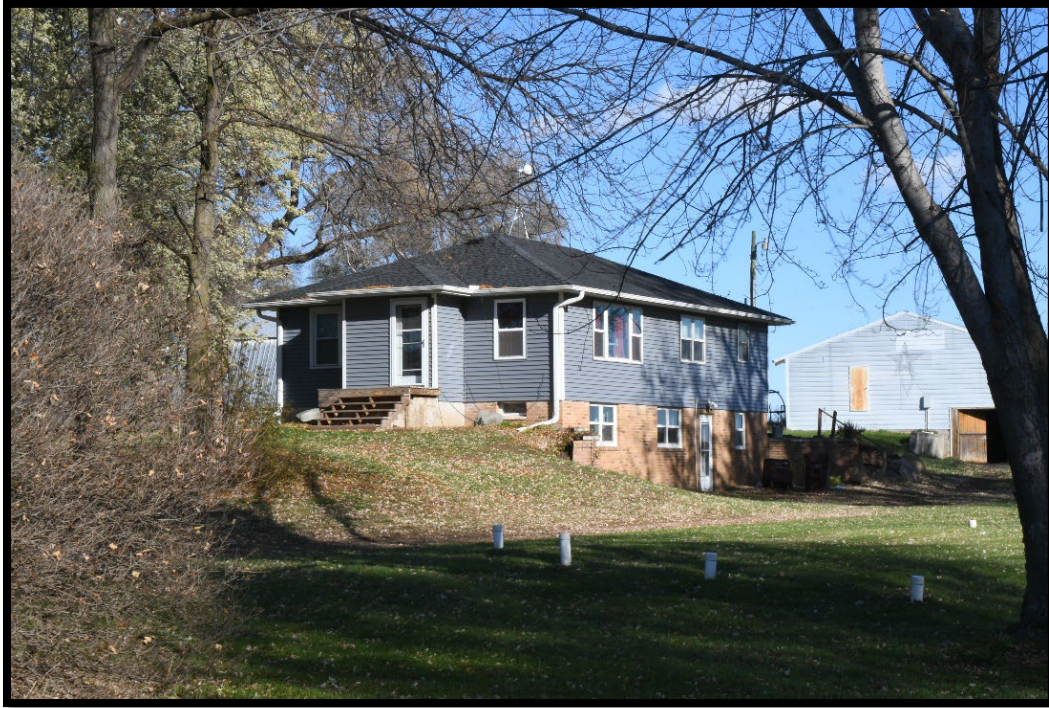
Plate 90. House, looking northeast.

This 15.31-acre parcel contains a house (primary resource), a grain bin, a shed, a barn, and two equipment barns. The single-story, circa 1954 house has a hipped roof. The roof is covered with asphalt shingles and the walls are clad with vinyl siding. The house has W-D-W fenestration with 1/1 vinyl windows. The dwelling rests on a brick foundation. The house is sited on a slope and there is a walk-out basement.

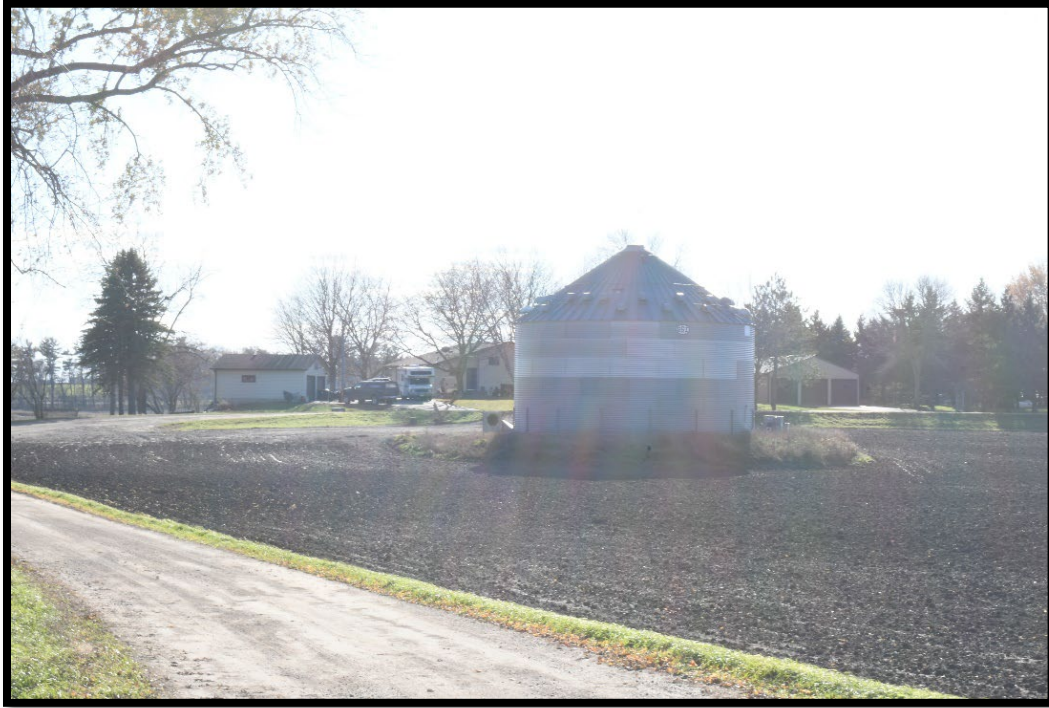
Plate 91. Grain bin, looking southwest.

Located to the north of the primary resource are two metal clad equipment barns; the larger of the two was built circa 2005. To the southwest of the primary resource is a metal grain bin. A shed clad in metal is located to the south of the dwelling. To the east of the primary resource is a barn clad in metal siding and topped with a front gable metal roof. The barn rests on a concrete block foundation and has a shed addition attached to the rear elevation.

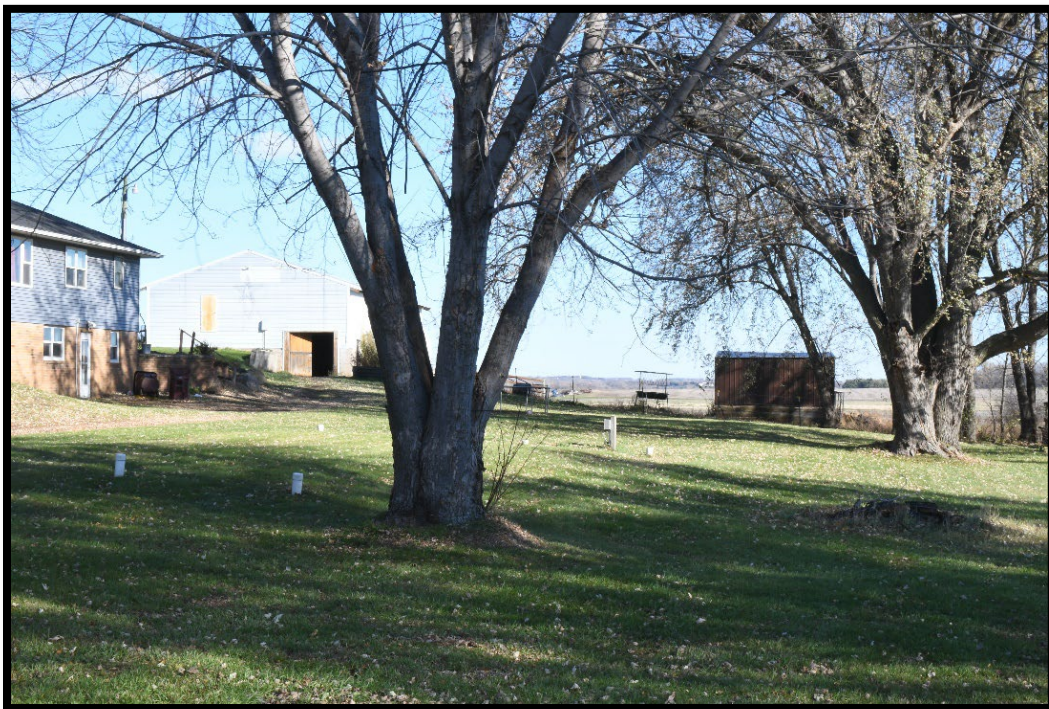
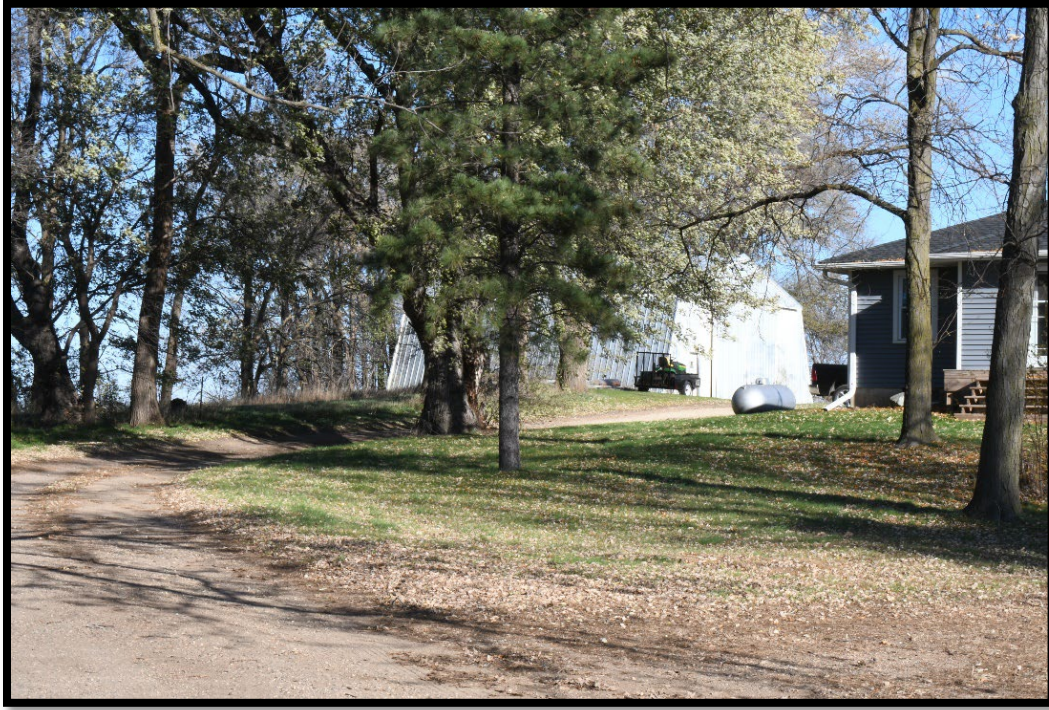
Plate 92. Barn and shed, looking east.

Plate 93. Equipment barn, looking northeast.

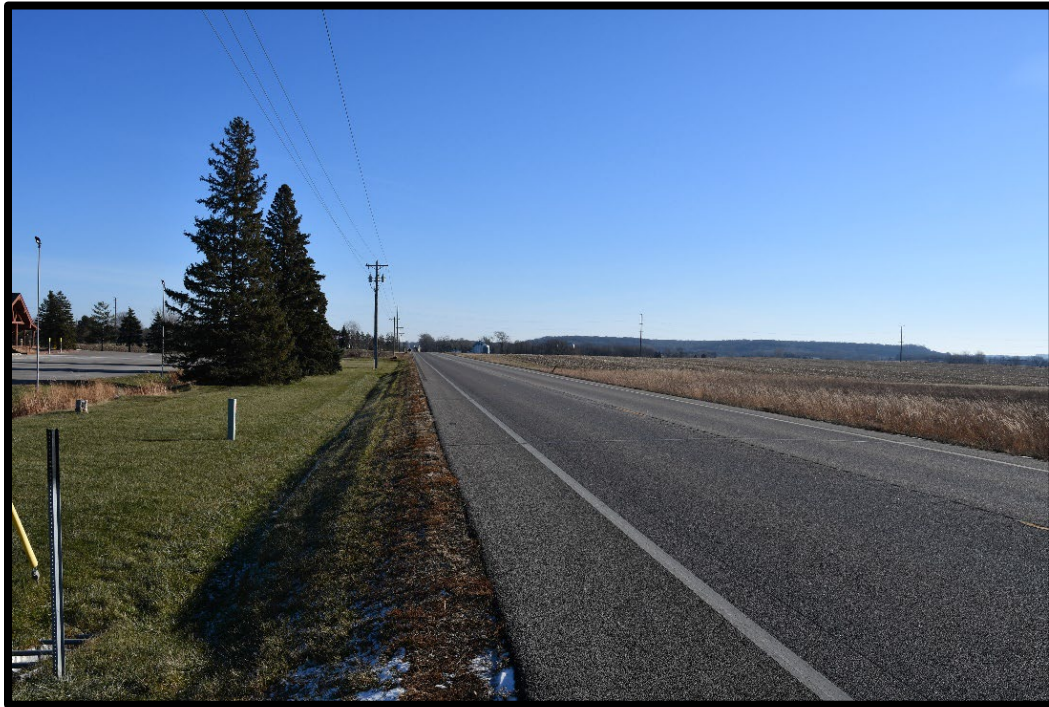
Plate 94. Trunk Highway 50, looking east from western edge of APE.

The portion of Trunk Highway 50 that lies within the APE runs between the junction of Dakota County Highway 79 on the west to a point approximately .16 mile east of the junction with Annette Avenue. This approximately 1.17 stretch of highway is a two-lane bituminous roadway with undivided travel lanes and narrow paved shoulders. The highway runs in an east – west direction. The area surrounding the highway is primarily flat agricultural land with residential subdivisions.⁵¹

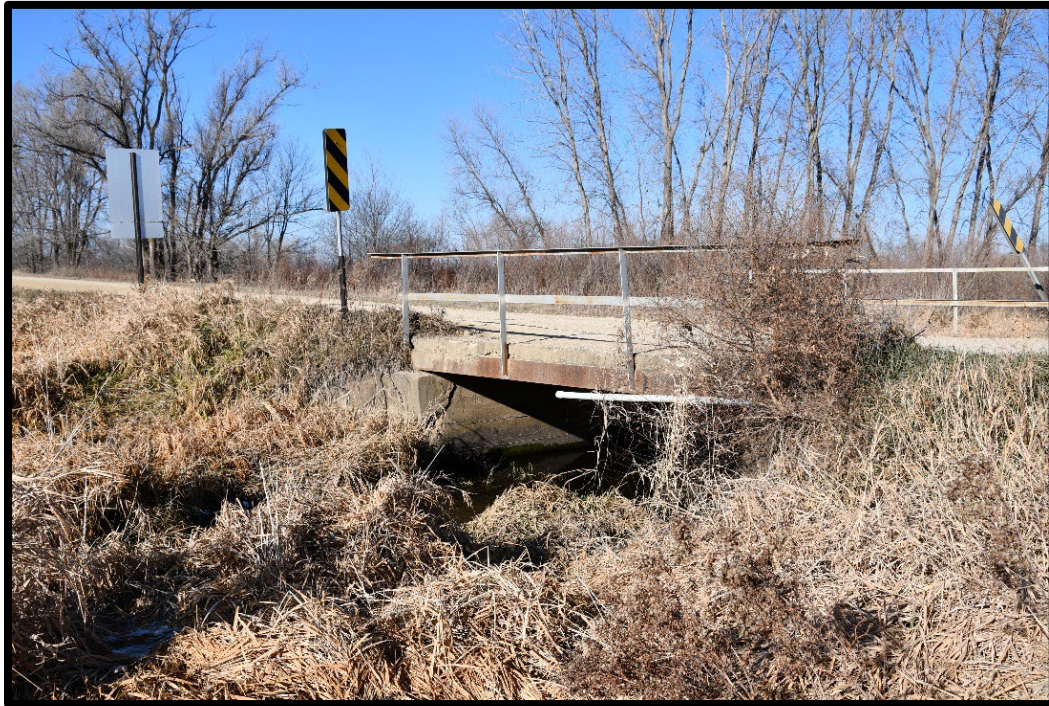
Plate 97. Bridge L3253, looking northwest.

This 1945 steel beam span bridge is located over a stream on Township Road 93, .01 miles west of the junction with CSAH 79. The main span length is 14.6 feet with a structure length of 17 feet. The cast-in-place concrete deck is 21.8 feet wide. The two-lane bituminous roadway (Township Road 93) with two-way traffic over the bridge has an approximate surface width of 22 feet. The bridge is supported by concrete footing piles. The bridge is painted and has signage indicating vehicle and semi load limits, as well as horizontal object markers. Metal railings and reinforced concrete abutments with wingwalls are located along the bridge.⁵³

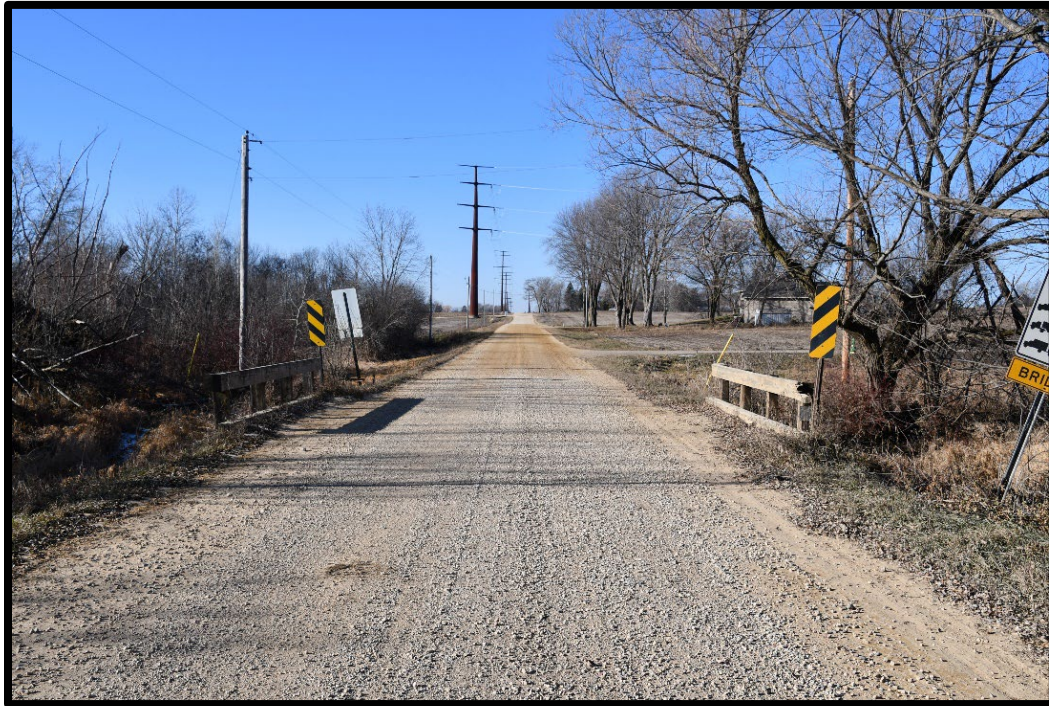
Plate 99. Bridge L3254, looking west.

This 1945 timber slab span bridge is located over the Vermillion River on Township Road 93, .05 miles west of the junction with CSAH 79. The main span length is 20.1 feet with a structure length of 22.1 feet. The timber deck is 25.8 feet wide. The two-lane gravel roadway (Township Road 93) with two-way traffic over the bridge has an approximate surface width of 24.3 feet. The bridge is supported by timber pile bents. The bridge has signage indicating vehicle and semi load limits, as well as horizontal object markers. Metal railings and timber abutments are located along the bridge.⁵⁴

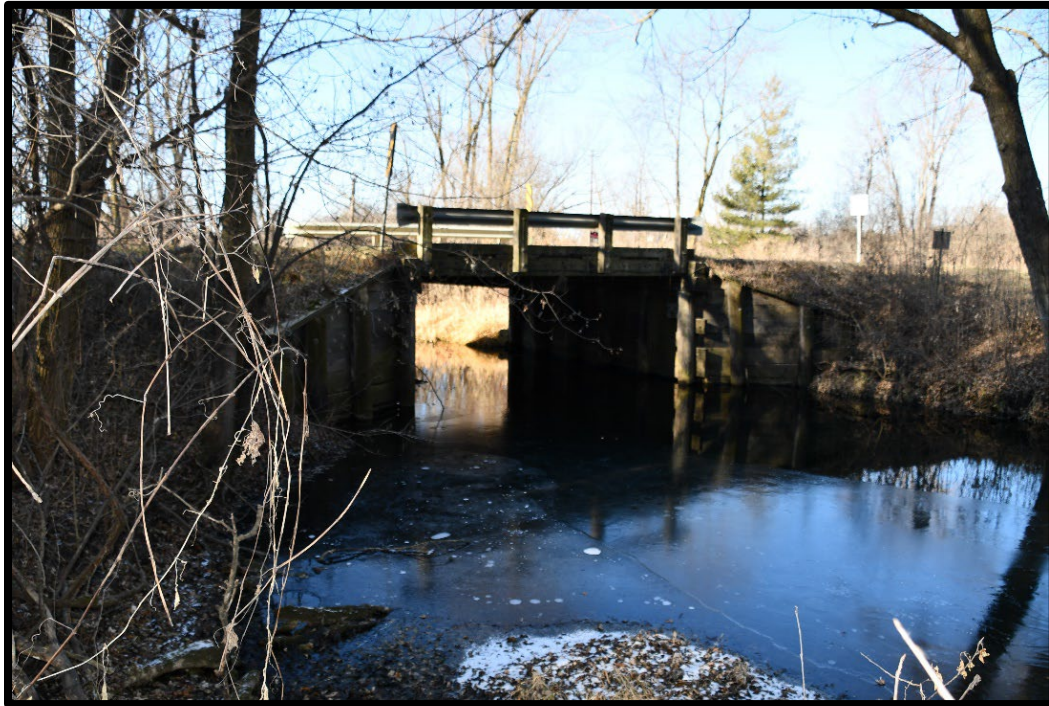
Plate 101. Bridge 19505, looking northwest.

This 1945 steel beam span bridge is located over the South Branch of the Vermillion River on Township Road 172, 1.4 miles north of the junction with CSAH 80. The main span length is 20.1 feet with a structure length of 22.2 feet. The timber deck is 26 feet wide. The two-lane gravel roadway (Township Road 172) with two-way traffic over the bridge has an approximate surface width of 24.6 feet. The bridge is supported by timber pile bents. The bridge has signage indicating load limit, as well as horizontal object markers. Metal and timber railings, timber abutments, and wingwalls are located along the bridge.⁵⁵
