**Appendix F**  
**Geotechnical Evaluation of New ISFISI Pads**

# Geotechnical Evaluation Report

New ISFISI Pads  
Xcel Energy – Prairie Island Nuclear Generating Plant  
1717 Wakonade Drive  
Welch, Minnesota

Project B2403029

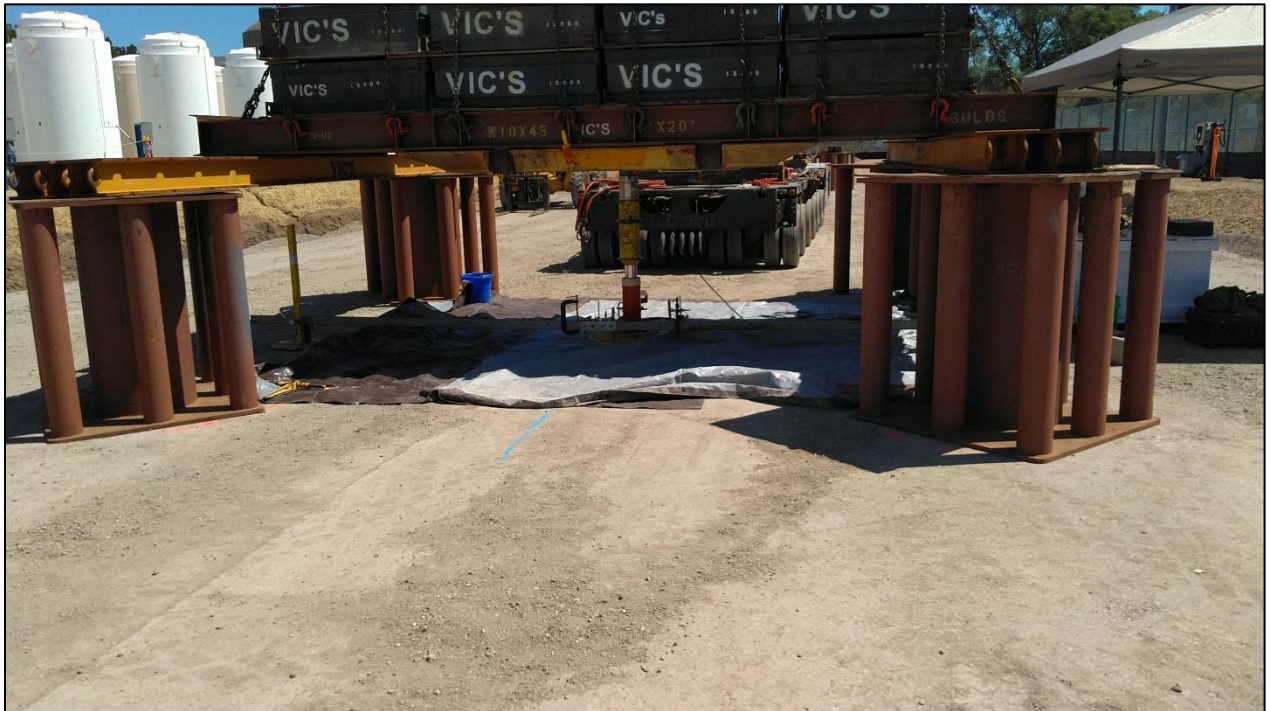
**Photograph 1. Test Setup at Location 1**

The load tests were performed by placing the hydraulic jack in line with a resistance weight and grillage totaling a reported 140,808 pounds (not including stands) to resist the force of the system, provided by others. Stands were placed 8 feet away. The actual loading point was chosen based on access and centered between the support stands. A photograph illustrating the setup is shown below.

- Spread tarps across the ground.
- Setup of the reaction measurement beam stand were located 8 feet from the bearing plate.
- Setting of the load plate using sand as needed to create level, uniform bearing.
- Setup ram, spacers, and load cell.
- Setup of the LVDT – three at equally spaced locations with same offset.
- Initialization of the DAQ.
- Pre-loading the bearing plate to achieve “zero” (ASTM 1196 – 5.4).
- Apply test loads at 5 kips, 10 kips and additional 10-kip increments to 120 kips.
