Line 3 Permanent Deactivation Plan

Enbridge Energy, Limited Partnership

Line 3 Permanent Deactivation Plan (U.S.)

January 2017

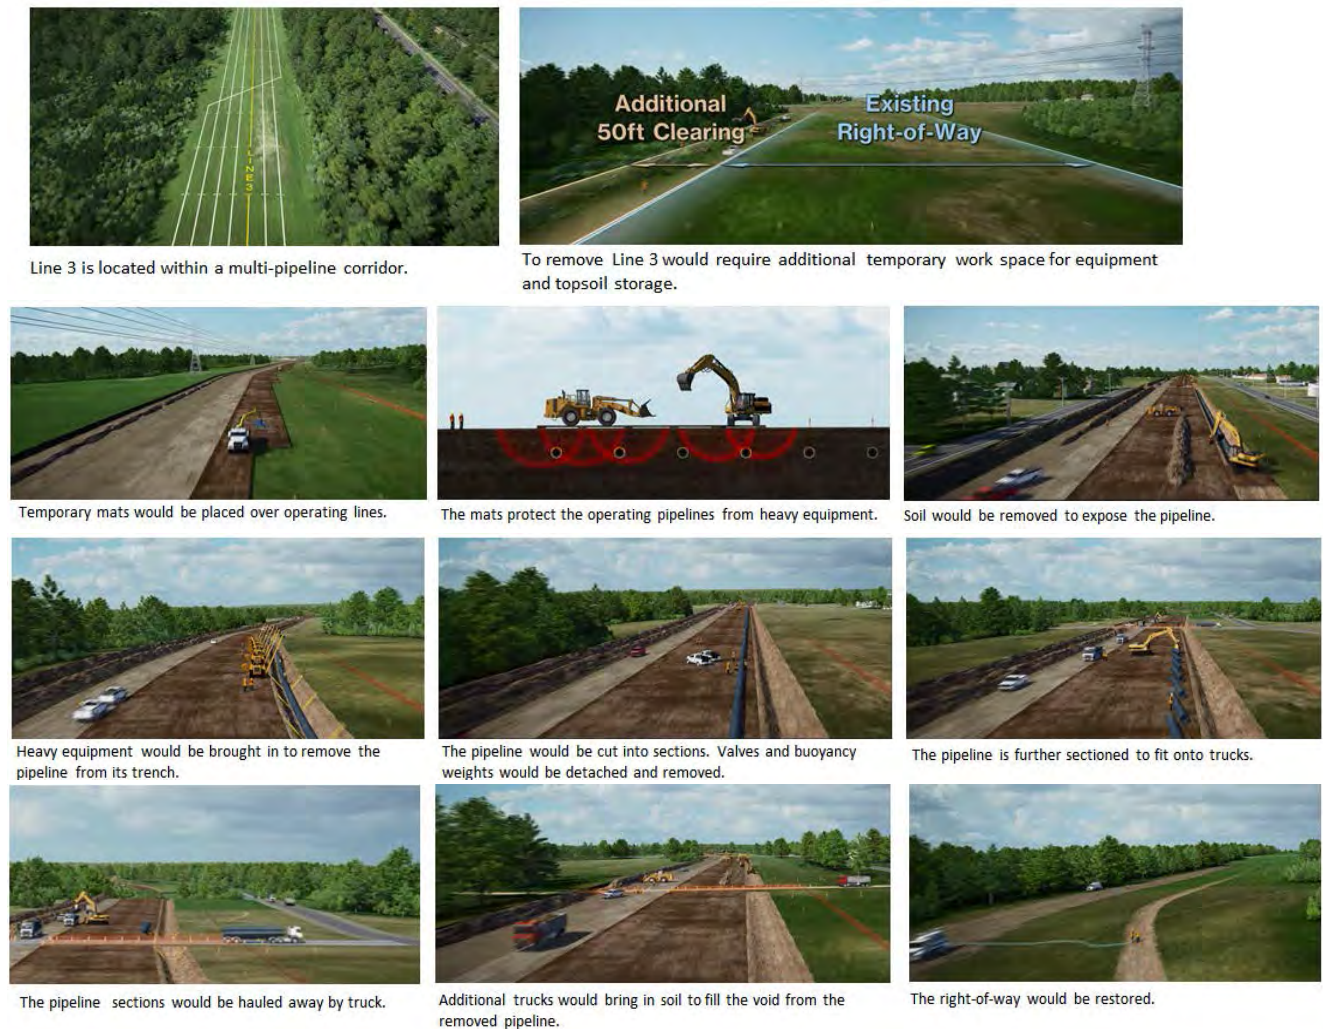
Figure 3-1: Stages of Pipeline Removal

In areas where the abandoned pipe is both (a) on the interior of a multi-pipeline corridor and (b) within a saturated wetland, mats and sheet piling will not provide the protections they would normally offer in a dry area based upon the lack of bearing capacity of the saturated wetland's soil. This lack of bearing capacity introduces the potential for the placed matting to *sink* when it is driven over by heavy equipment. This sinking could progress all the way until the mats are resting upon those very same pipes they were once trying to protect. Again, because of the lack of bearing pressure, even when considering relatively long sheet piling, there exists risk that driven sheet pile will not "reach bottom" and, as such, will not serve as adequate soil stability or as the "foundation" for a temporary matting road and would prevent access to those areas. Due to the access issues identified in saturated wetlands, Enbridge anticipates there will be areas where pipe removal cannot be safely performed. Please see Figure 3-1 which shows the stages of pipeline removal.

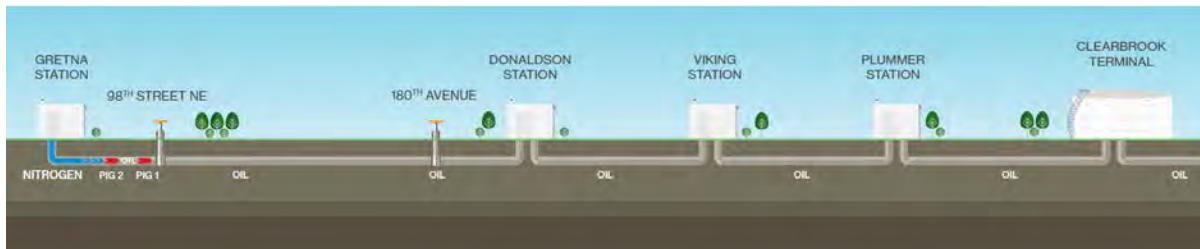
Figure 4-2: Purge Diagram (Gretna to Clearbrook)

For each section, a batch of two (2) 34" pigs will be loaded and launched. The first pig will be a purge pig followed by a batch of oil and a tailing purge pig. Nitrogen injected at the beginning of the section is used to propel the pigs to the downstream side of the nearest intermediate station. This will "push" the oil along the pipeline. The purge operation will continue by injecting nitrogen at each of the intermediate stations until the pigs reach the end of the section; the Clearbrook Terminal (MP 909) or Superior Terminal (MP 1097), respectively. The oil that has been pushed to the terminus of the pipeline (i.e., purged oil) will be delivered to tankage at either the Clearbrook Terminal for section 1 or the Superior Terminal for section 2. All purging activities will be undertaken subject to any federal, state or local permitting requirements.

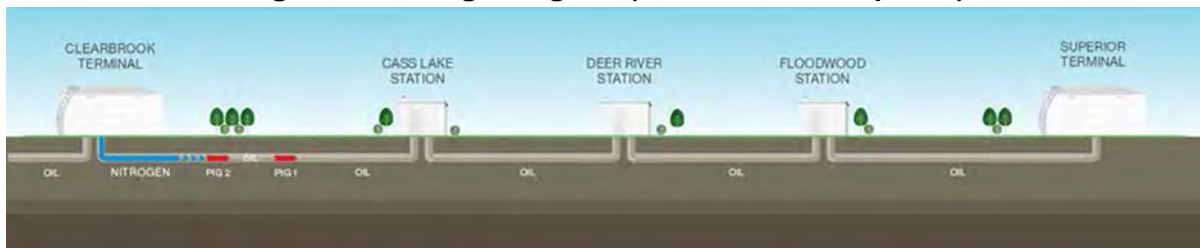
Figure 4-3: Purge Diagram (Clearbrook to Superior)

Section two will consist of a pipeline purge, pipeline cleaning, and disconnecting the pipeline from the facilities at Clearbrook Terminal (MP 909) and along the pipeline to the Superior Terminal (MP 1097). See Figure 4-3.

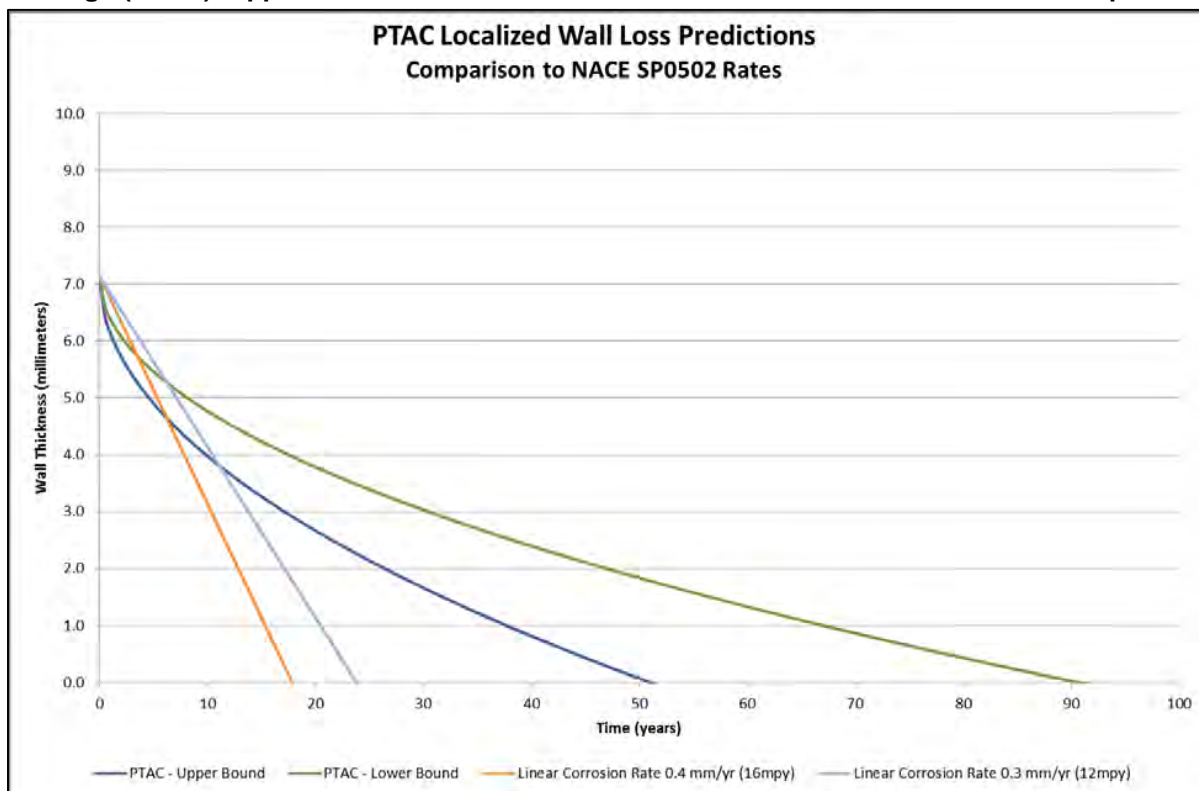
Figure 4-6: Upper and Lower Bound Wall loss progression due to corrosion as a function of soil drainage (PTAC). Applicable NACE SP0502 corrosion rates have been included for comparison.

These corrosion rates are generally considered conservative as presented below in Section 4.3.6, but are presented for comparison.

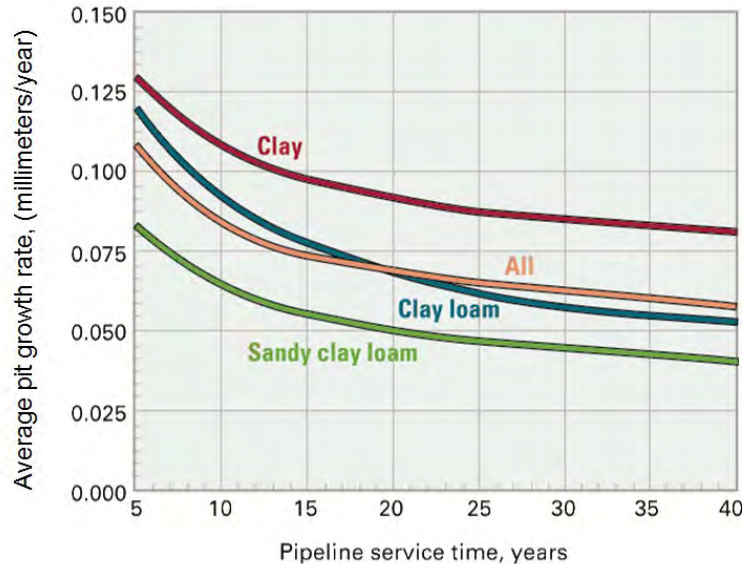
Figure 4-7: Average Corrosion Pitting Growth Rates as a Function of Time and Soil Classifications (Reproduced from Oil and Gas Journal – Corrosion)¹⁷

Both general and pitting corrosion rates have been shown to decline with age, as shown in Figure 4-7.¹⁷ Velazquez presented a statistical analysis of over 250 excavations to predict the long term rates of pitting corrosion over a 40 year period.¹⁷ For comparison, the worst case pitting growth rate (based on the X80 value) for the various soil types considered in this study was presented as 0.119 mm/year (4.7 mpy), or roughly a third of the 0.4 mm/year growth rate proposed by NACE.¹⁵

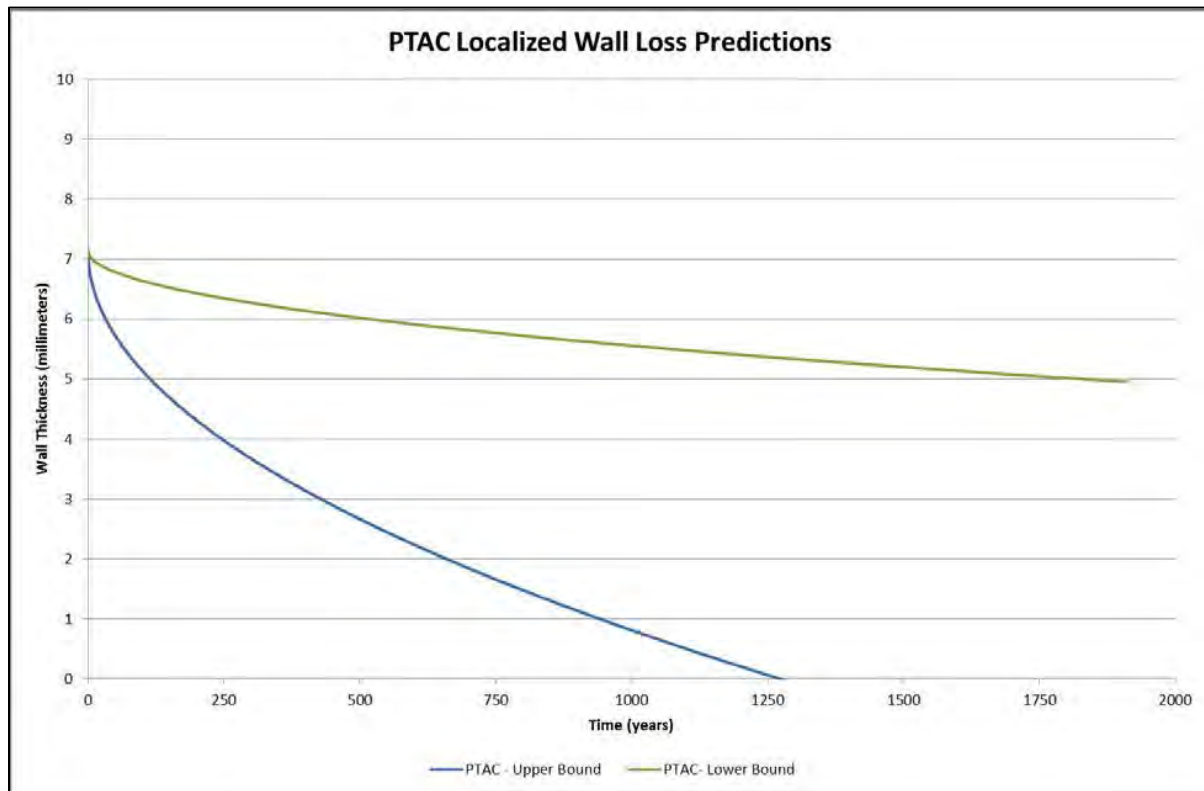
Figure 4-9: Pipe Wall Thickness Affected by Uniform Corrosion as a Function of Time and Drainage of the Soil (PTAC). Comparison to 2011 ILI Results.

An analysis was conducted to evaluate the time it would take for the entire pipe wall thickness to corrode to zero due to uniform corrosion. Figure 4-9 shows the wall thickness reduction with time due to uniform external corrosion under types of soils, one considering good drainage resulting in a generally moderate corrosion rate (green curve), and one with very poor drainage resulting in a more aggressive corrosion rate (blue curve). The worst case estimates for time to total pipe degradation due to generalized corrosion, based on the PTAC model are greater than 1,250 years.

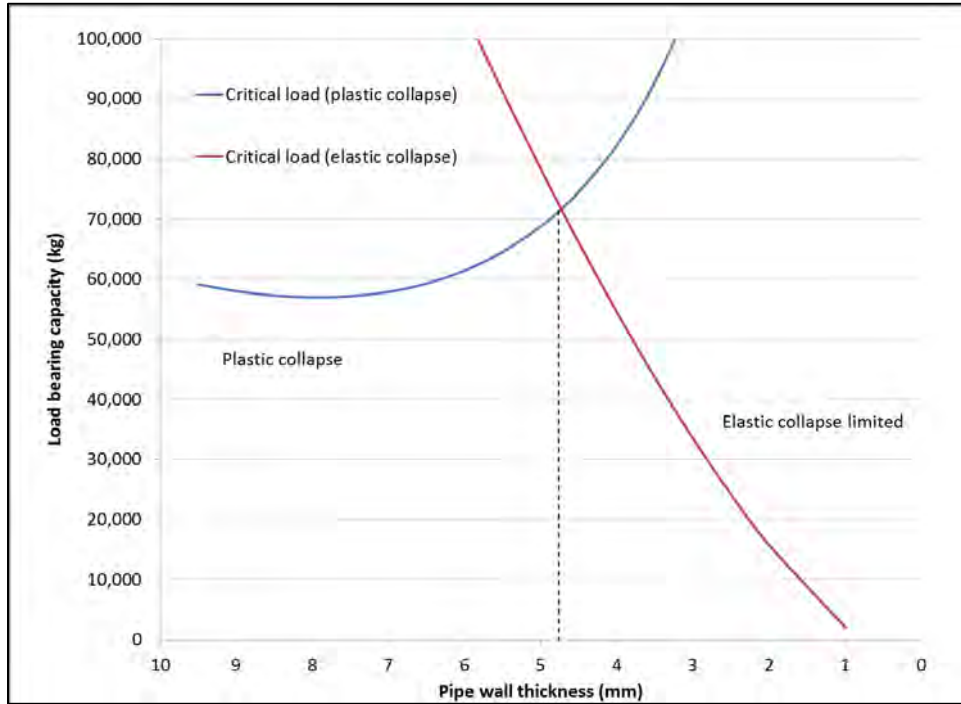
Figure 4-13: Example Plot of Load Bearing Capacity as a Function of Pipe Wall Thickness 2

As represented in Figure 4-13, the pipe can fail in two ways (elastic and plastic). As the pipe wall thins, the wall becomes more flexible being able to support greater loads following the blue curve. At the intersection of the curves, the pipe becomes weaker; following the red curve as the wall thickness decreases until failure results from a given load.

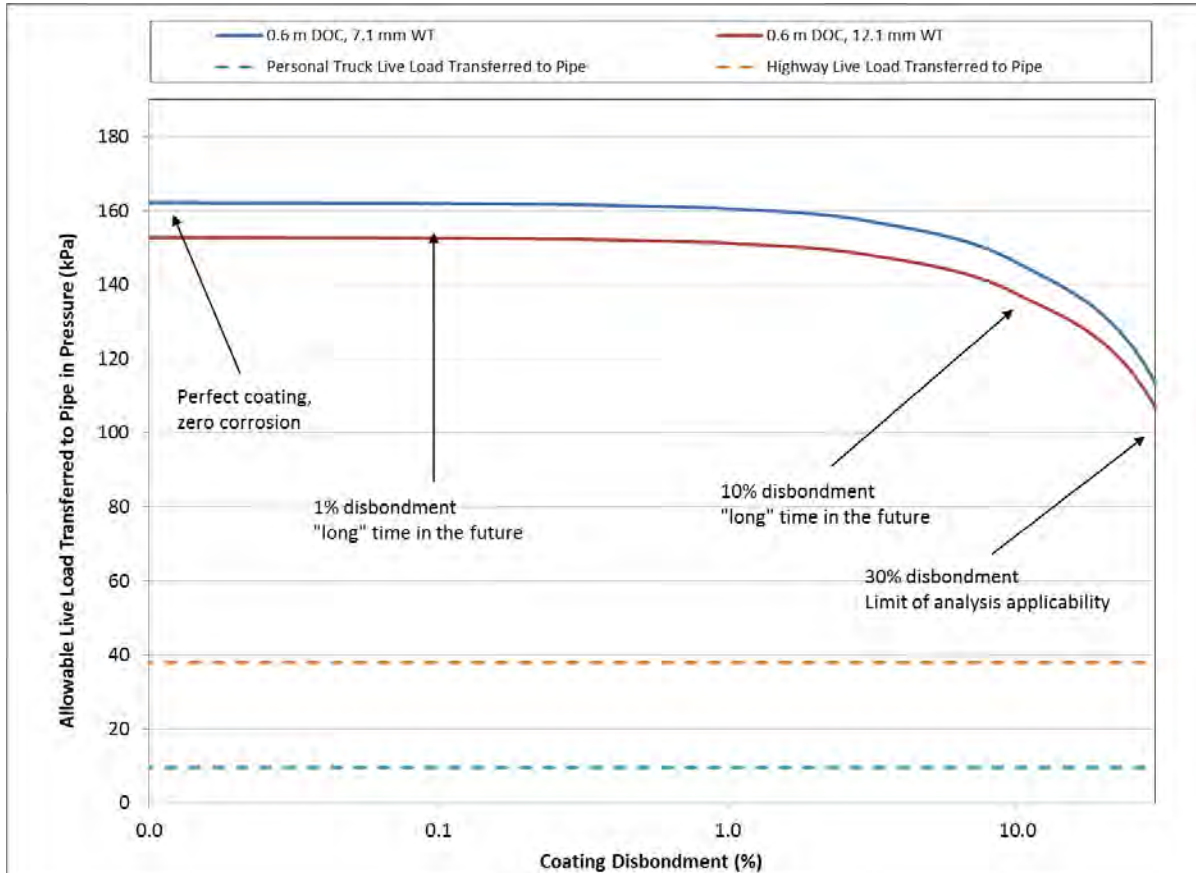
Figure 4-16: Allowable surface loading per Pitting Corrosion Model, at 0.6m (2.0 ft.) DOC

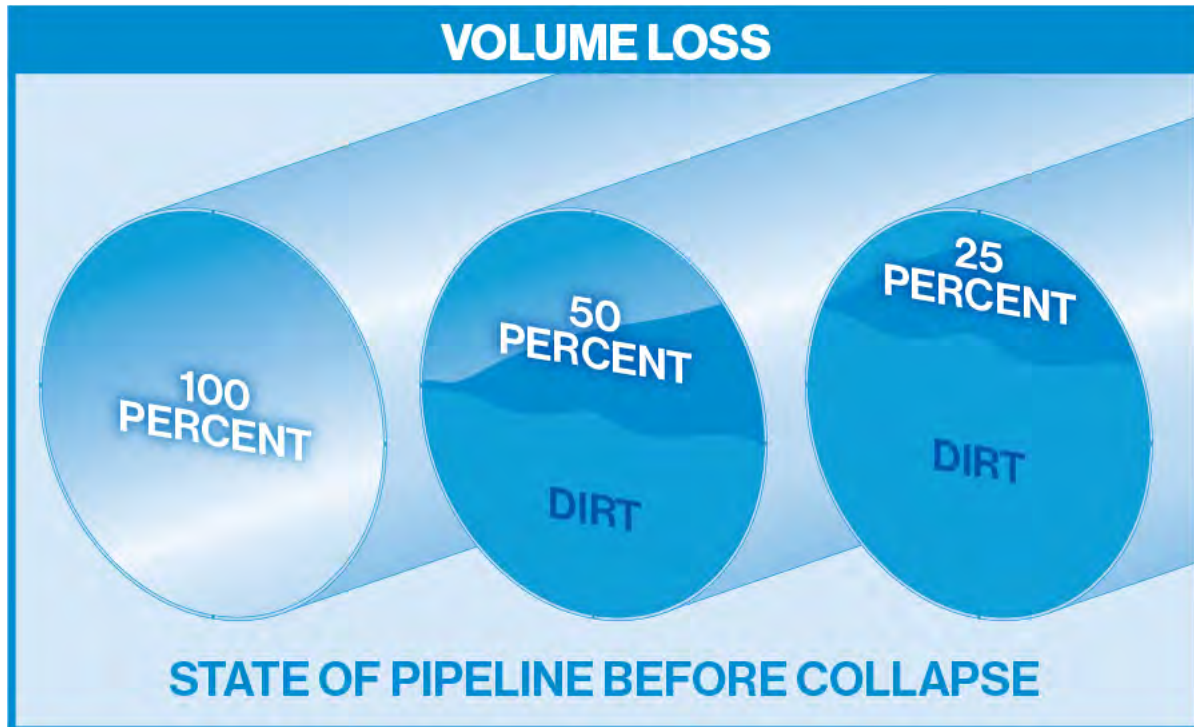
Figure 4-19: Pictorial Representation of Volume Loss for the 100%, 50%, and 25% Scenarios

A series of assessments were conducted to predict ground subsidence profiles considering 25%, 50% and 100% volume loss at various depths of cover. Note: 100% volume loss represents complete infill of the pipeline (i.e., at the time of collapse, the pipe is completely empty), while the 25% and 50% volume loss estimates represent a partial infill of the pipeline

(i.e., at the time of collapse, 75% and 50% of the pipe is filled with soil, respectively), see figure 4-19.

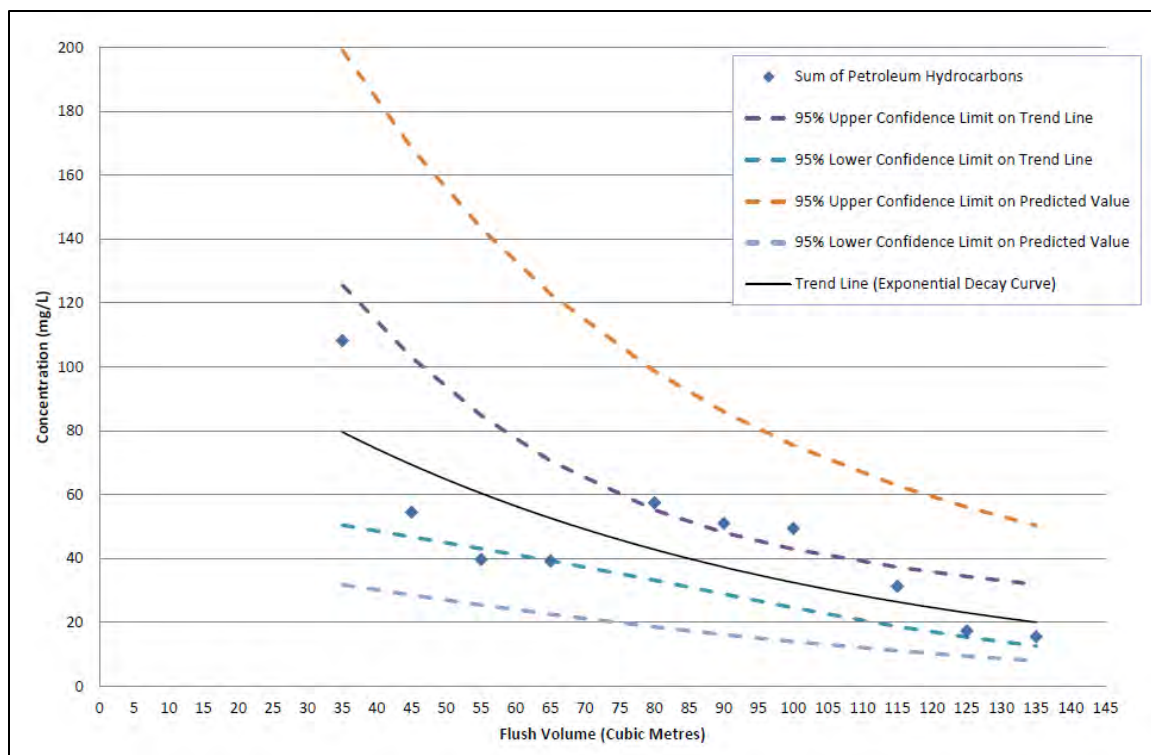
Figure 2: Rinse train sample TPH analysis based on flush volume

Samples taken at the discharge of the pipeline demonstrated that the cleaning program developed was effective in removing residual hydrocarbons from the deactivated pipeline. The cleaning and rinse trains were designed to identify possible limitations in cleaning technologies when decommissioning Line 3. Sampling of the water rinse batches indicated a strong downward trend in the concentration of hydrocarbon constituents between rinse batches as shown by Figure 2. The remaining water flush sample concentrations ranged from 108.2 mg/L for the initial sample to 15.54 mg/L for last samples of the final rinse. As the total petroleum hydrocarbon (TPH) concentrations in the water samples produced a statistically significant exponential decay curve with a high degree of confidence, the measured decrease in the TPHs are expected to be repeatable when using similar cleaning methodology, cleaning equipment/materials, and initial conditions on Line 3.
